BUILDING INSPECTION

Complies with Australian Standard AS 4349.1-2007 Inspection of Buildings Part 1: Pre-Purchase Inspections of Residential Buildings - Appendix C

19 Bunberra St Cronulla, NSW 2230, Australia

Inspection Date: 04 Sep 2016 Inspected by:

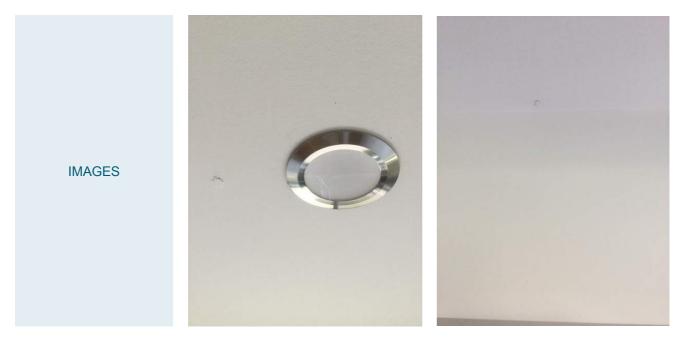
Comments : Defect Significance: Defect Type: Nail popping evident near down light & bulk head Minor B (Distortion, Warping, Twisting)

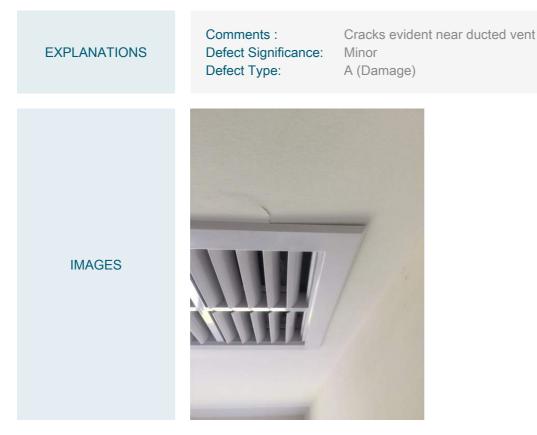
Ceiling

X Moderate cracks were located in areas

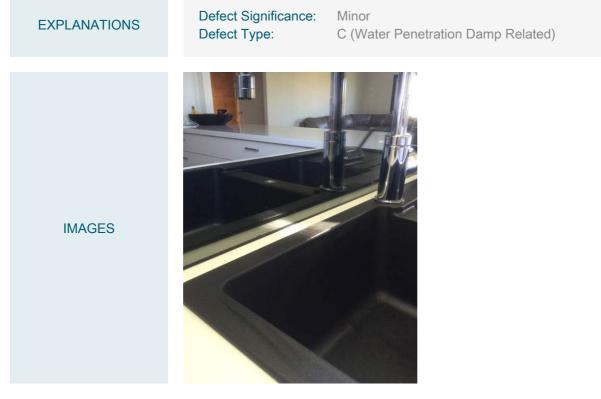
Splashback

× Reseal at bench and splashback junctions

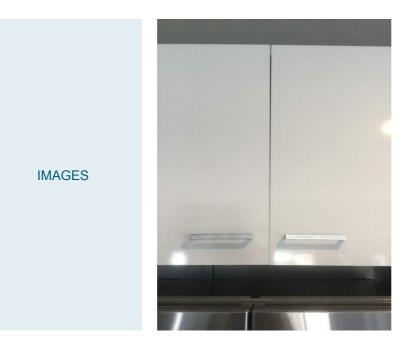
Comments : Defect Significance: Defect Type: Doors binding above fridge hinges require adjusting Minor E (Operational)

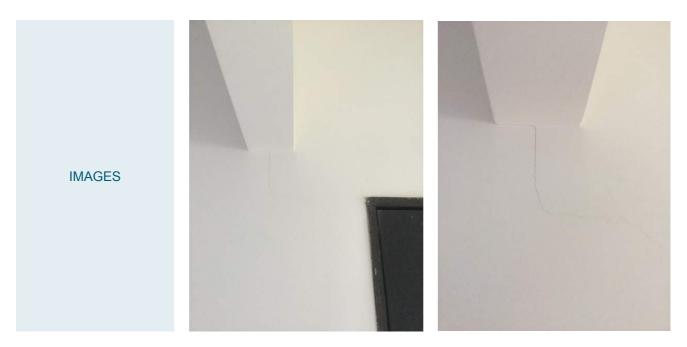
EXPLANATIONS	Comments :	Cracking under support beam evident (Next to side entrance door)
	Defect Significance: Defect Type:	Minor B (Distortion, Warping, Twisting)

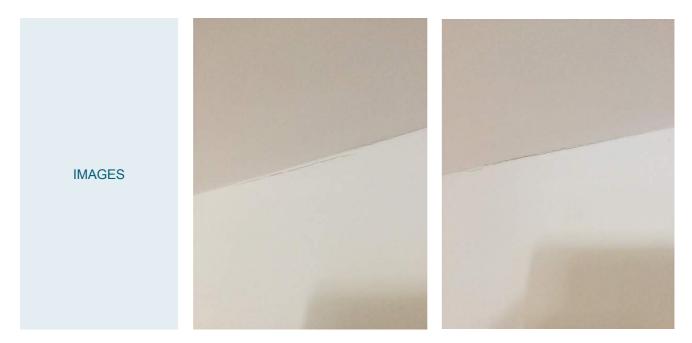
imes Minor cracks to lining joints evident in areas

EXPLANATIONS	Comments :	Cracks evident at wall & ceiling junction rear wall (north wall) of dining
	Defect Significance: Defect Type:	Minor B (Distortion, Warping, Twisting)

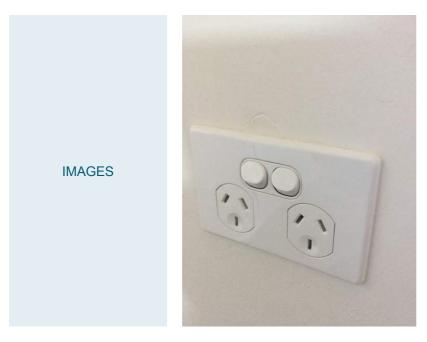
Patching evident above power point western wall Minor A (Damage)

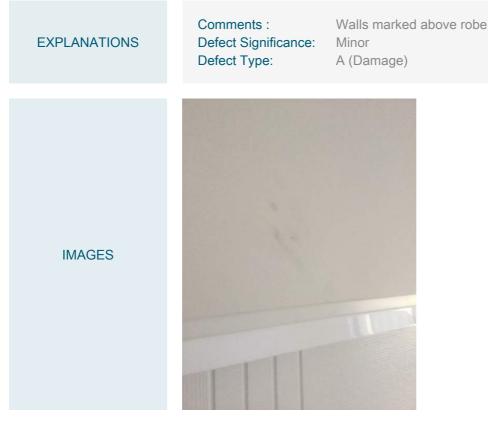
Walls

× Marked & scuffed in areas

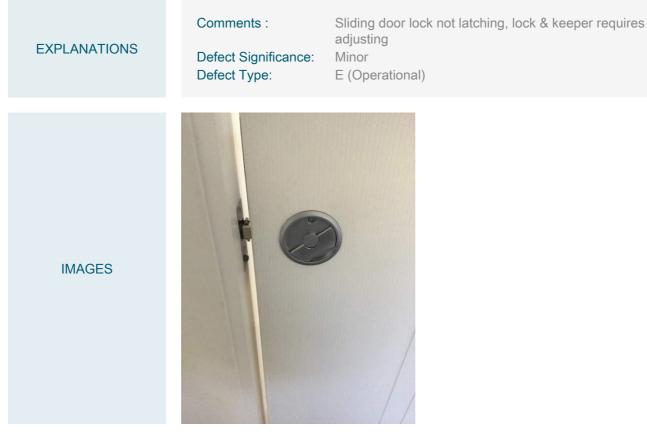
Door/s and door furniture

× Not latching

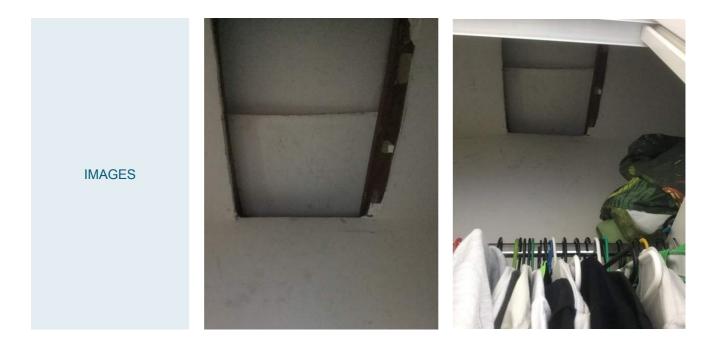
Defect Significance: Defect Type: Man hole located in robe bed 2 , man hole cover incomplete. Minor E (Operational)

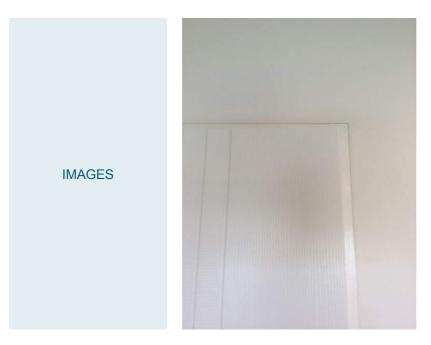
Top of door binding on door jamb E (Operational)

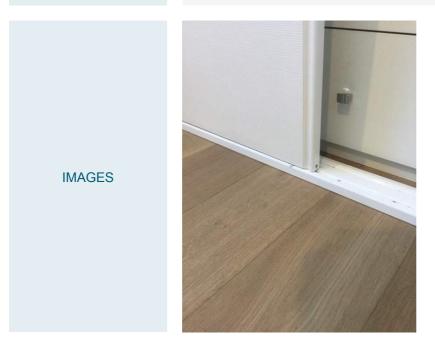
Rollers on middle door require adjusting Minor E (Operational)

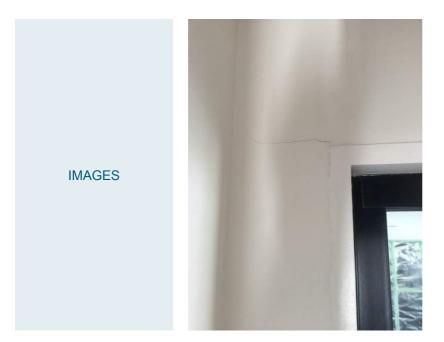
× Minor cracks to lining joints evident

Cracking evident around sliding glass door Minor B (Distortion, Warping, Twisting)

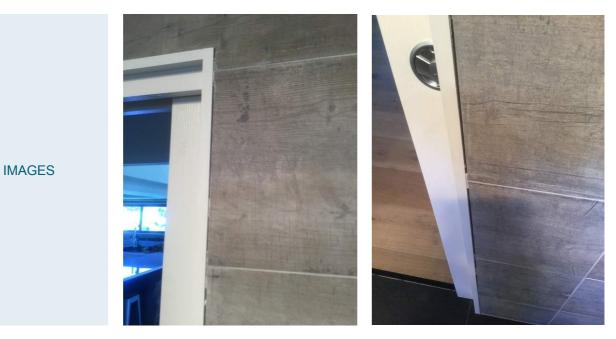
Comments : Defect Significance: Defect Type: Re-sealing required around door jamb Minor C (Water Penetration Damp Related)

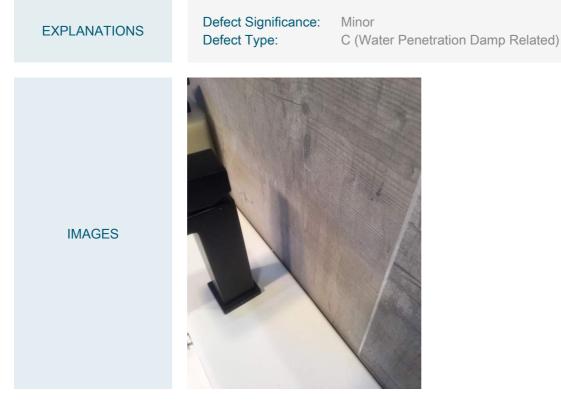
Splashback Tiles

imes Re-seal at wall and basin junction

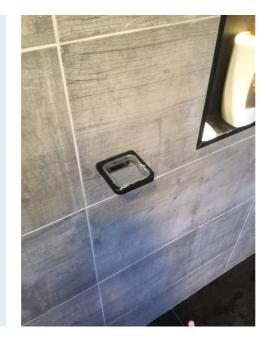
× Broken Soap Holder

Comments : Defect Significance: Defect Type: Soap dispenser not located in shower recess Minor E (Operational)

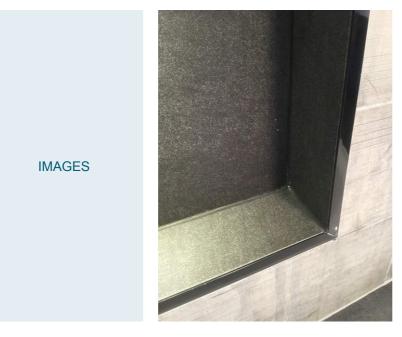
Neiche requires re-sealing Minor C (Water Penetration Damp Related)

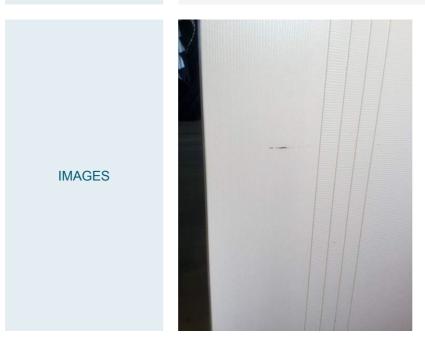
Defect Significance: Defect Type: Sliding door catching on screw inside of frame causing damage to door (Door requires adjusting) Minor A (Damage)

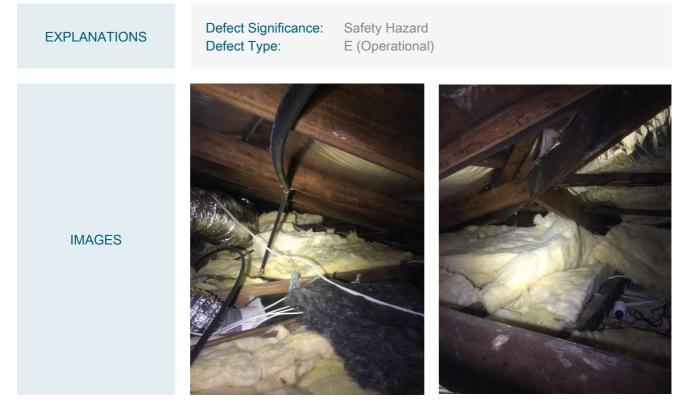
Defect Significance: Defect Type: Exhaust fan from bathroom has fallen off purlin, sitting on air conditioner ducting suggest re-fitting back onto purlin. Minor E (Operational)

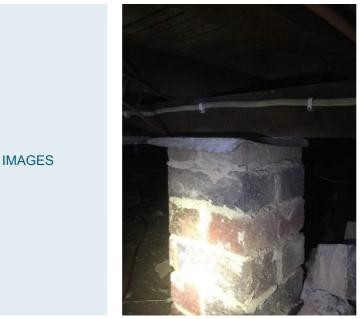
\times Ant capping inadequate

EXPLANATIONS	Comments :	Ant capping inadequate on many piers.Inadequate ant-capping must be replaced and installed as required.
	Defect Significance: Defect Type:	Minor E (Operational)

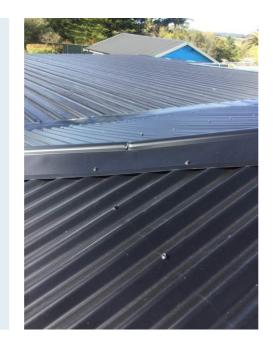
Comments : Defect Significance: Defect Type: Ridge dented (West side of property) Minor A (Damage)
