# BUILDING INSPECTION

Complies with Australian Standard AS 4349.1-2007 Inspection of Buildings Part 1: Pre-Purchase Inspections of Residential Buildings - Appendix C

21 Island Point Road Campbeltown, NSW 2560, Australia

Inspection Date: 23 Jan 2017, (none) to (none)

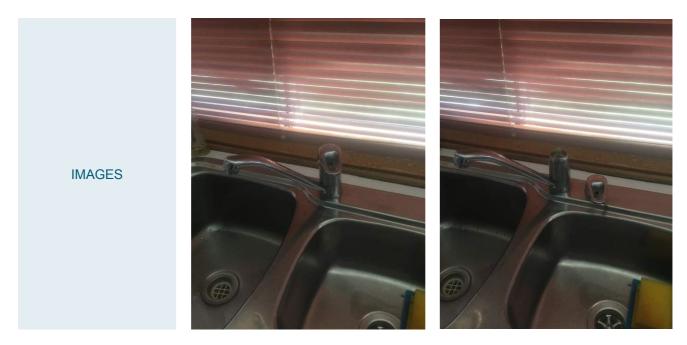
imes Reseal at bench and splashback junctions

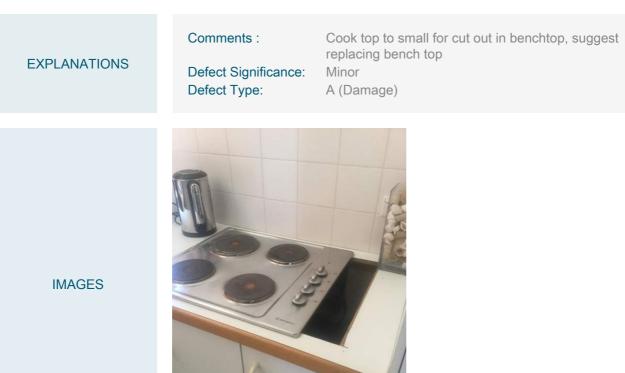
# Bench top

× Laminate lifting evident

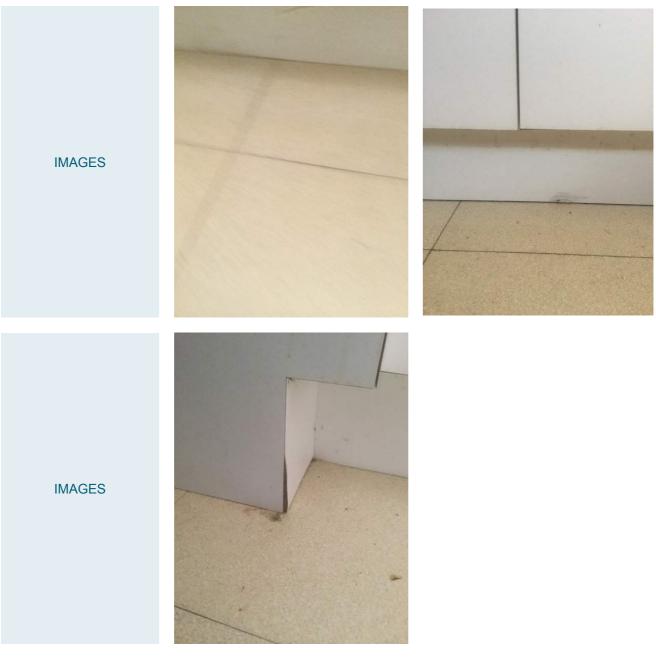
# **Bottom Cupboards**

$\times$ Damage evident

Minor A (Damage)

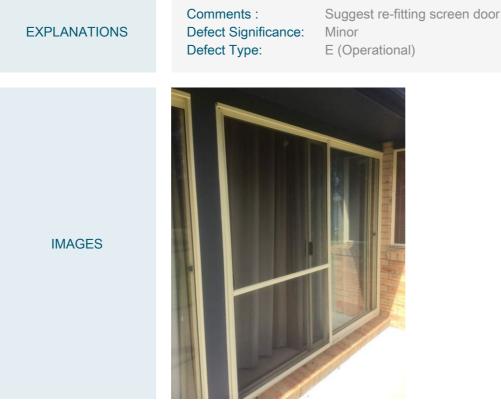
# Rear security/screen door

× Screen mesh damaged suggest replacing

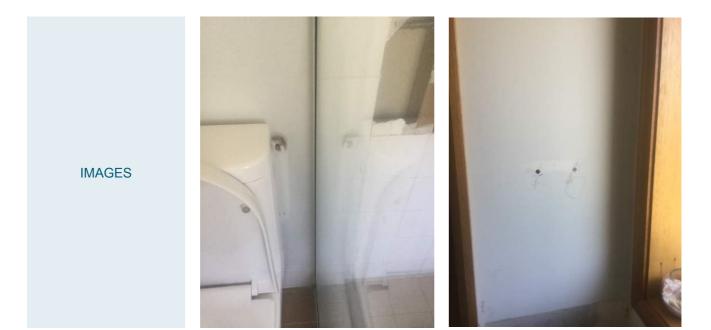
# Painting

× Poor condition

EXPLANATIONS	Comments :	Damage evident around mixer area. Water penetration evident onto gyprock in adjacent room front entrance linen press.
	Defect Significance:	Major
	Defect Type:	C (Water Penetration Damp Related)

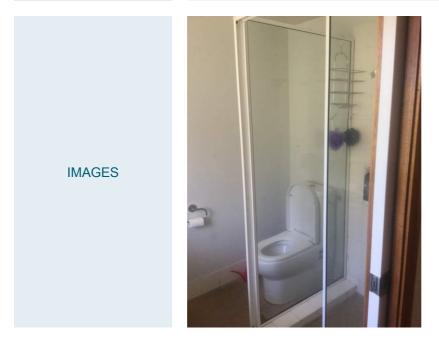
# Shower Recess Under Water Test

➤ Leaking evident in adjacent room

Defect Significance: Defect Type: Shower leak evident in bedroom 1 wet carpet & underlay Major C (Water Penetration Damp Related)

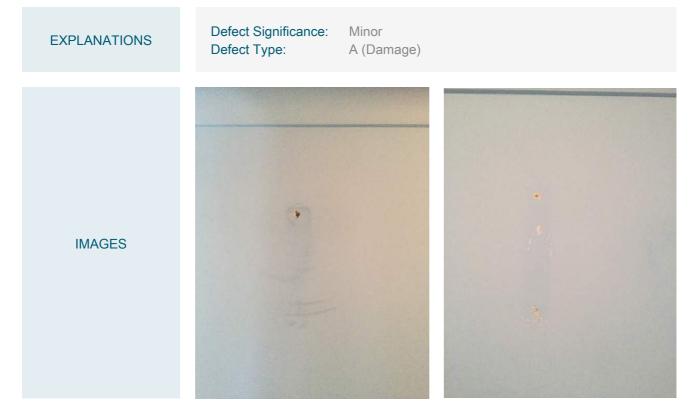
#### Painting

$\times$  Poor condition

EXPLANATIONS	Defect Significance:	Minor
	Defect Type:	A (Damage)

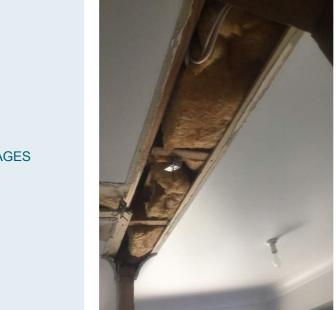
Comments : Defect Significance: Defect Type: Bottom chord not supported suggest hanging beam Major E (Operational)

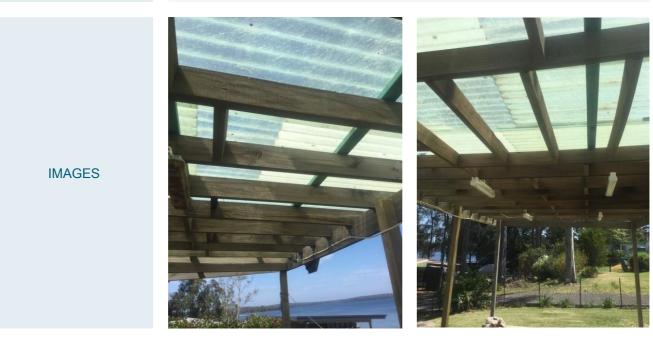
Defect Significance: Defect Type: Spacing between rafters do not meet Australian standards sagging evident suggest removal, seek council for approval of rear pergola Safety Hazard E (Operational)

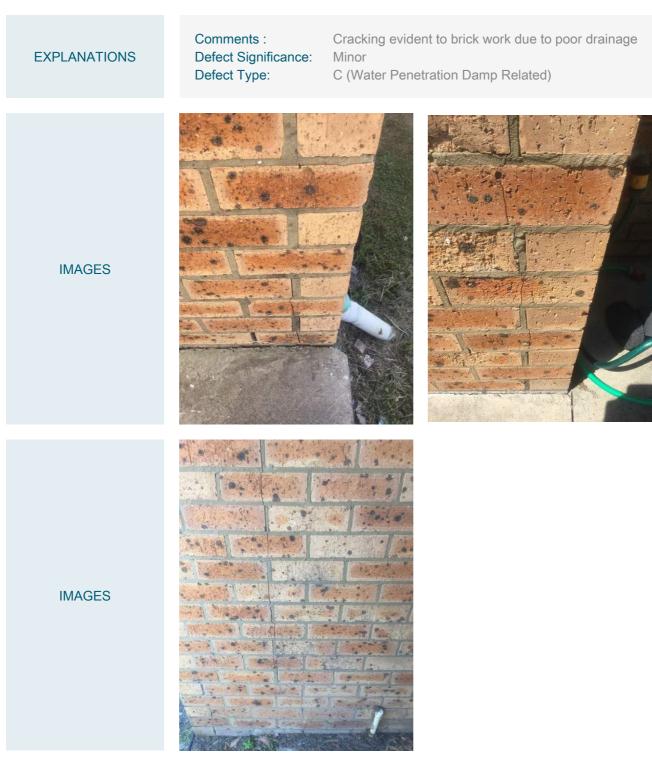
#### Exterior brick/render finish

X The wall is black or green algae affected

Defect Significance: Defect Type: Minor C (Water Penetration Damp Related)

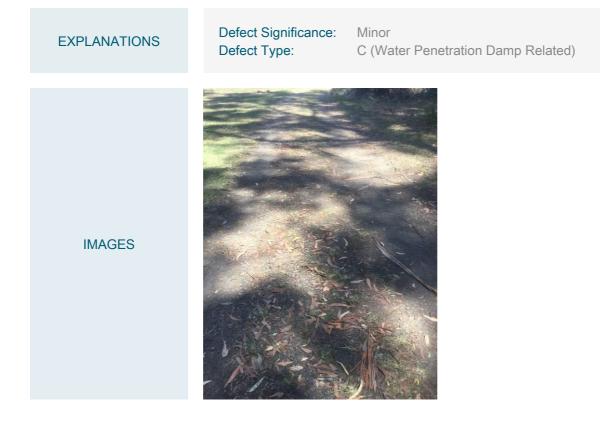
#### Driveway

$\times$  Cracks evident in areas

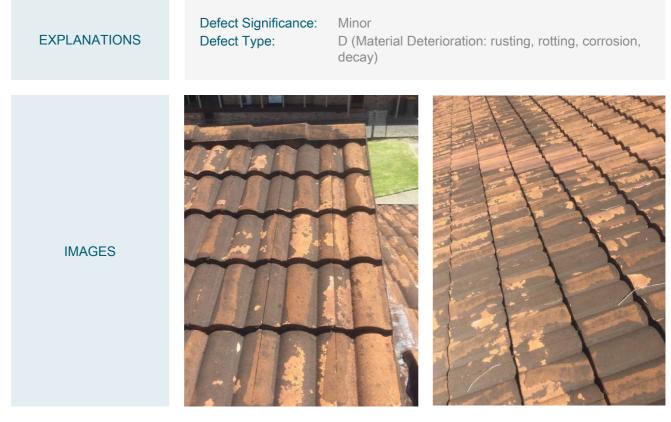
#### **Roof Covering**

Tiles require re-fitting in areas  $\times$
