BUILDING INSPECTION

Complies with Australian Standard AS 4349.1-2007 Inspection of Buildings Part 1: Pre-Purchase Inspections of Residential Buildings - Appendix C

80 Coogee Street Kiama, NSW 2533, Australia

Inspection Date: 16 Feb 2017, 7:44 AM to 10:08 AM

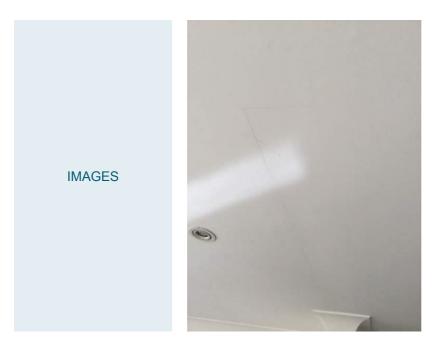
➤ Cracks to lining evident in some areas

Defect Significance: Defect Type:

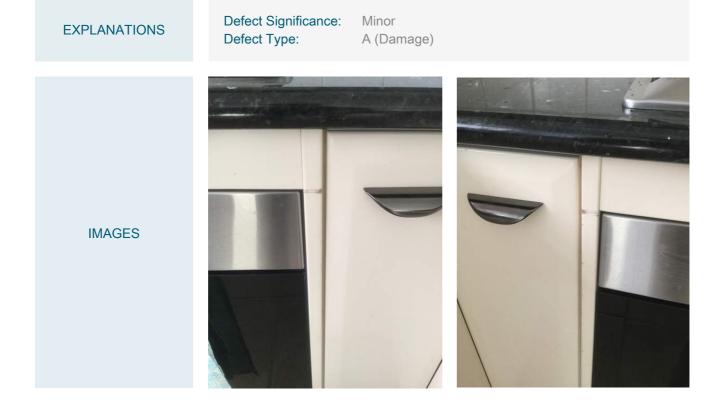
Bottom Cupboards

× Damage evident

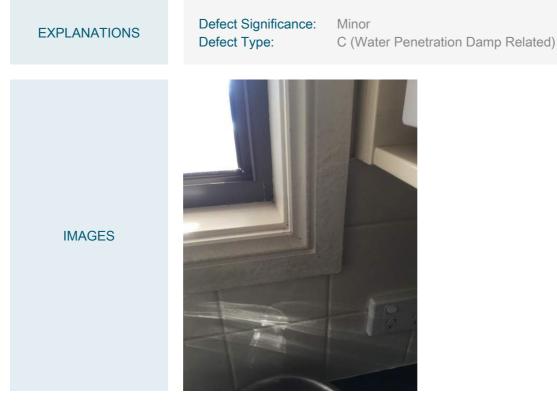
Architraves

× Water damage evident

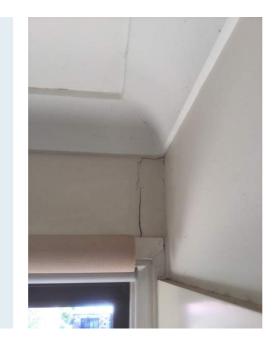
× Minor cracks to lining joints in areas

Defect Significance: Defect Type: Minor B (Distortion, Warping, Twisting)

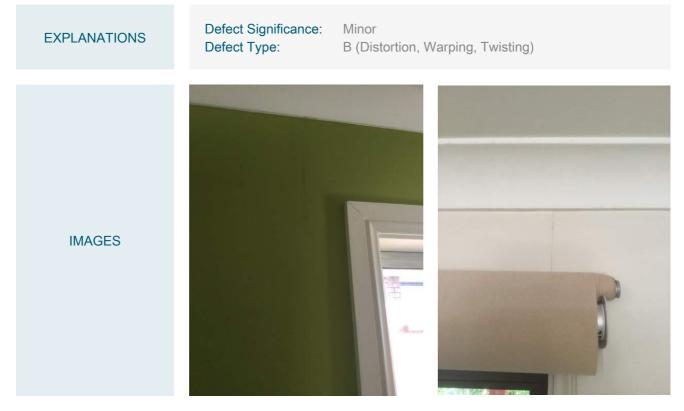
Walls

imes Minor cracks to lining joints evident in areas

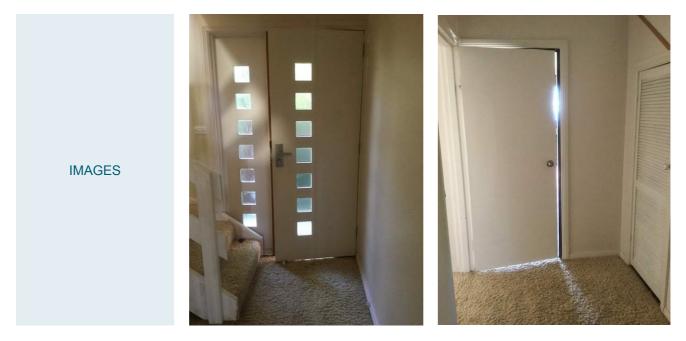
× Damaged plasterboard evident

EXPLANATIONS	Defect Significance: Defect Type:	Minor A (Damage)
IMAGES

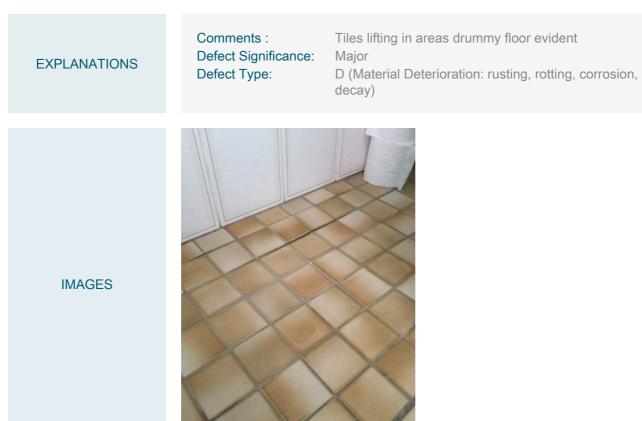
Ensuite floor

× Other

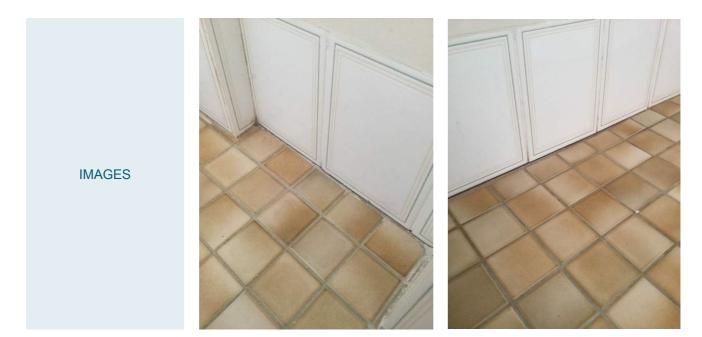
Comments : Defect Significance: Defect Type: Skirting tiles & floor tiles separating Major D (Material Deterioration: rusting, rotting, corrosion, decay)

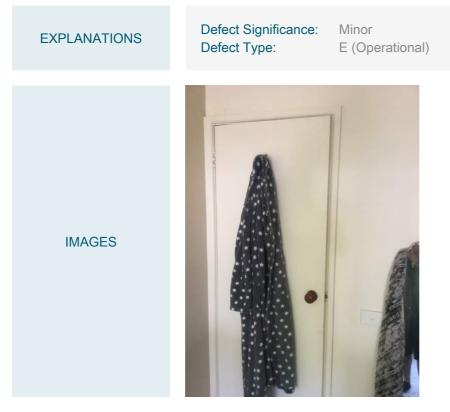
Door/s and door furniture

X Door binding suggest shaving or cutting

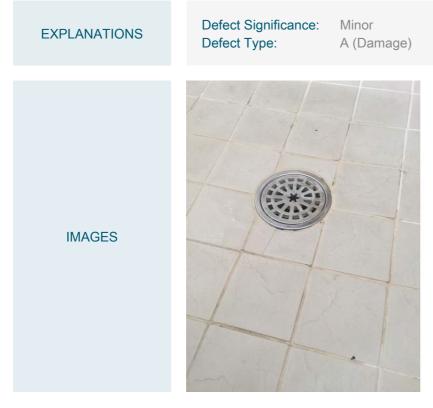
Shower floor

× Cracked tiles evident

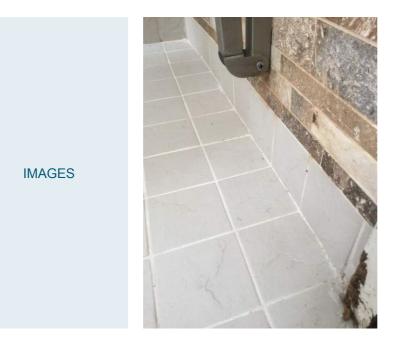
Shower floor

imes Re-seal at wall and floor junction

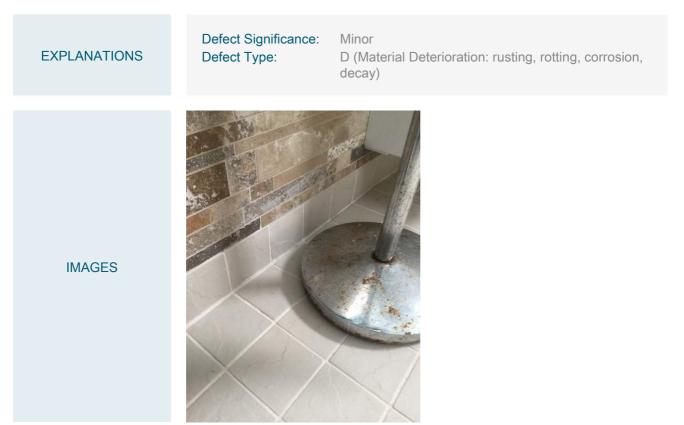
Bathroom floor

\times Re-seal at wall and floor junction

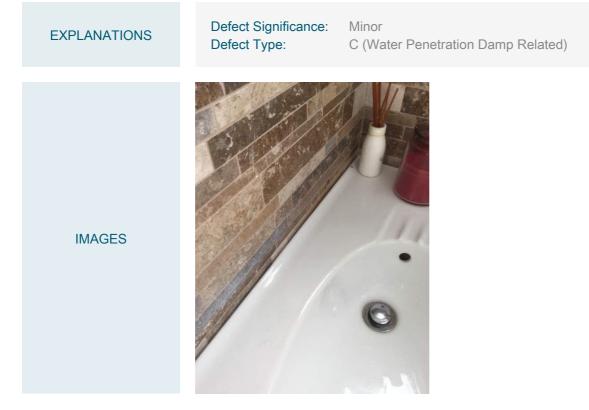
Splashback Tiles

\times Re-seal at wall and basin junction

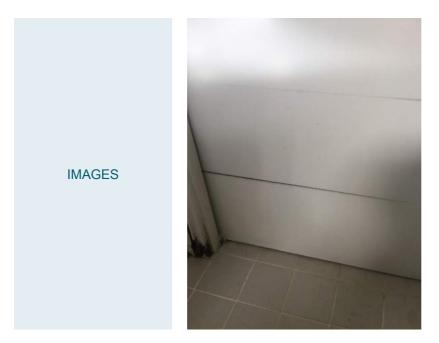
× Door damaged

Defect Significance: Minor Defect Type:

A (Damage)

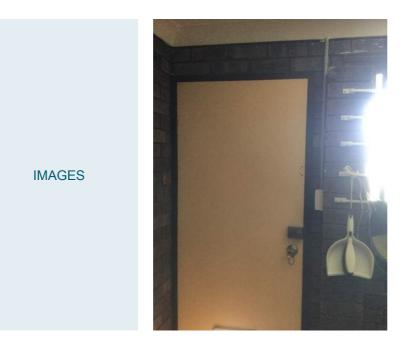
Door binding suggest shaving or cutting Minor E (Operational)

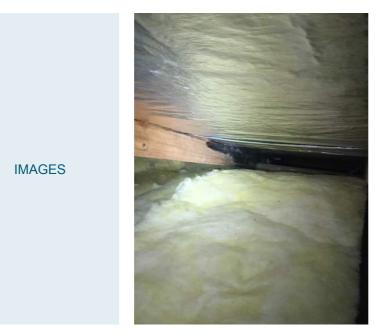
\times Decay evident in roof elements

Decay & water damage evident Minor C (Water Penetration Damp Related)

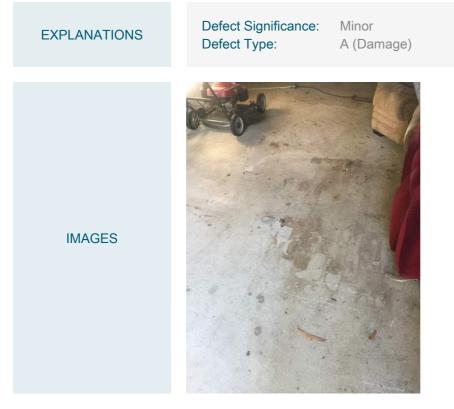
Concrete Floor

× Stained & marked in areas

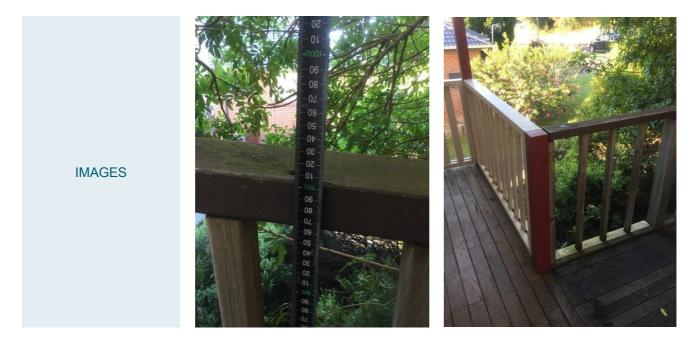
Balustrade

× Minor wood decay evident

EXPLANATIONS	Defect Significance: Defect Type:	Minor D (Material Deterioration: rusting, rotting, corrosion, decay)
IMAGES

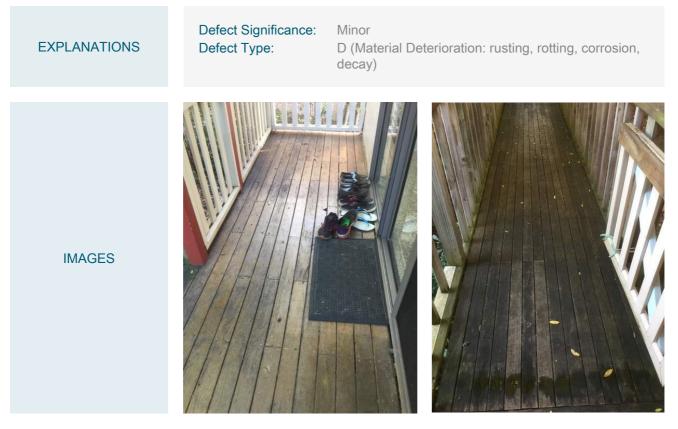
Decking

× Suggest oiling / staining for further weather protection

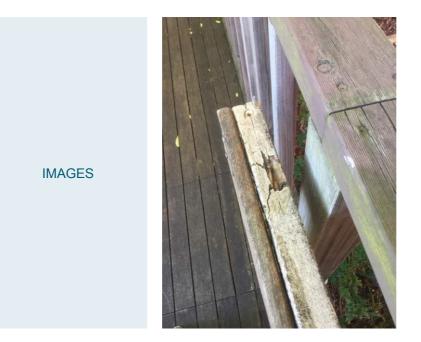
Comments : Defect Significance: Defect Type: Decay evident on gate Minor D (Material Deterioration: rusting, rotting, corrosion, decay)

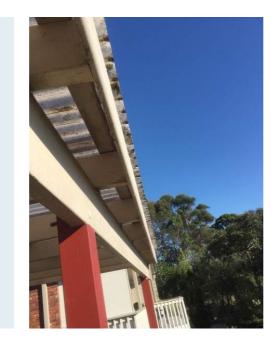
Comments : Defect Significance: Defect Type: Suggest gutter & down pipes to improve drainage Minor C (Water Penetration Damp Related)

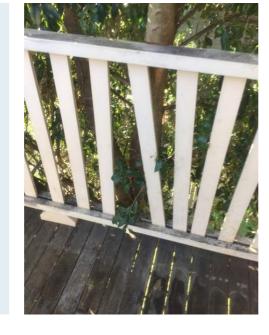
Tree causing damage to balustrade suggest removal of branches & replacement of balustrade Safety Hazard A (Damage)

Balusters require re-fixing Safety Hazard A (Damage)

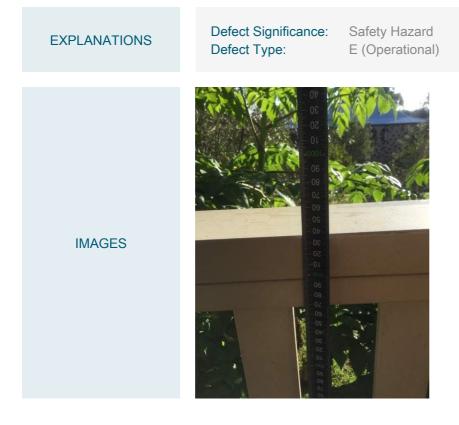
Balustrade

imes Hand rail height does not meet Australian standards requirements of 1m

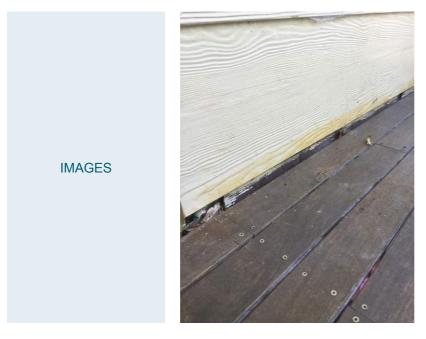
EXPLANATIONS	Comments : Defect Significance: Defect Type:	Decay evident in areas Minor D (Material Deterioration: rusting, rotting, corrosion, decay)
IMAGES

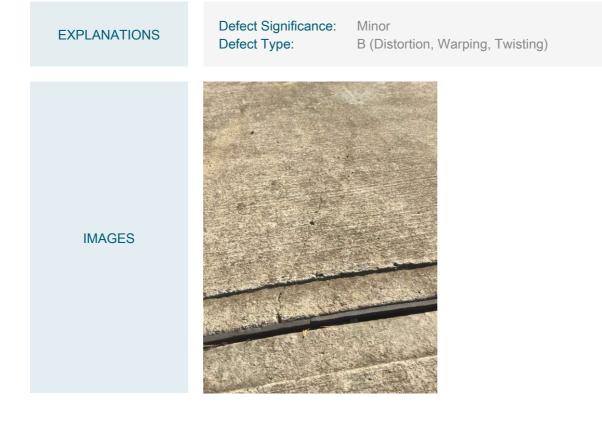
Driveway

\times Cracks evident in areas

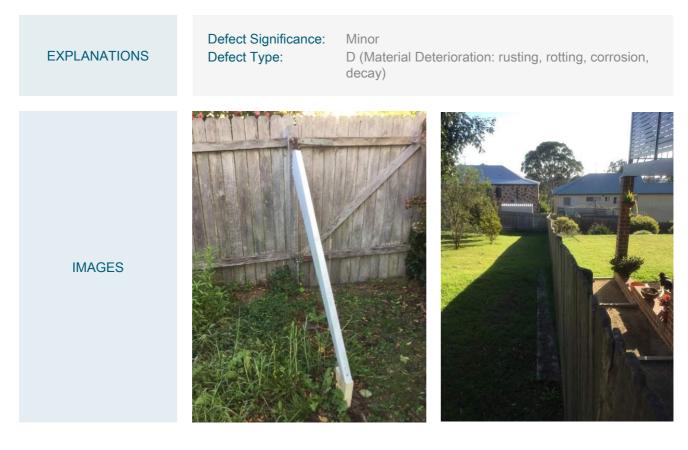
Timber Pailing Fencing

X Timber posts show timber decay & posts are leaning

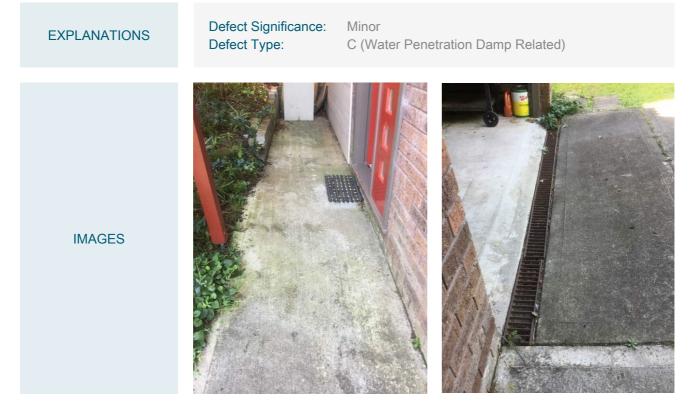
Drainage

X This site has inadequate surface inlet drainage. We recommend that additional site surface run off inlet and or diversion drainage be put into place around this property to protect this dwellings foundation materials.

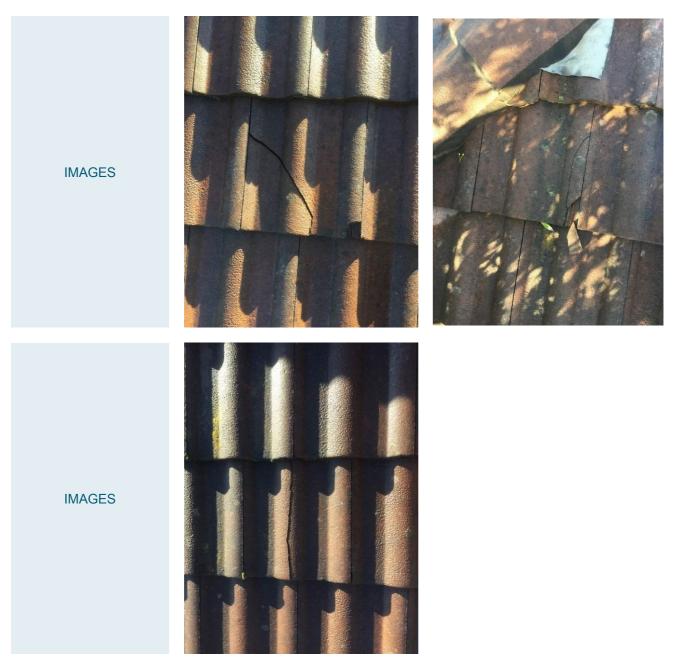
× Cracked tiles requiring replacement

Minor A (Damage)

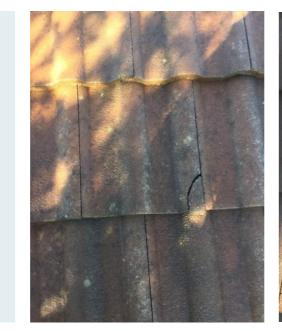
Roof Covering

X There are several tiles with chipped corners

Defect Significance: Defect Type: Minor A (Damage)

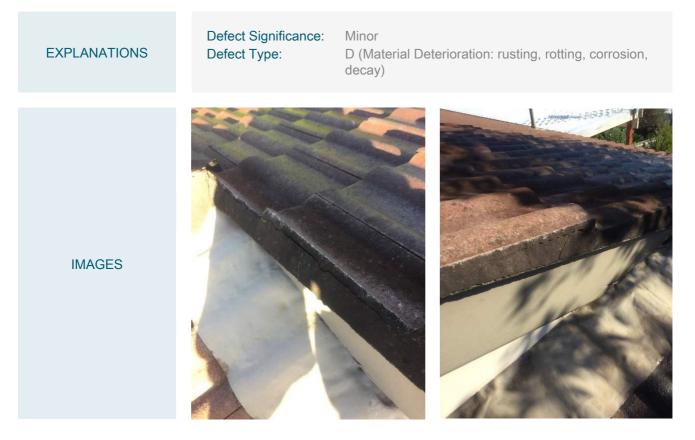
Barge capping

\times Re-bedding/pointing is required

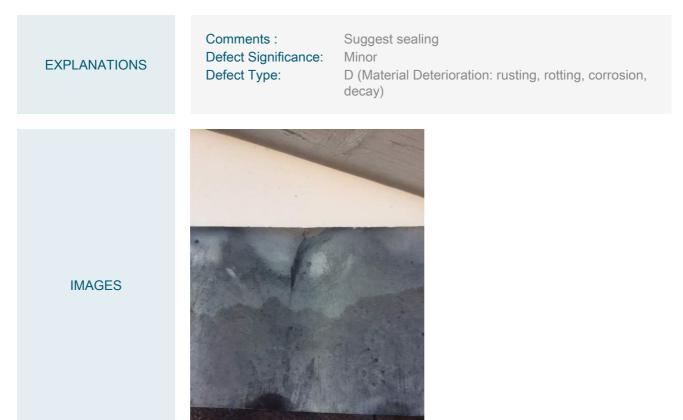
Lead flashings

\times Cracking in some areas
