BUILDING INSPECTION

Complies with Australian Standard AS 4349.1-2007 Inspection of Buildings Part 1: Pre-Purchase Inspections of Residential Buildings - Appendix C

8 Clarence Street Batemans bay, NSW 2536, Australia

Inspection Date: 14 Feb 2017, 12:52 PM to 3:25 PM Inspected by: Travis Reeves

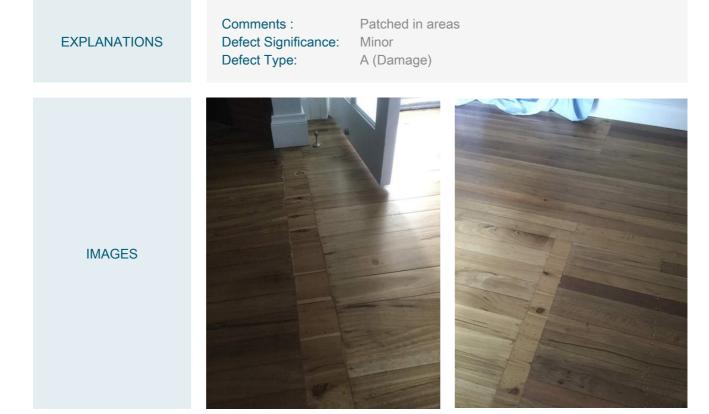
Floor

\times Other

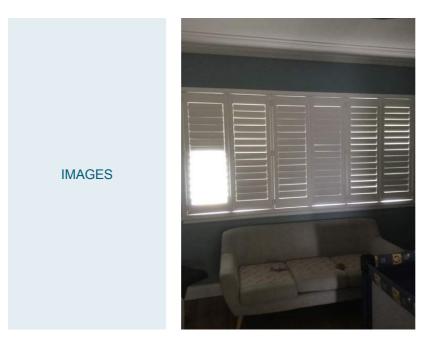
Window/s

Defect Significance: Defect Type: Windows painted shut, suggest easing to open. Sash balances may require replacing Minor E (Operational)

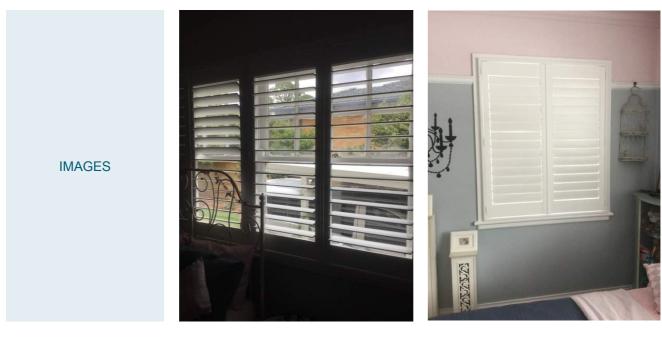
Defect Significance: Defect Type: Windows painted shut suggest easing to open. Sash balances may require replacing Minor E (Operational)

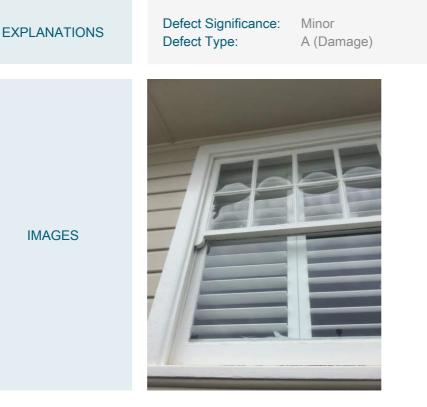
Window/s

\times Cracked glass evident

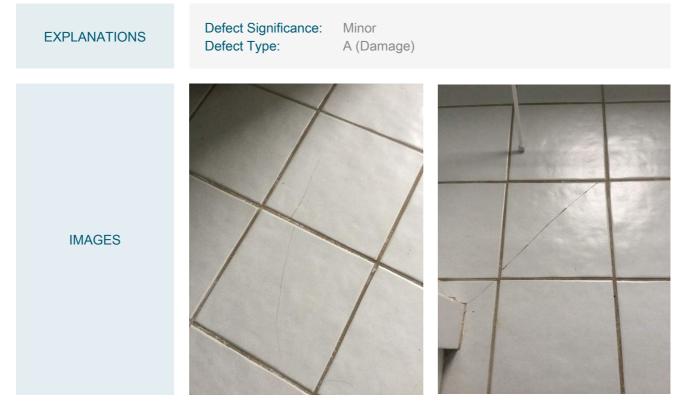
Floor

× Cracked tiles evident in some areas

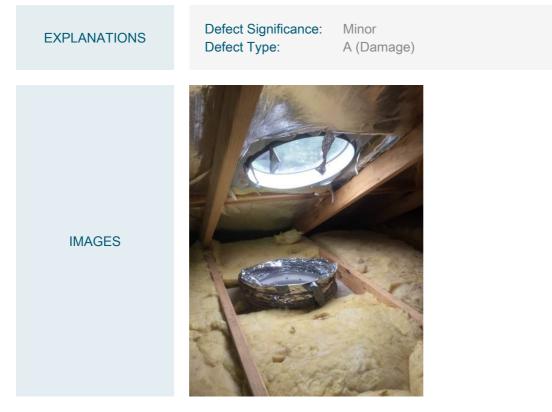
Skylights

\times Tube requires re-fixing

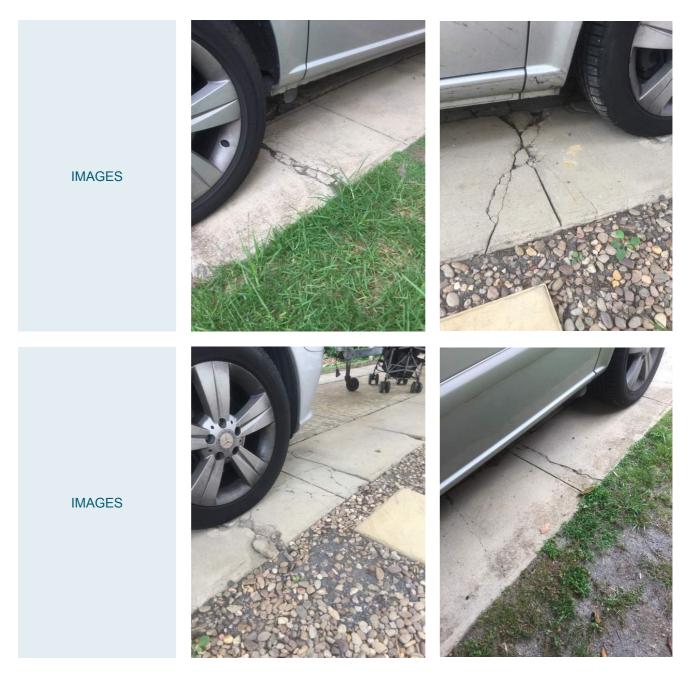
× Concrete driveway has cracked in areas

Driveway cracked in many areas Minor B (Distortion, Warping, Twisting)

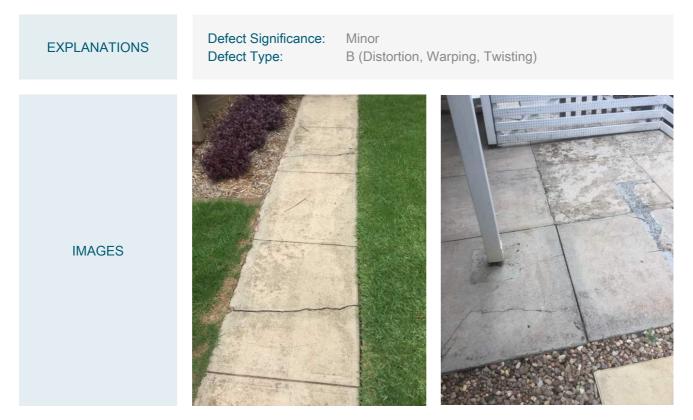
Paths

\times Concrete paths cracked in areas

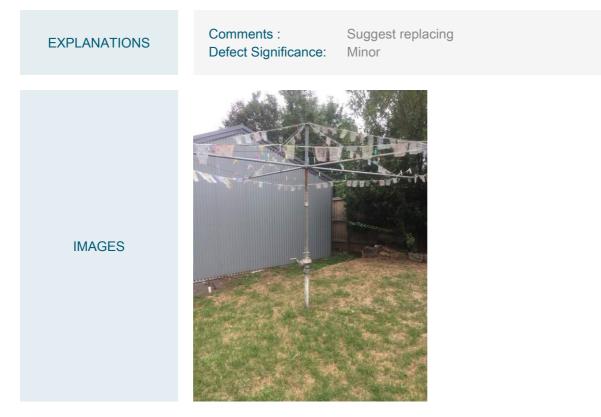
Clothes Line

imes Does not operate as intended

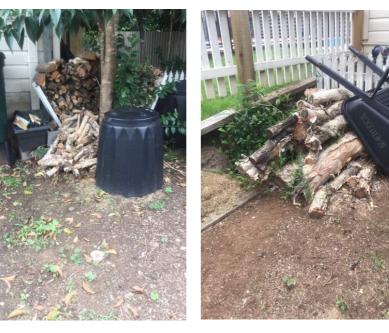
Stored Timbers/Fire Wood

X Stored Timbers/fire wood should be removed or raised as there are conducive for termites

Defect Significance: Defect Type: Minor D (Material Deterioration: rusting, rotting, corrosion, decay)

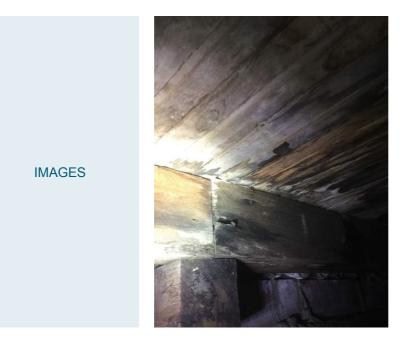
Flooring

imes Water damage evident in areas

Previous water damage evident next to main bathroom Minor C (Water Penetration Damp Related)

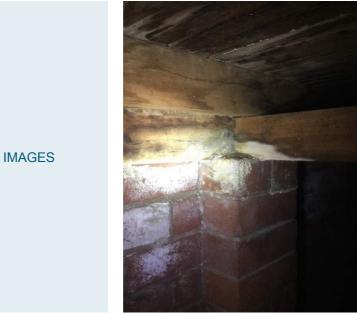
Bearers & Joists

× Other

Comments : Defect Significance: Defect Type: Water damage evident under dining area Minor C (Water Penetration Damp Related)

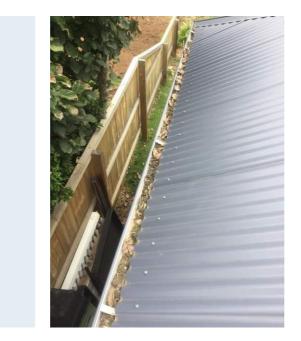
Gutters

× Suggest cleaning

Defect Significance: Defect Type: Minor E (Operational)
