BUILDING INSPECTION

Complies with Australian Standard AS 4349.1-2007 Inspection of Buildings Part 1: Pre-Purchase Inspections of Residential Buildings - Appendix C

11 Coniston Close Sussex Inlet, NSW 2540, Australia

Inspection Date: 21 Mar 2017, 1:08 PM to 3:48 PM

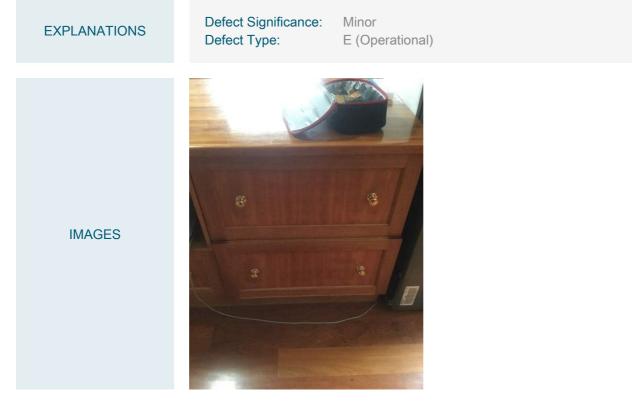
Bottom Cupboards

X Drawers binding suggest adjusting or replacing guides to drawers

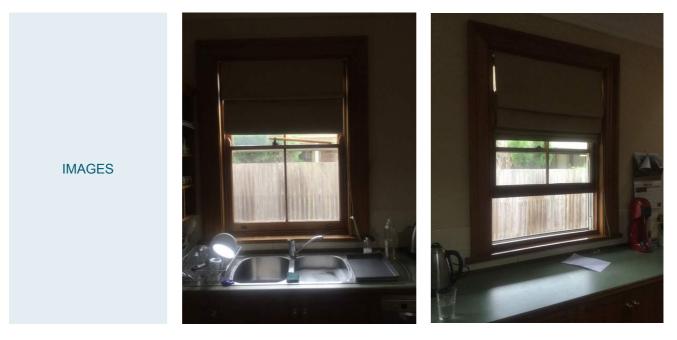
Window/s

X Window sashes painted shut could not be tested, suggest easing for operation. Sash balances/ cords may have to be replaced

Comments : Defect Significance: Defect Type: Top sash only Minor E (Operational)

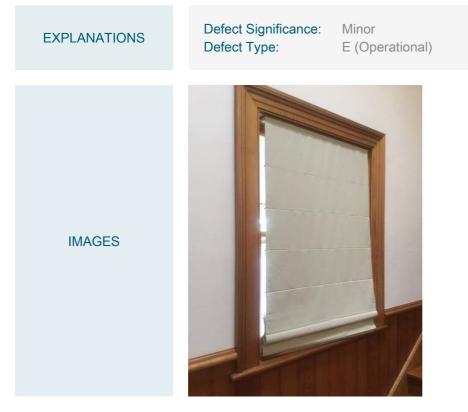
Window/s

× Sash balances/cords require replacing

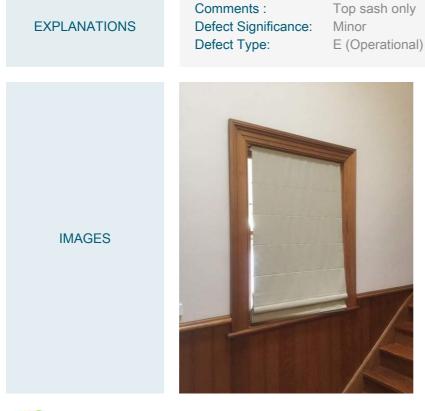
Window/s

X Window sashes painted shut could not be tested, suggest easing for operation. Sash balances/ cords may have to be replaced

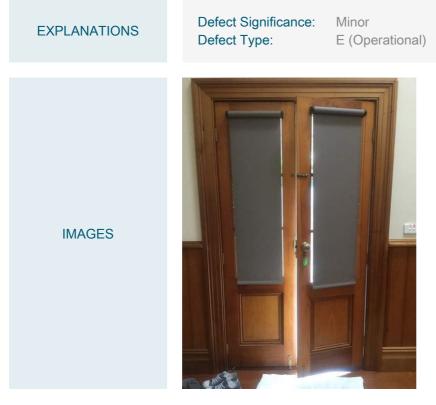
Rear Exit Door

imes Door Binding suggest shaving or cutting

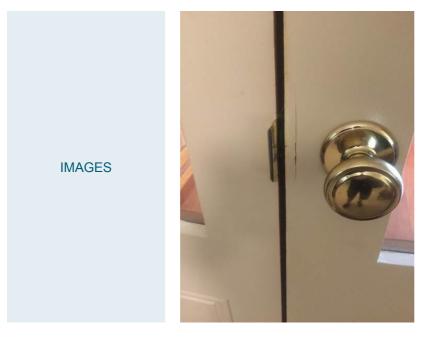
× Door damaged

Defect Significance: Minor Defect Type:

A (Damage)

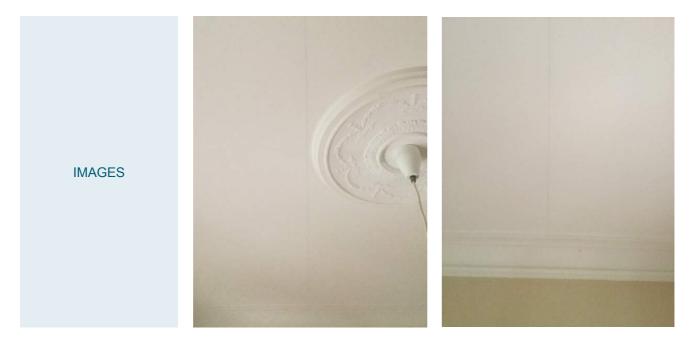
× Cracks to lining evident in some areas

Defect Significance:MinorDefect Type:B (Dis

Minor B (Distortion, Warping, Twisting)

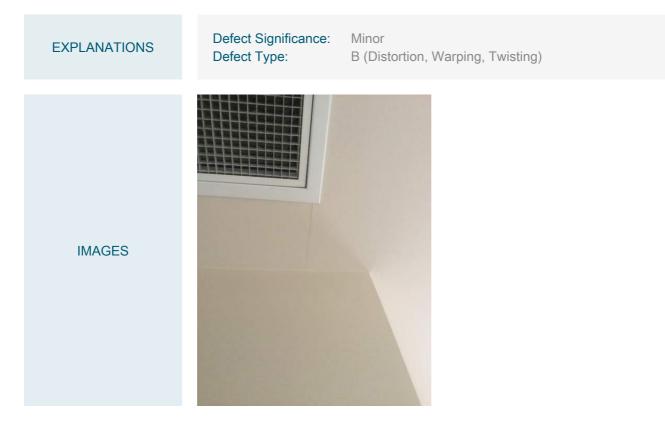
Ceiling

× Minor cracks evident in areas

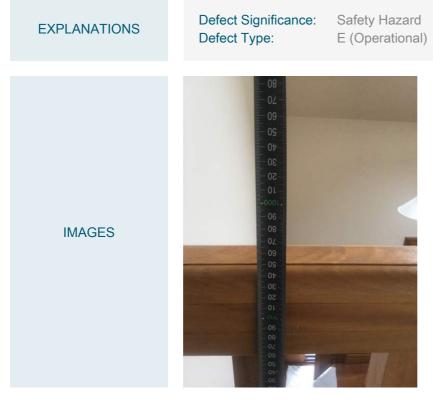
Hand Rail

× All veranda's, decking, balconies and any internal void area railings, if applicable to this property must be a minimum height of 1.0metre high for compliance with the most recent Australian Standards. (If under 1.0m this is a safety hazard.)

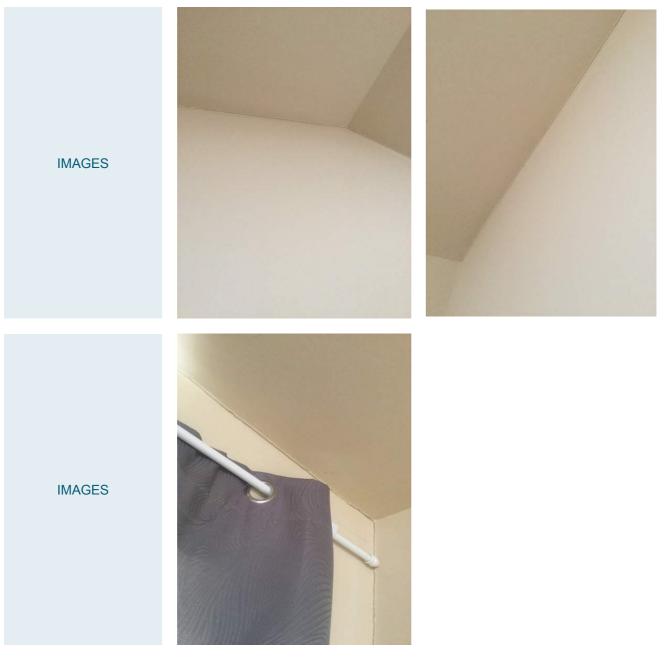
× Minor cracks were evident in areas

Defect Significance:MinorDefect Type:B (Dis

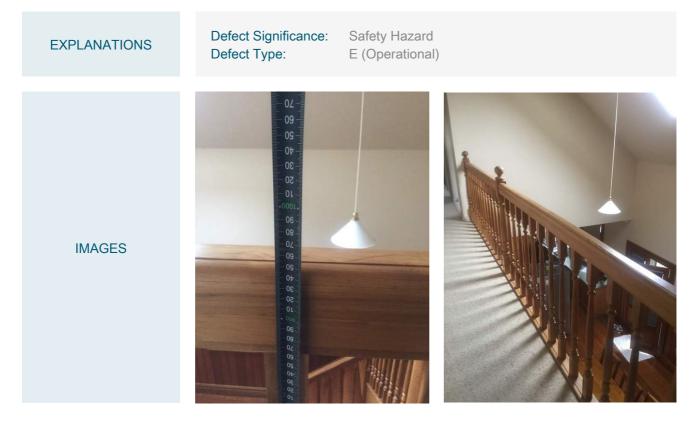
Hand Rail

× All veranda's, decking, balconies and any internal void area railings, if applicable to this property must be a minimum height of 1.0metre high for compliance with the most recent Australian Standards. (If under 1.0m this is a safety hazard.)

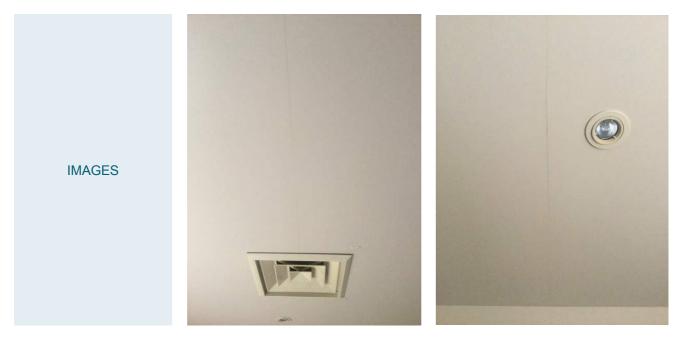
➤ Minor cracks were evident in areas

Defect Significance:MinorDefect Type:B (Dis

Minor B (Distortion, Warping, Twisting)

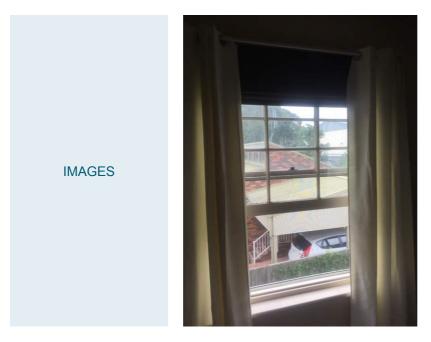
Window/s

X Window sashes painted shut could not be tested, suggest easing for operation. Sash balances/ cords may have to be replaced

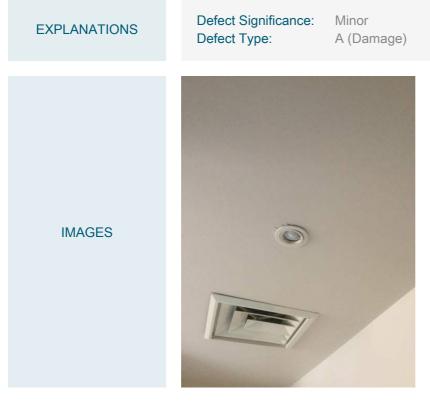
Ceiling

➤ Damaged plasterboard evident

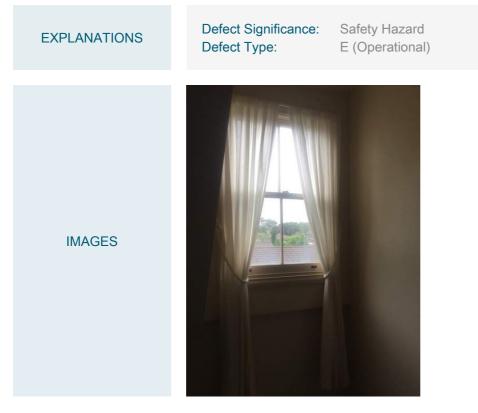
Window/s

× From Jan 2013 all second story windows must not open up more than .125mm.

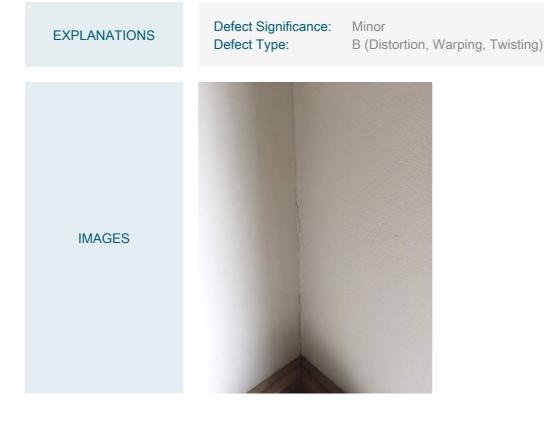
Walls

➤ Minor cracks evident in areas

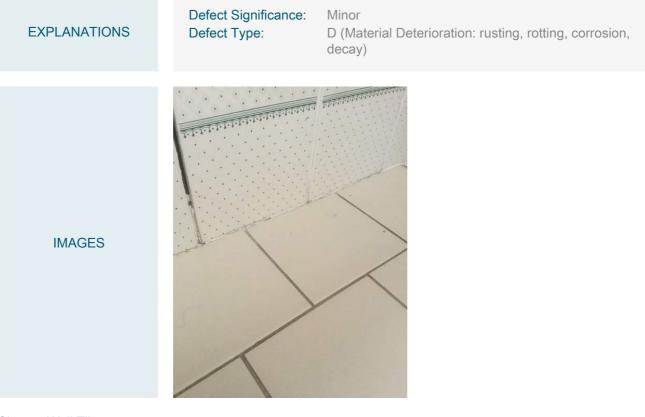
Bathroom floor

× Re-seal at wall and floor junction

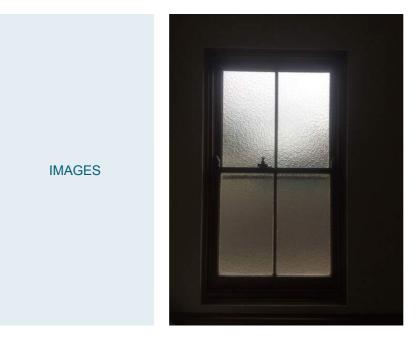
X Window sashes painted shut could not be tested, suggest easing for operation. Sash balances/ cords may have to be replaced

Top sash only Minor E (Operational)

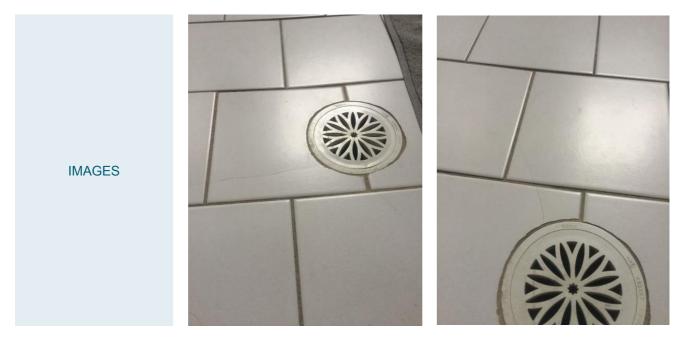
Bathroom floor

\times Cracked tiles evident

| EXPLANATIONS | Defect Significance: Defect Type: | Minor A (Damage) |

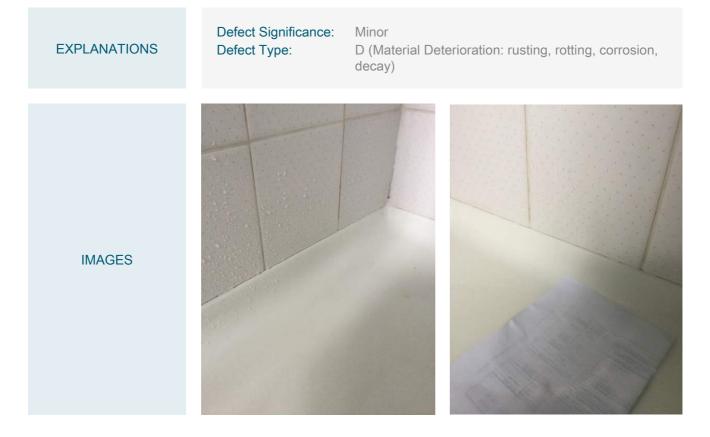
Shower Wall Tiles

× Re-seal at wall and floor junction

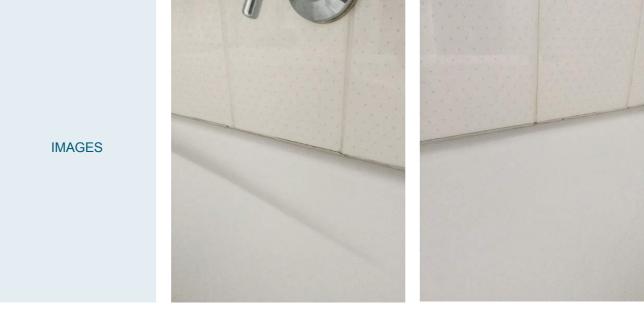
| EXPLANATIONS | Defect Significance: Defect Type: | Minor D (Material Deterioration: rusting, rotting, corrosion, decay) | |
|--|---|--|--|
| imes Re-seal at wall and basi | × Re-seal at wall and basin junction | | |
| EXPLANATIONS | Defect Significance: Defect Type: | Minor D (Material Deterioration: rusting, rotting, corrosion, decay) | |

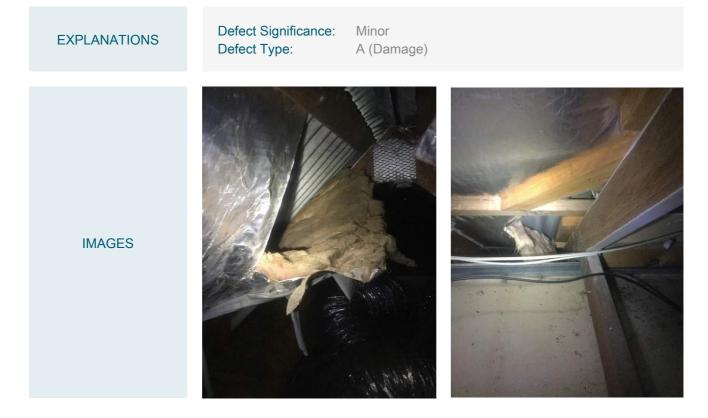
Reflective foil

\times Sarking torn in areas

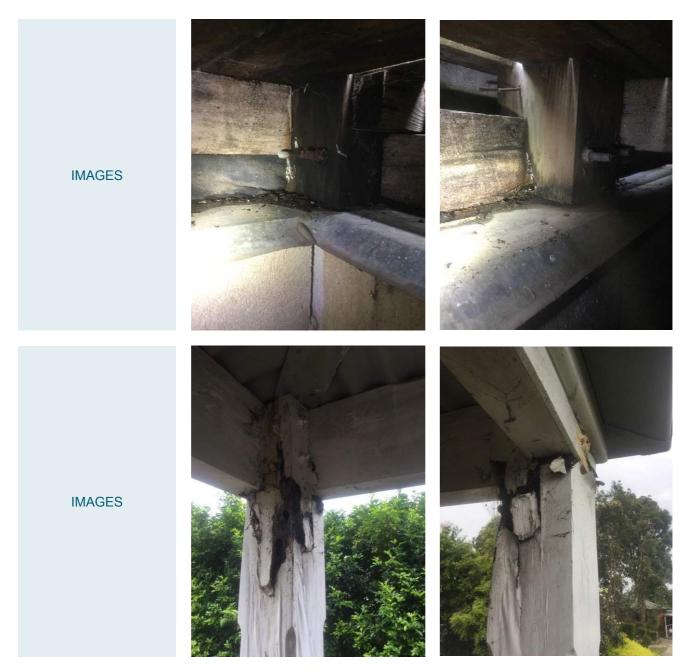
× Significant wood decay evident

Defect Significance: Defect Type:

Safety Hazard D (Material Deterioration: rusting, rotting, corrosion, decay)

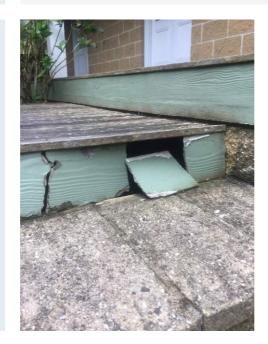
Broken cladding Minor A (Damage)

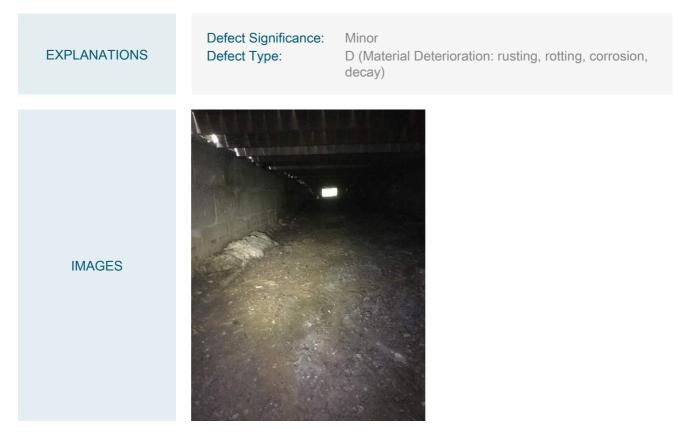
Drainage

\times Inadequate drainage

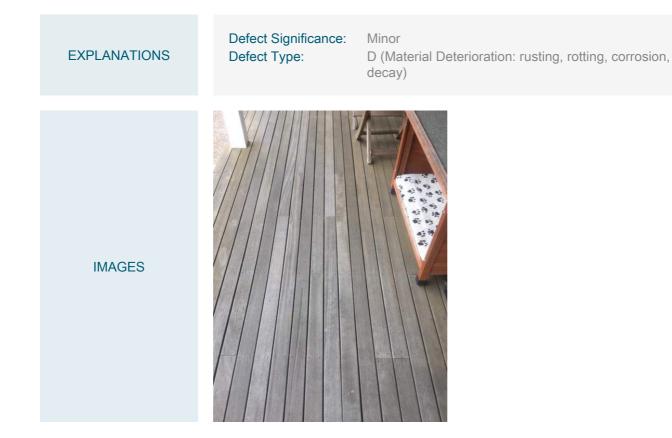
Decking

X Suggest oiling / staining for further weather protection

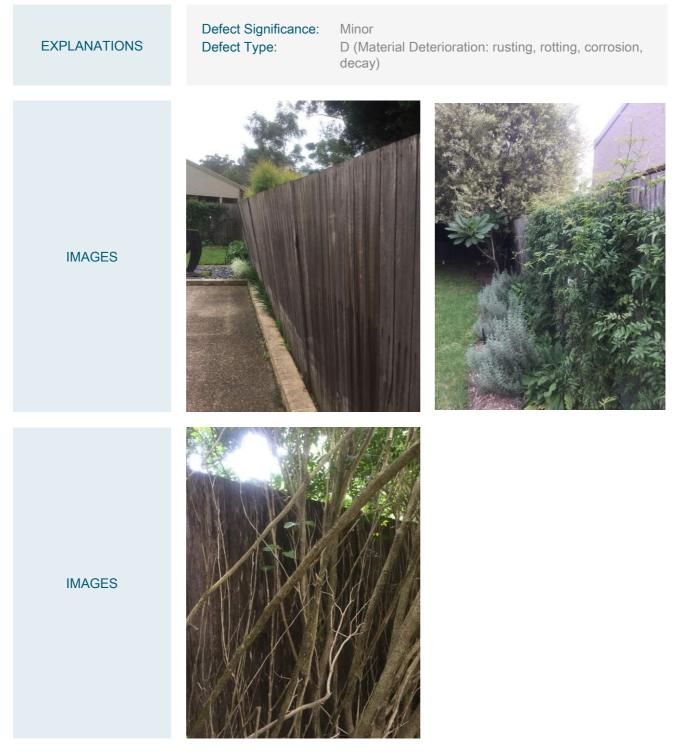
Timber Pailing Fencing

X Timber posts show timber decay & posts are leaning

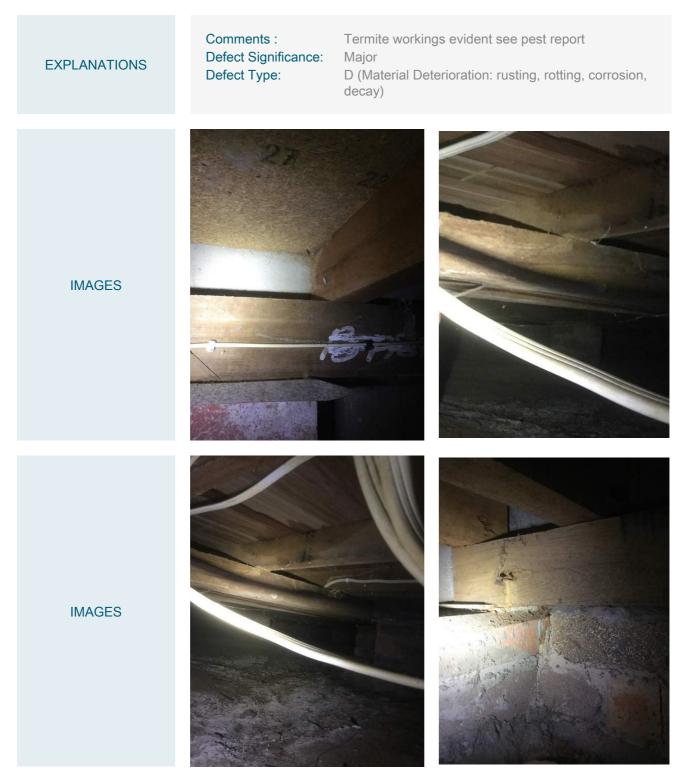
Bearers & Joists

× Termite damage evident

Termite workings evident see pest report Major D (Material Deterioration: rusting, rotting, corrosion, decay)

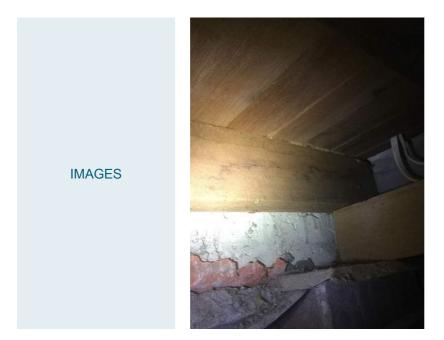
× Ant capping inadequate

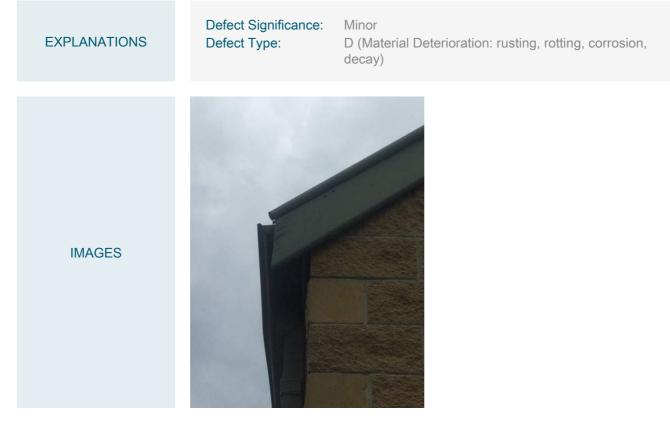
Bargeboard

× Significant wood decay was evident

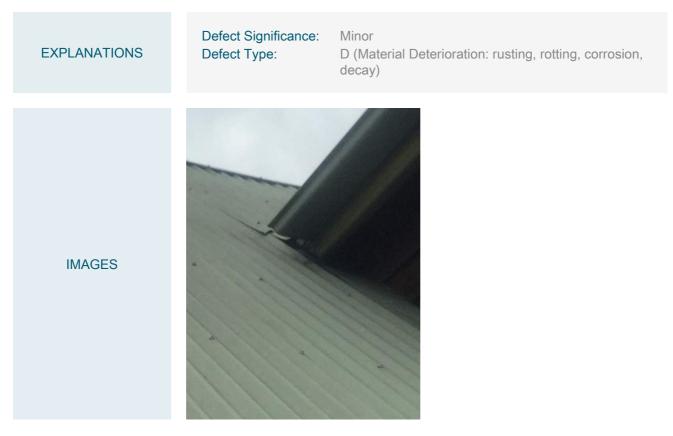
Fascia

X Visible wood decay damage was evident in areas
