BUILDING INSPECTION

Complies with Australian Standard AS 4349.1-2007
Inspection of Buildings Part 1: Pre-Purchase
Inspections of Residential Buildings - Appendix C

88a Emmett Street
Narooma, NSW
2546, Australia

Inspection Date: 04 Apr 2017, 9:05 AM to 11:49 AM

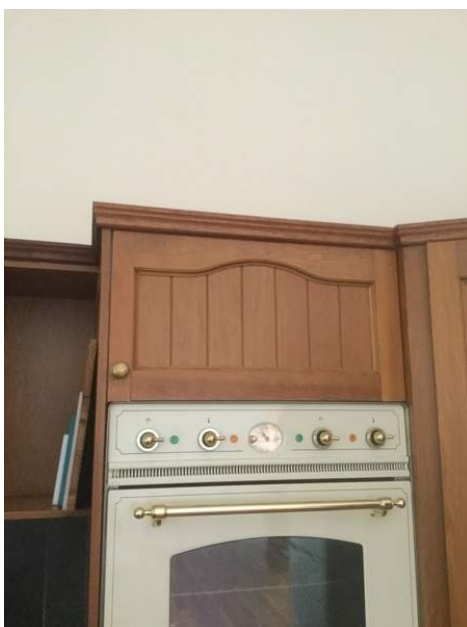
Defect Significance: Minor
Defect Type: E (Operational)

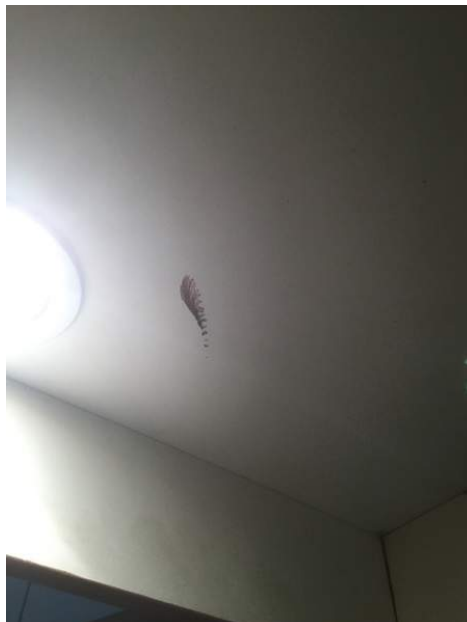
✗ Damage evident in areas

Defect Significance: Minor
Defect Type: A (Damage)

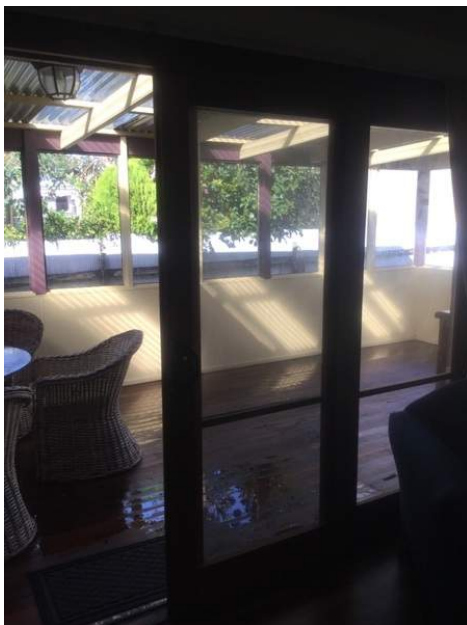
✗ Rollers worn suggest adjusting or replacing

Defect Significance: Minor
Defect Type: E (Operational)

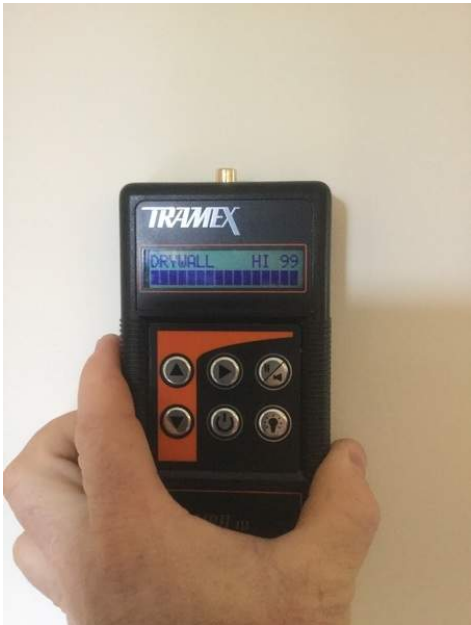
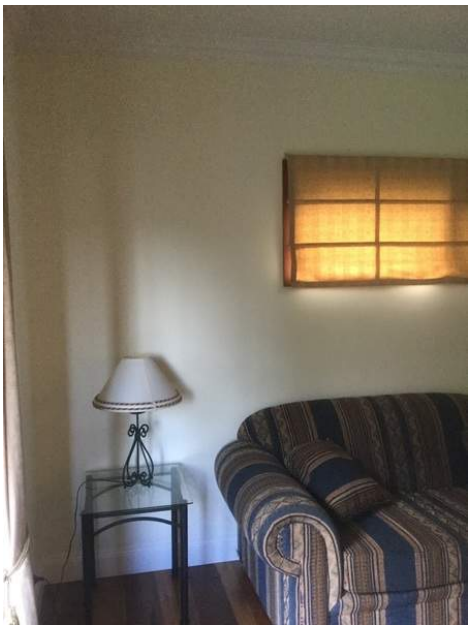
✗ Moisture identified

Reading: High 71 - 99
Comments : High moisture reading on eastern side wall next to window

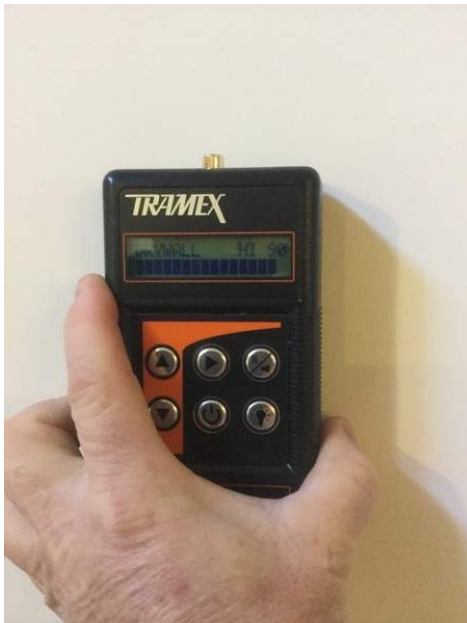
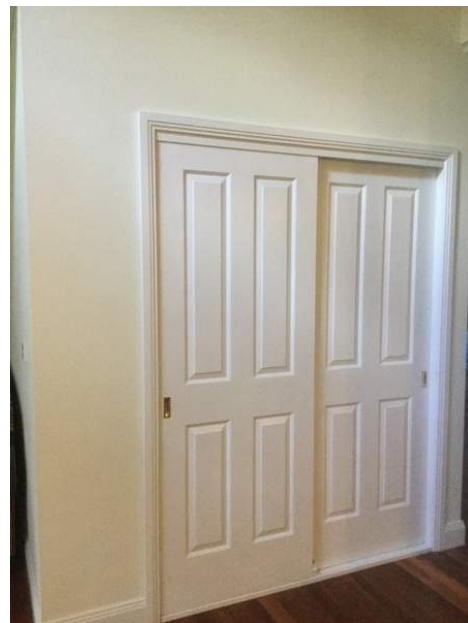
✗ Moisture identified

High moisture reading on wall next to linen press

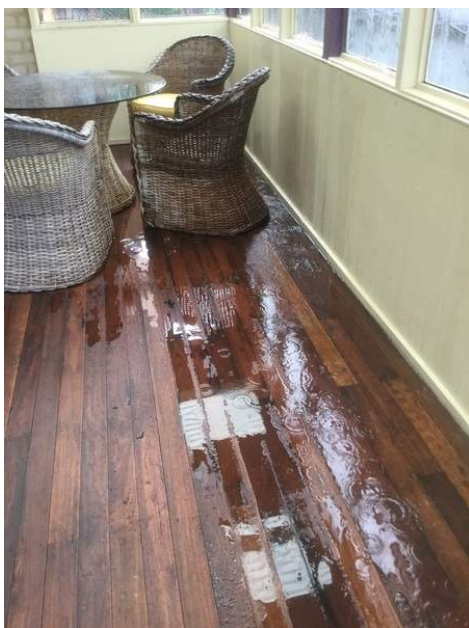
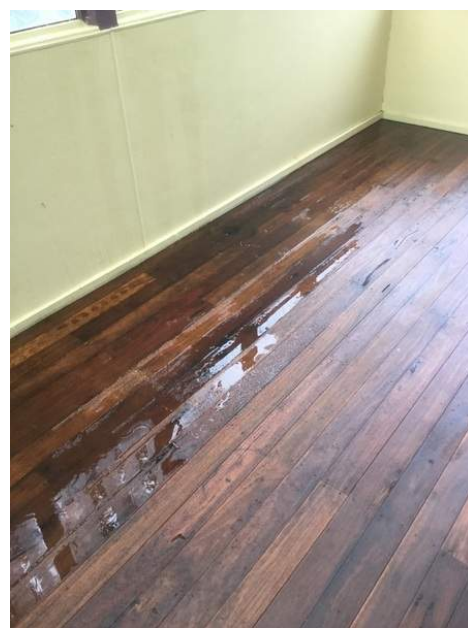
✗ Average condition

Defect Significance:

C (Water Penetration Damp Related)

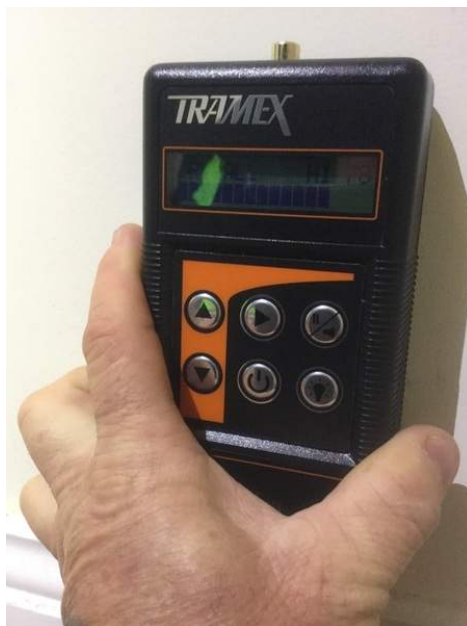
✗ Moisture identified

High moisture reading in robe wall adjacent to shower recess

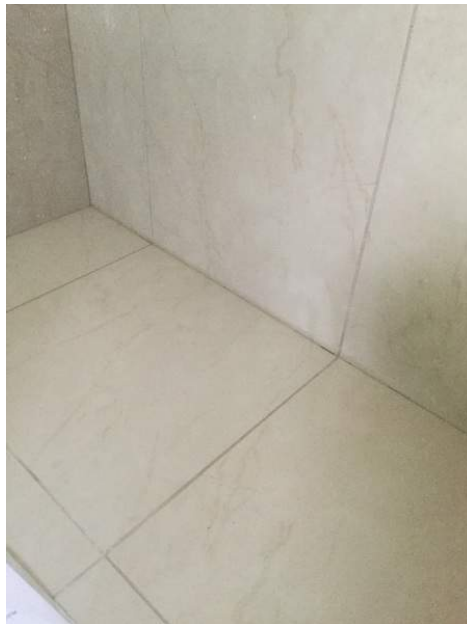
Defect Significance: Minor
Defect Type: D (Material Deterioration: rusting, rotting, corrosion, decay)

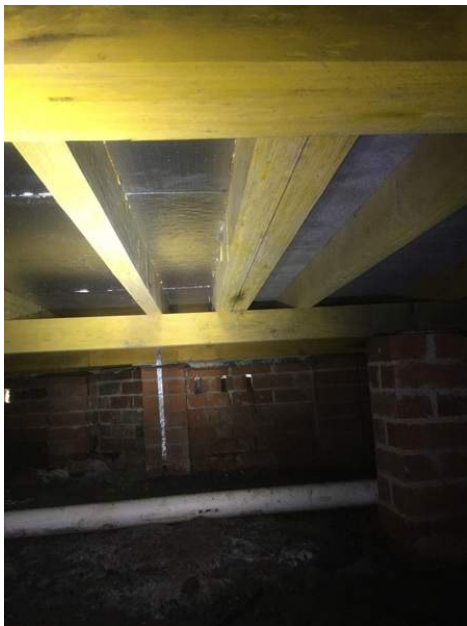
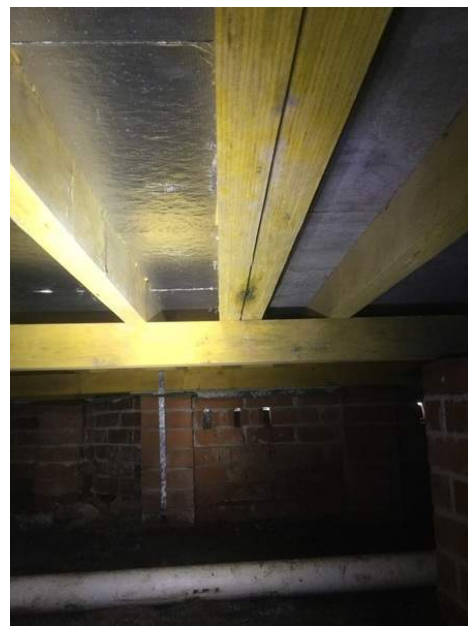
✗ Evident of shower recess leak in subfloor

Defect Significance: Major
Defect Type: C (Water Penetration Damp Related)

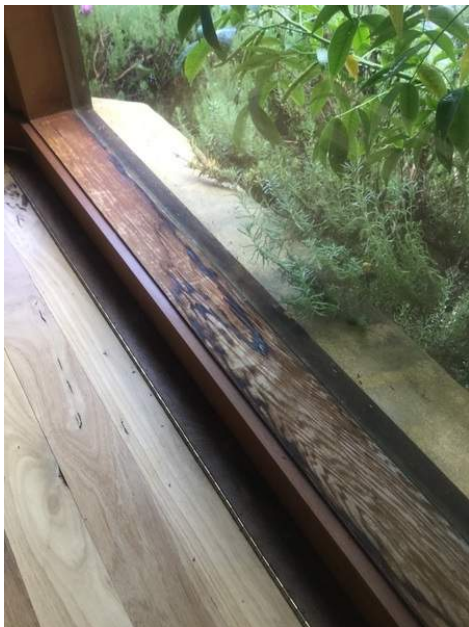
Defect Significance: Minor

Defect Type: D (Material Deterioration: rusting, rotting, corrosion, decay)

Comments : Suggest oiling or staining for further weather protection

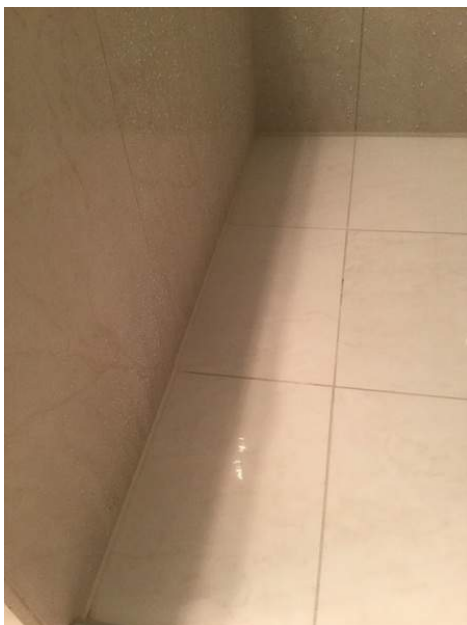
Defect Significance: Minor
Defect Type: D (Material Deterioration: rusting, rotting, corrosion, decay)

✗ Re-seal at wall and floor junction

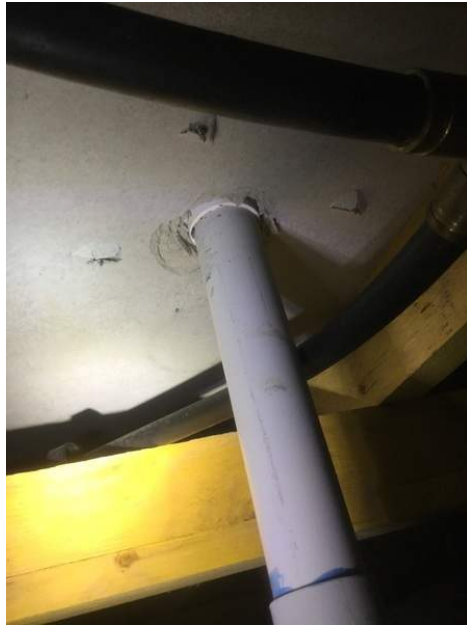
✗ Evident of shower recess leak in subfloor

Defect Significance: Major
Defect Type: C (Water Penetration Damp Related)

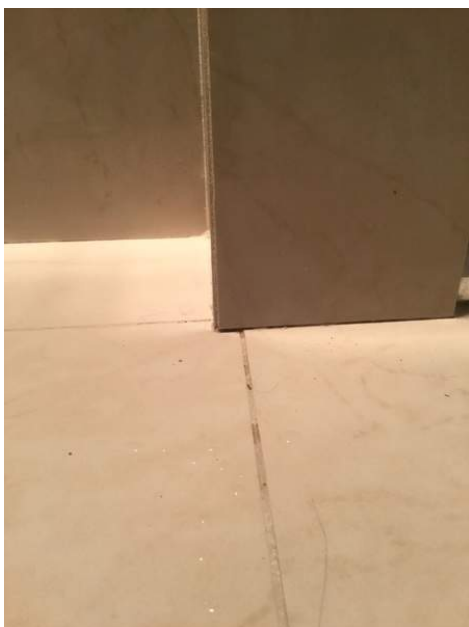
Defect Significance: Minor
Defect Type: D (Material Deterioration: rusting, rotting, corrosion, decay)

✗ Re-seal at wall and basin junction

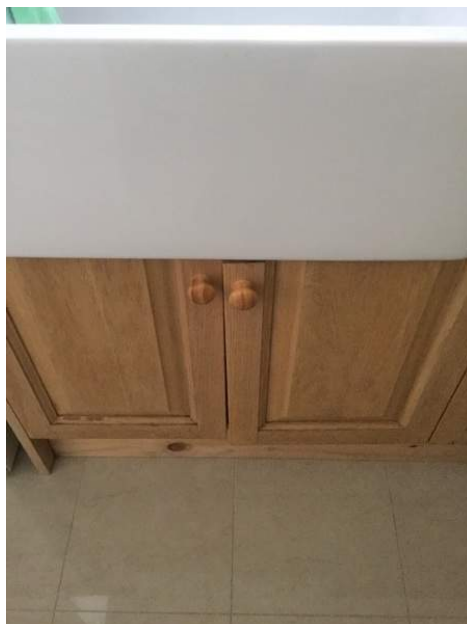
Comments : Suggest adjusting hinges or replacing
Defect Significance: Minor
Defect Type: E (Operational)

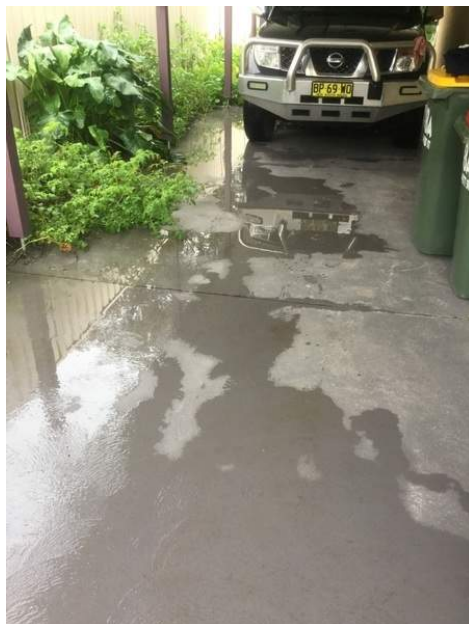
Comments : Inadequate drainage evident
Defect Significance: Minor
Defect Type: C (Water Penetration Damp Related)

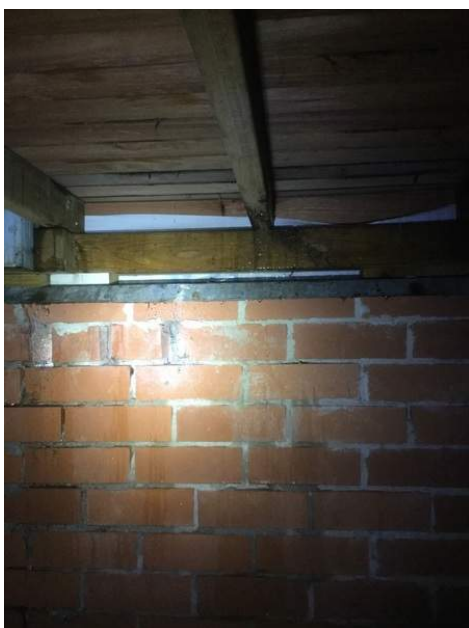
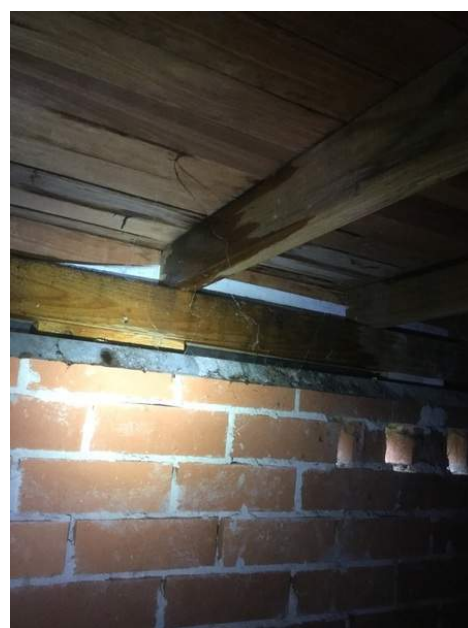
✗ Inadequate drainage

Defect Significance: Major
Defect Type: C (Water Penetration Damp Related)

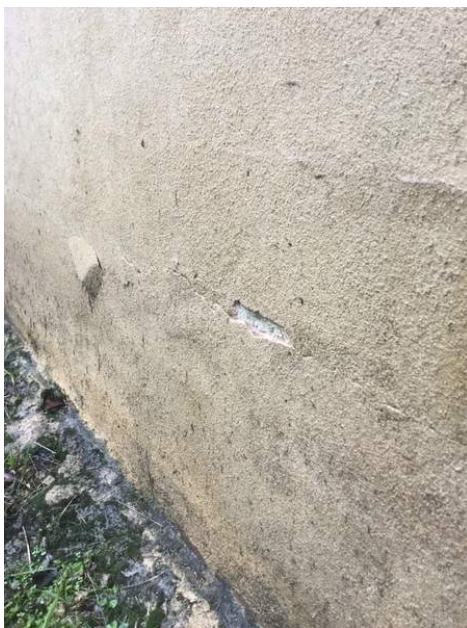
✗ Cracking evident in areas

Defect Significance: Minor
Defect Type: B (Distortion, Warping, Twisting)

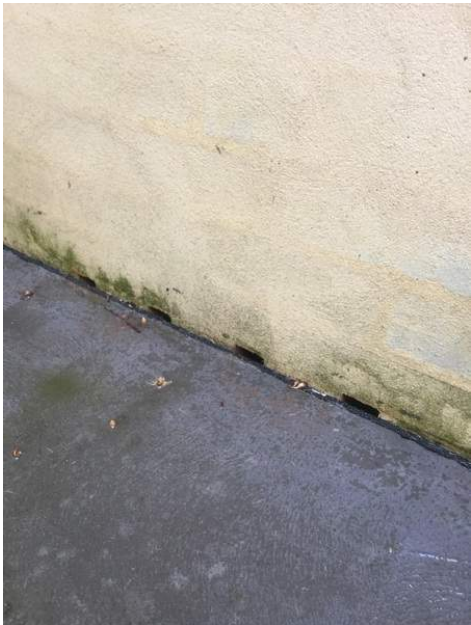
✗ Average condition

- ✗ Weep Holes: Relating to concrete slab properties and also multi-level properties of brick construction. All of the weep holes are to be left completely exposed, unobstructed and clean at all times. They must be BCA code and Australian Standard compliant in relation to the time as to when the building was first built. Blocked, missing and obscured weep holes can and will cause further dampness problems within the building's interior and within the wall cavity areas. This also includes wall areas above windows and doors are to be BCA code compliant. In recent years weep holes are required to be put into place to the underside of window sills to all windows over .900mm in width and be no more than at 1.2metre centres.

Defect Significance: Major
Defect Type: E (Operational)

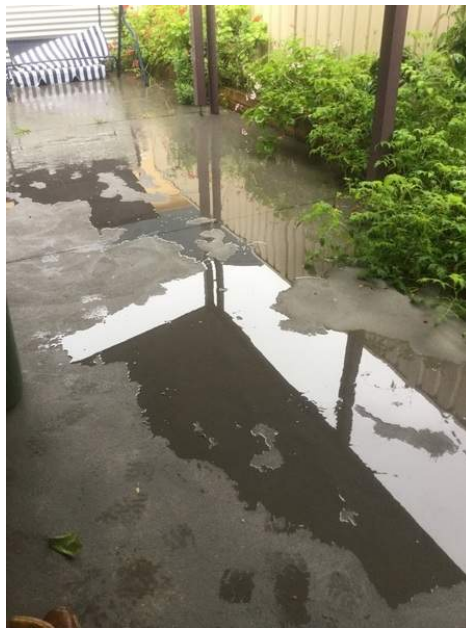
Comments : Inadequate drainage evident
Defect Significance: Minor
Defect Type: C (Water Penetration Damp Related)

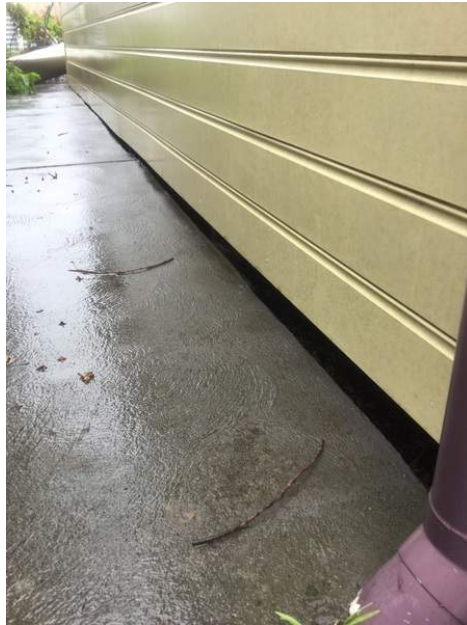
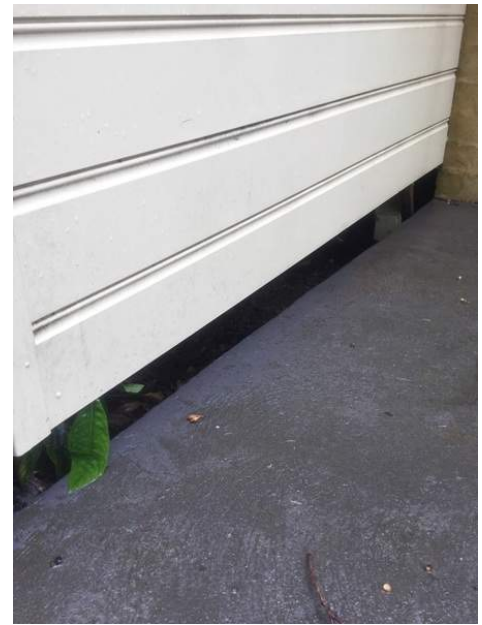
Comments : Inadequate drainage water penetration evident in subfloor
Defect Significance: Major
Defect Type: C (Water Penetration Damp Related)

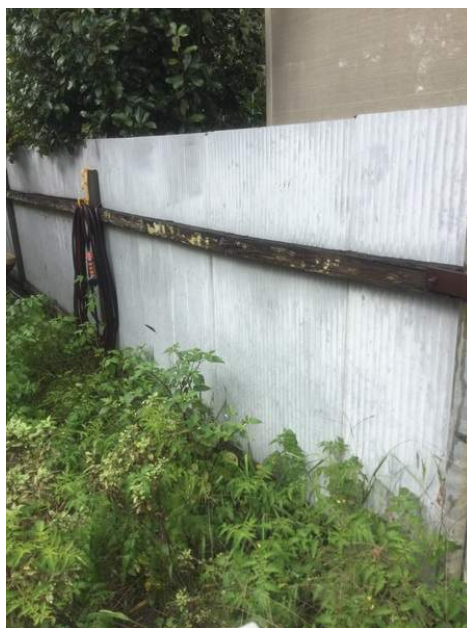
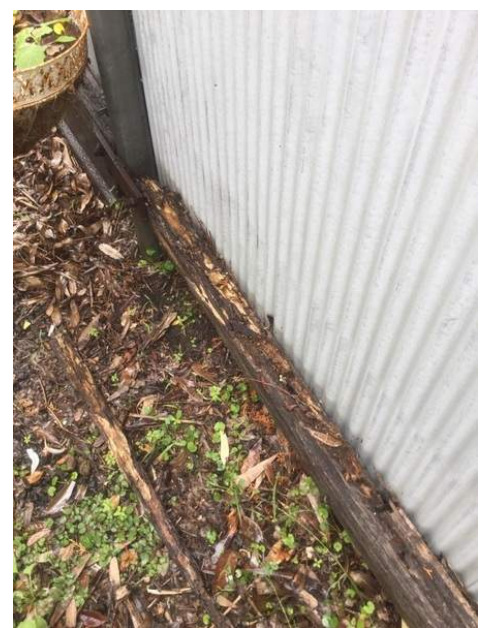
Comments : Significant decay evident on rails suggest replacing
Defect Significance: Safety Hazard
Defect Type: E (Operational)

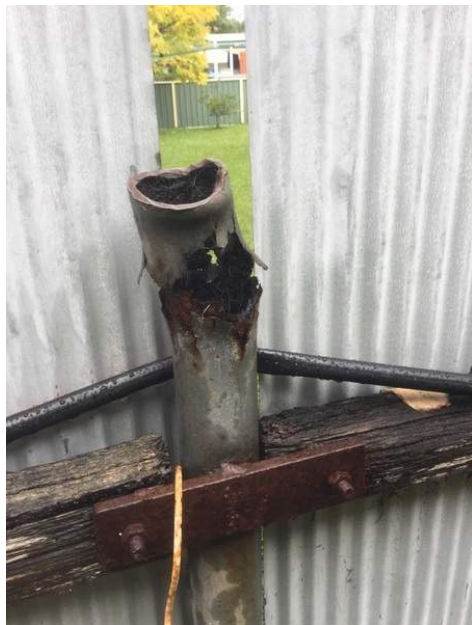
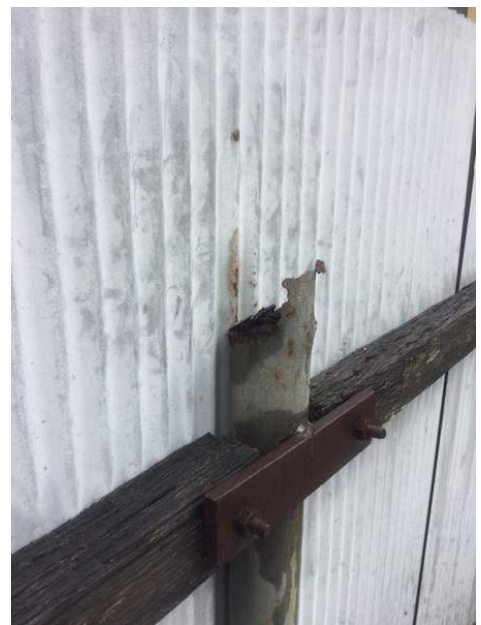
Significant rust evident on post suggest replacing
Safety Hazard
D (Material Deterioration: rusting, rotting, corrosion, decay)

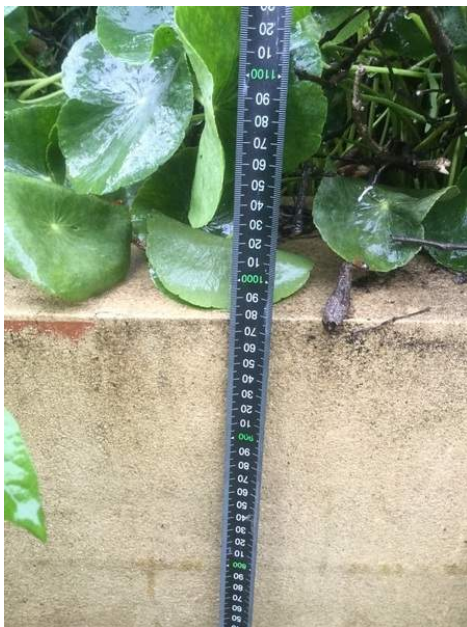
✗ Any retaining walls over 700mm high will require inspection and certification from a Structural Engineer

Defect Significance: Safety Hazard
Defect Type: E (Operational)

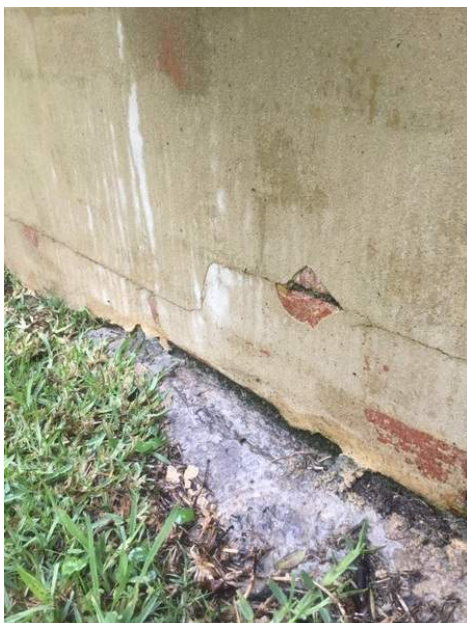
✗ Cracked in areas

Defect Significance: Minor
Defect Type: D (Material Deterioration: rusting, rotting, corrosion, decay)

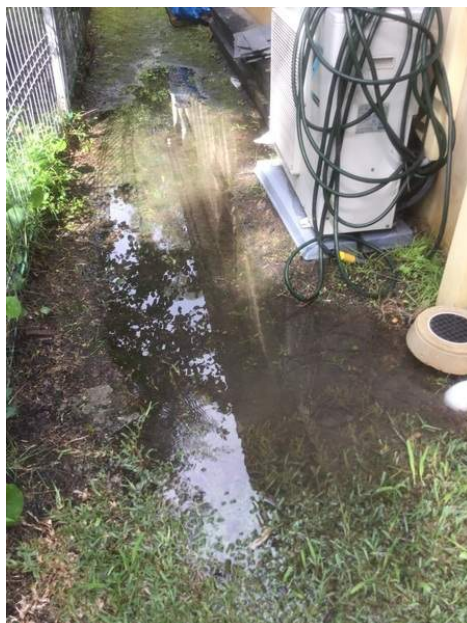
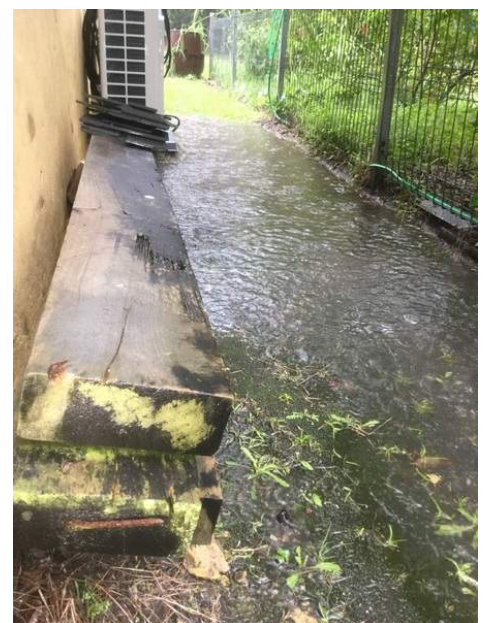
✗ This site has inadequate surface inlet drainage. We recommend that additional site surface run off inlet and or diversion drainage be put into place around this property to protect this dwellings foundation materials.

Defect Significance: Minor
Defect Type: C (Water Penetration Damp Related)

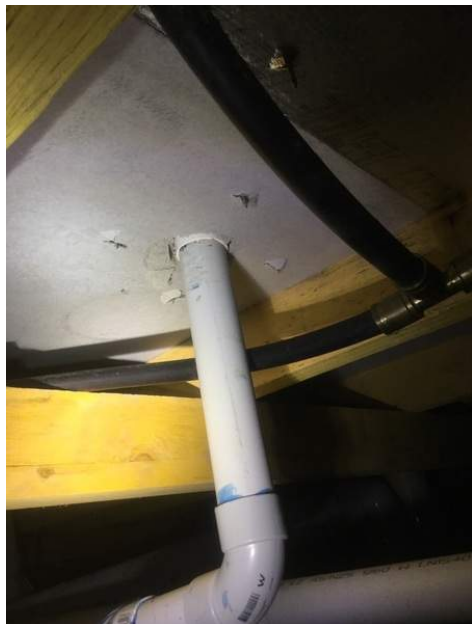
✗ Water damage evident in areas

Comments : Shower recess leak evident in subfloor
Defect Significance: Major
Defect Type: C (Water Penetration Damp Related)

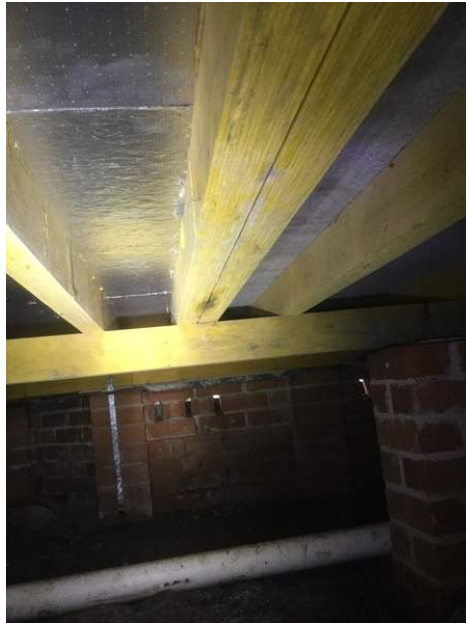
✗ Water damage evident in areas

Comments : Shower recess leak evident in subfloor
Defect Significance: Major
Defect Type: C (Water Penetration Damp Related)

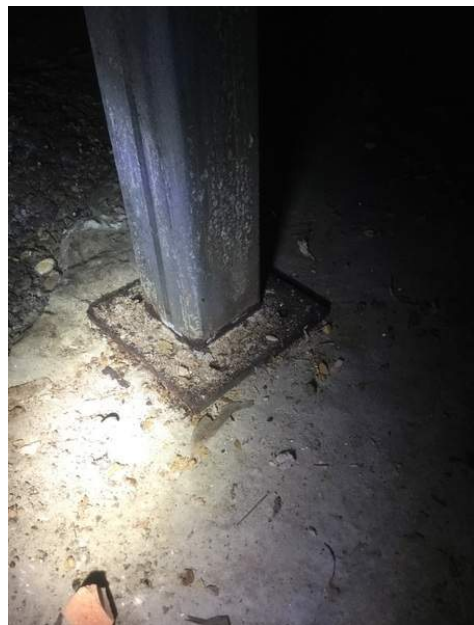
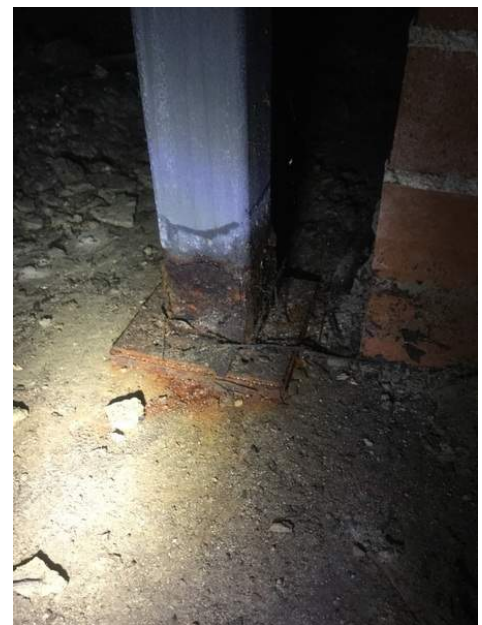
Significant rust evident to support post base
Major
D (Material Deterioration: rusting, rotting, corrosion, decay)

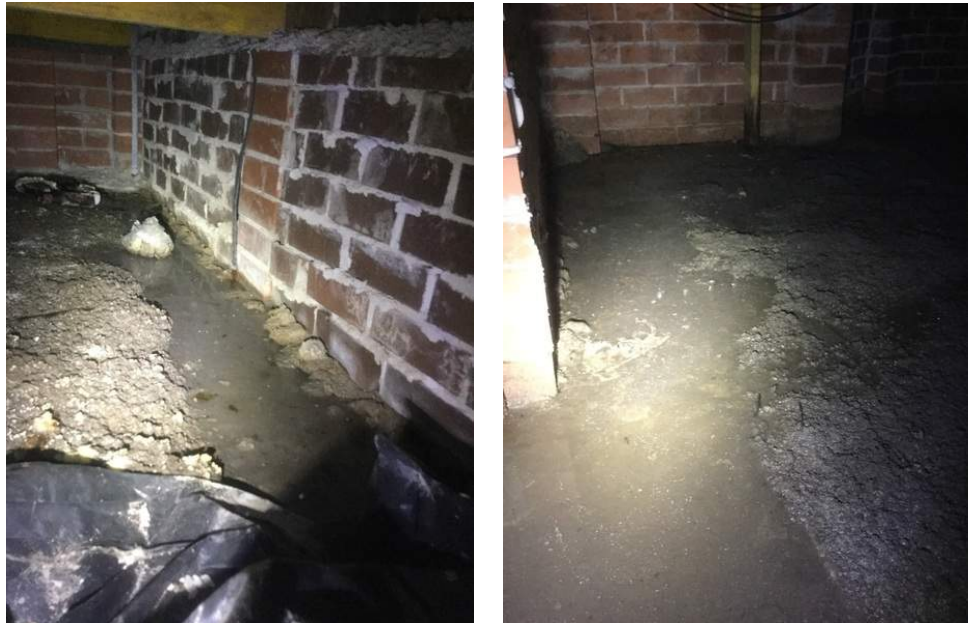
- ✗ Pooling water around brick wall evident

Defect Significance: Major
Defect Type: C (Water Penetration Damp Related)

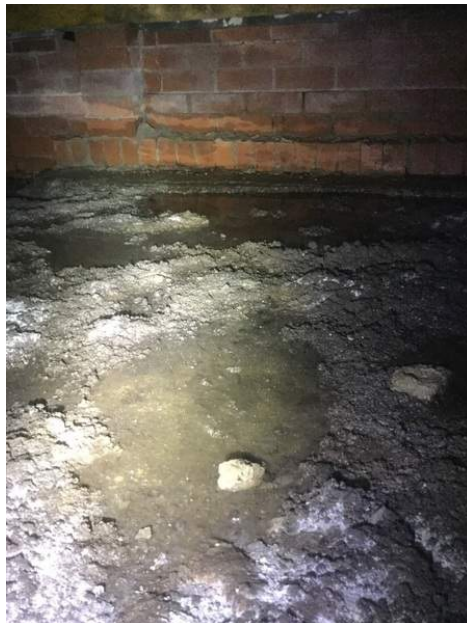
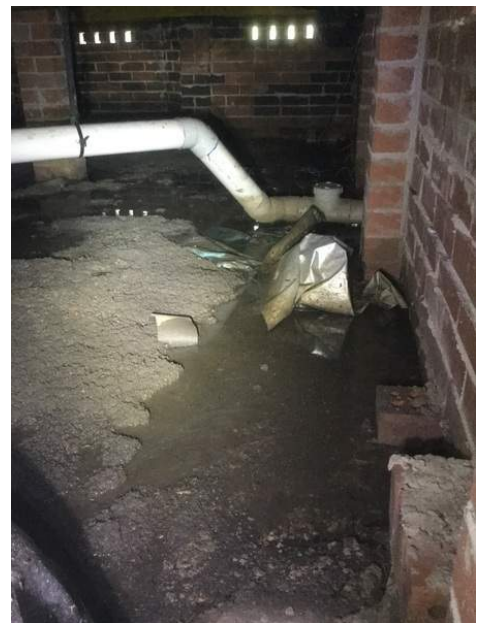
- ✗ Inadequate drainage

Defect Significance: Major
Defect Type: C (Water Penetration Damp Related)

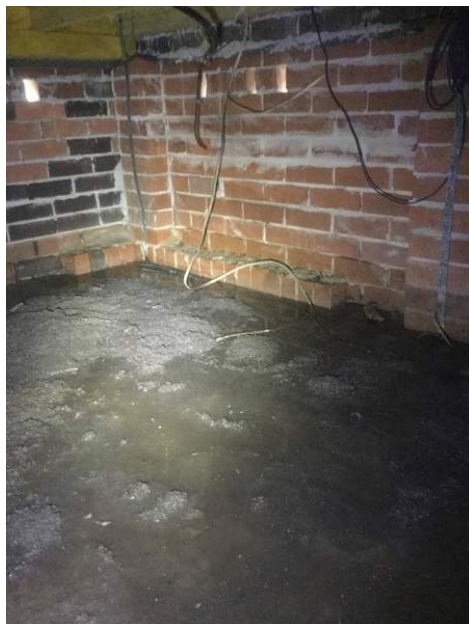
Comments : Electrical cables in pooling water in areas
Defect Significance: Safety Hazard
Defect Type: E (Operational)

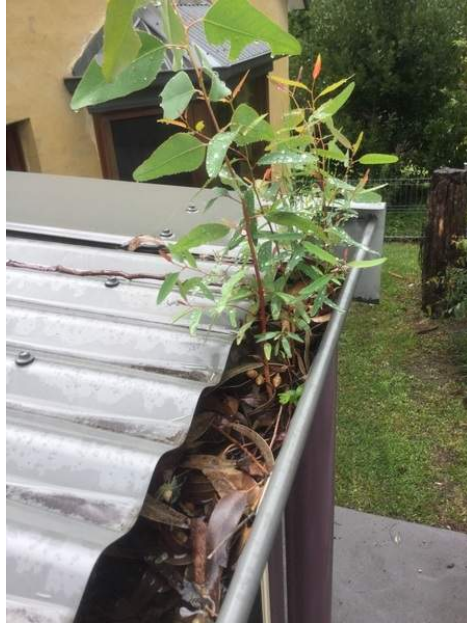
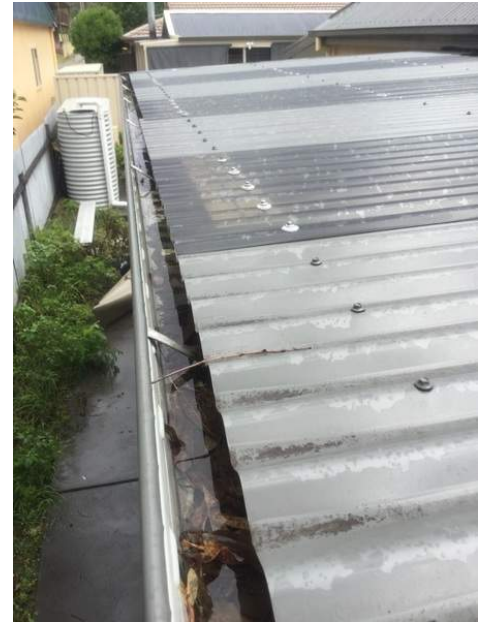
Comments : Inadequate drainage suggest cleaning all gutters & down pipes
Defect Significance: Minor
Defect Type: C (Water Penetration Damp Related)

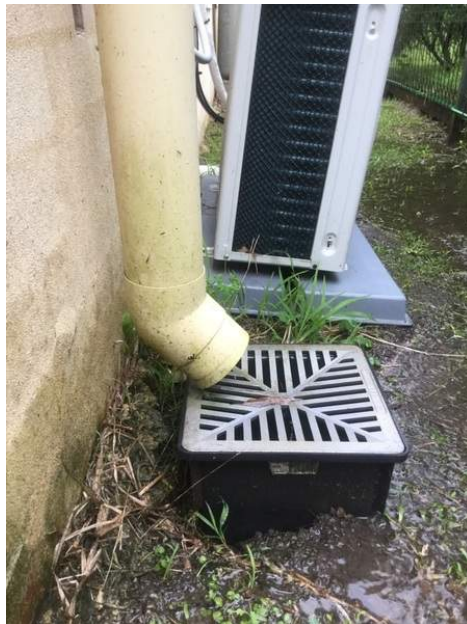
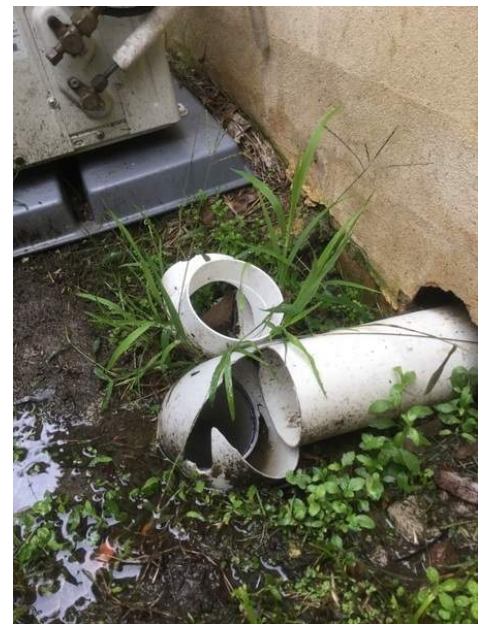
✗ Gutters & downpipes are leaking at their joints in areas & need rectification. (Excessive leaking can cause "Conducive" conditions to possible termite attack.) inadequate drainage

Defect Significance: Minor
Defect Type: C (Water Penetration Damp Related)
