BUILDING INSPECTION

Complies with Australian Standard AS 4349.1-2007 Inspection of Buildings Part 1: Pre-Purchase Inspections of Residential Buildings - Appendix C

9 Glenhaven Avenue North Nowra, NSW 2541, Australia

Inspection Date: 26 Jun 2017, 8:39 AM to 12:05 PM Inspected by: Travis Reeves

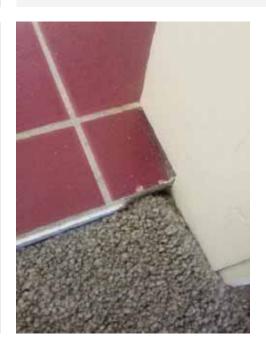
Cracked tiles

Defect Significance: Minor

Defect Type: A (Damage)

Defect Significance: Minor
Defect Type: A (Damage)

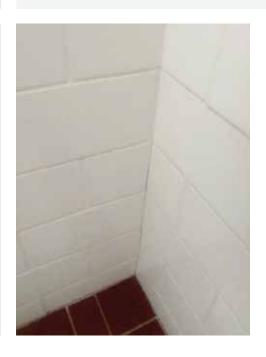
X Re-seal at wall and floor junction

Defect Significance: Minor

Defect Type: D (Material Deterioration: rusting, rotting, corrosion,

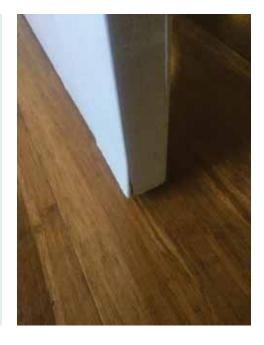
X Damage evident in areas

Defect Significance: Minor
Defect Type: A (Damage)

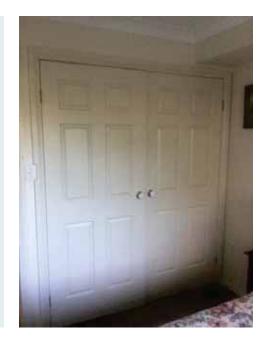
Defect Significance: Minor
Defect Type: A (Damage)

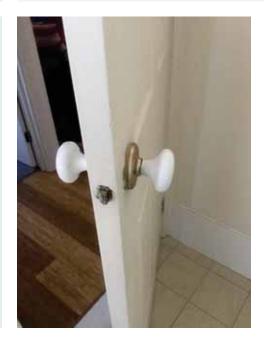
Comments: Door handle loose suggest maintenance

Defect Significance: Minor

Defect Type: A (Damage)

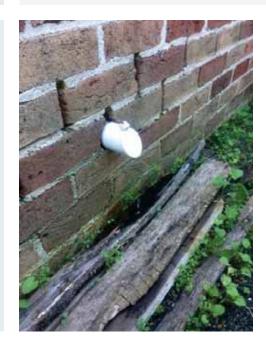
Comments: We recommend alternate water diversion excessive

moisture can be conducive for termites

Defect Significance: Minor

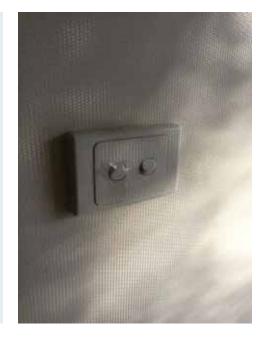
Defect Significance: Safety Hazard
Defect Type: E (Operational)

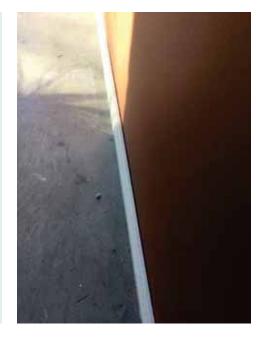
Defect Significance: Minor

Defect Type: B (Distortion, Warping, Twisting)

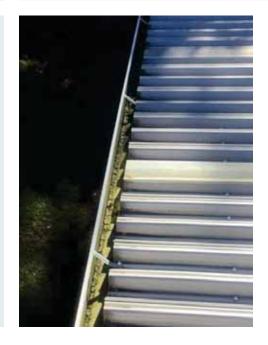
Gutters & downpipes are leaking at their joints in areas & need rectification. (Excessive leaking can cause "Conducive" conditions to possible termite attack.) inadequate drainage

Defect Significance: Majo

Defect Type: D (Material Deterioration: rusting, rotting, corrosion,

Comments: Recommend cleaning vegetation from gutters

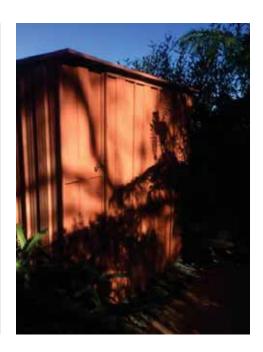
Defect Significance: Minor

Defect Type: A (Damage)

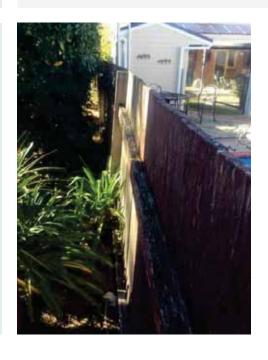
Timber posts show timber decay & posts are leaning

Defect Significance: Minor

Defect Type: D (Material Deterioration: rusting, rotting, corrosion,

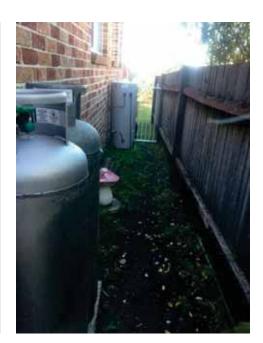
This site has inadequate surface inlet drainage. We recommend that additional site surface run off inlet and or diversion drainage be put into place around this property to protect this dwellings foundation materials.

Defect Significance: Minor

Defect Type: C (Water Penetration Damp Related)

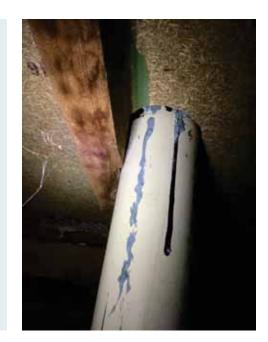
Comments: Joists has been cut for toilet waste we recommend

Defect Significance: Minor

Defect Type: A (Damage)

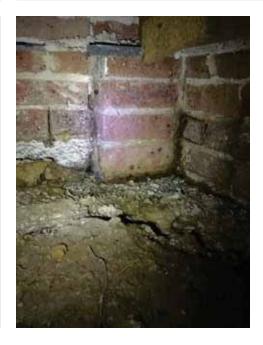
Defect Significance: Minor

Defect Type: C (Water Penetration Damp Related)

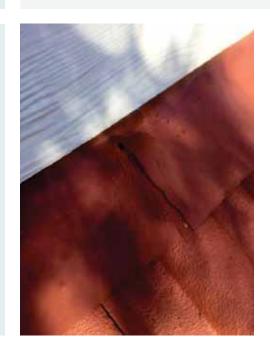
X Flashing shows signs of deterioration suggest replacing or re-sealing

Defect Significance: Minor

Defect Type: D (Material Deterioration: rusting, rotting, corrosion,

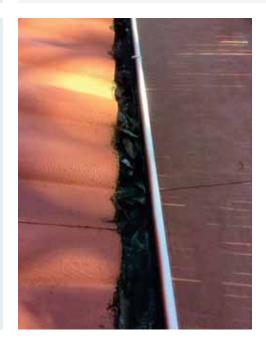
Gutters & downpipes are leaking at their joints in areas & need rectification. (Excessive leaking can cause "Conducive" conditions to possible termite attack.) inadequate drainage

Defect Significance: Mino

Defect Type: D (Material Deterioration: rusting, rotting, corrosion,

Comments: Recommend cleaning vegetation out of gutters
