BUILDING INSPECTION

Complies with Australian Standard AS 4349.1-2007 Inspection of Buildings Part 1: Pre-Purchase Inspections of Residential Buildings - Appendix C

26 Auster Crescent Sanctuary Point, 2540, Australia

Inspection Date: 22 Jun 2017, 10:52 AM to 2:18 PM Inspected by: Travis Reeves

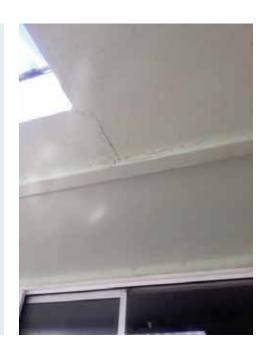
Comments: Cracking, damage, water penetration evident in

Defect Significance: Major

Defect Type: C (Water Penetration Damp Related)

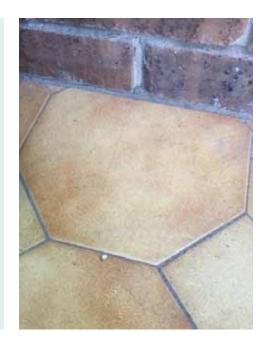
X Cracked tiles evident in some areas

Defect Significance: Minor

Defect Type: A (Damage)

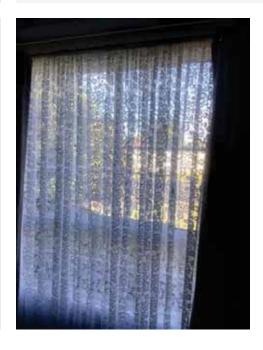
X Screen mesh damaged suggest replacing

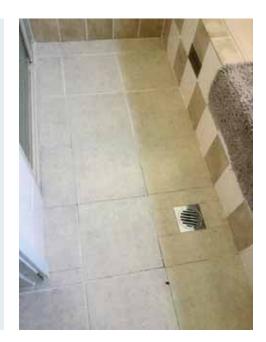
X Cracked tiles evident

Defect Significance: Minor
Defect Type: A (Damage)

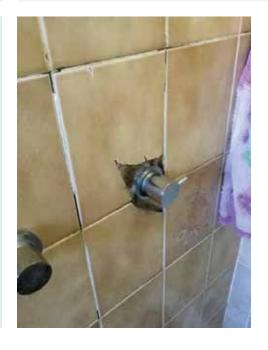
X Minor re-grouting required

Defect Significance: Minor

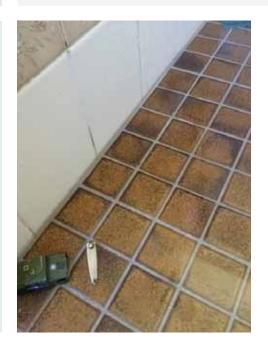
Cracked tiles evident

Defect Significance: Minor
Defect Type: A (Damage)

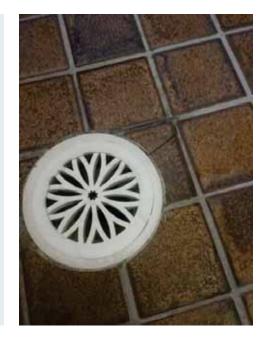
X Evident of shower recess leak in subfloor

Defect Significance: Major

Defect Type: C (Water Penetration Damp Related)

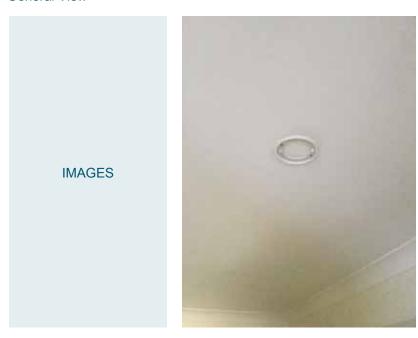
X AS 3786 − Advises, that Smoke detectors are required for all buildings where people sleep. It is recommended that an Electrician be consulted to seek advice on these detectors. Smoke detectors must be ceiling mounted and not wall mounted.

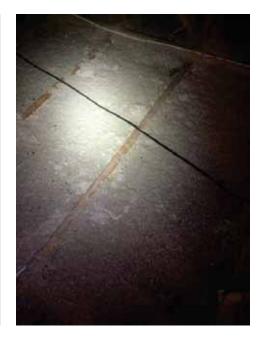
Comments: Insulation may contain asbestos recommend

Defect Significance: Further Investigation

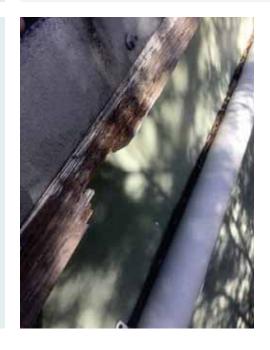
Gutters & downpipes are leaking at their joints in areas & need rectification. (Excessive leaking can cause "Conducive" conditions to possible termite attack.) inadequate drainage

Defect Significance: Mind

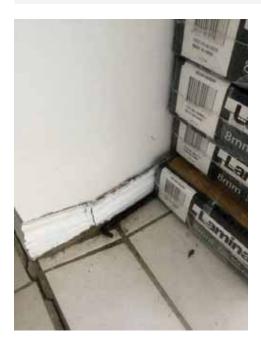
Moisture identified

Comments: High moisture reading in all walls to granny flat

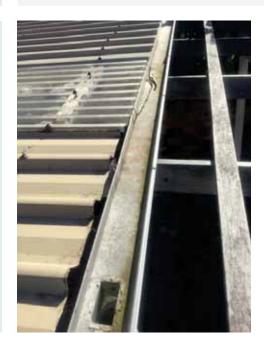
> Downpipes are leaking at their joints in areas & need rectification. (Excessive leaking can cause "Conducive" conditions to possible termite attack.) inadequate drainage

Defect Significance: Minor

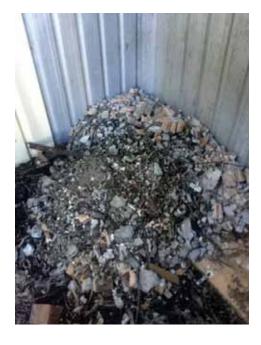
X Inadequate drainage

Defect Significance: Minor

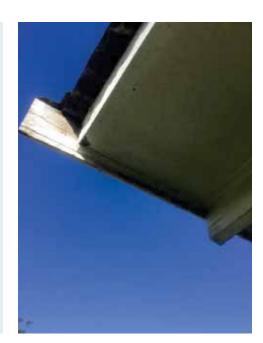
X Suggest painting for further weather protection

Defect Significance: Minor

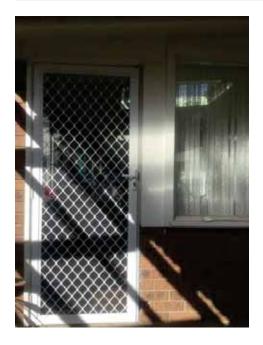
Comments: Damage evident in areas

Defect Significance: Minor

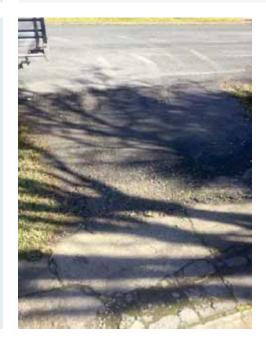
Cracks evident in areas

Defect Significance: Minor
Defect Type: A (Damage)

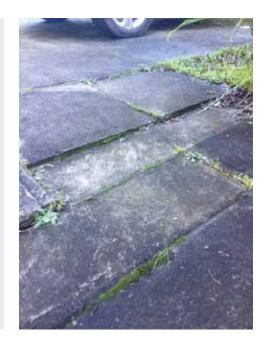
X Concrete paths cracked in areas

Defect Significance: Minor
Defect Type: A (Damage)

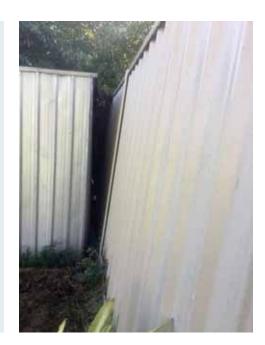
Comments : Suggest removal Defect Significance: Safety Hazard

Defect Type: B (Distortion, Warping, Twisting)
