# BUILDING INSPECTION

Complies with Australian Standard AS 4349.1-2007  
Inspection of Buildings Part 1: Pre-Purchase  
Inspections of Residential Buildings - Appendix C

40 Ocean Road  
Batehaven,  
2536, Australia

Inspection Date: 08 Jul 2017, 8:02 AM to 10:38 AM

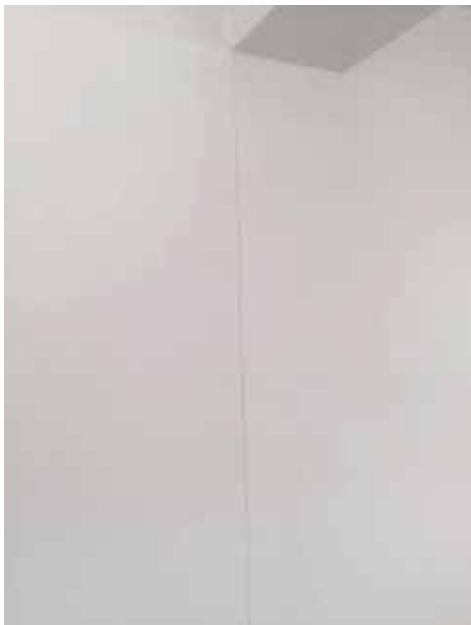
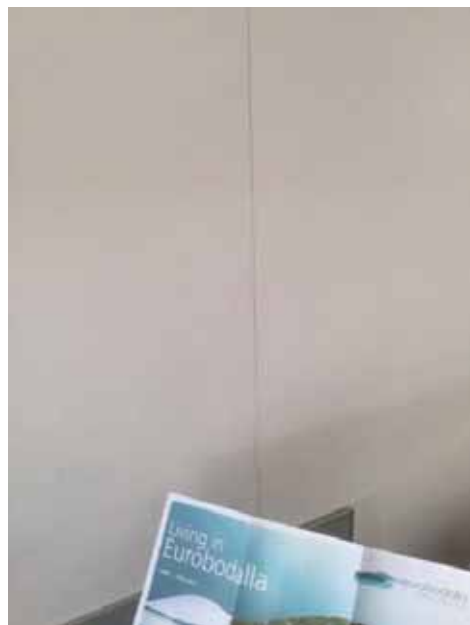
- ✗ Any other associated marks, indents, holes, scratches, cracks and/or poorly patched areas to some of the wall areas to this room can be rectified prior to the next time of repainting.

**Defect Significance:** Minor  
**Defect Type:** A (Damage)

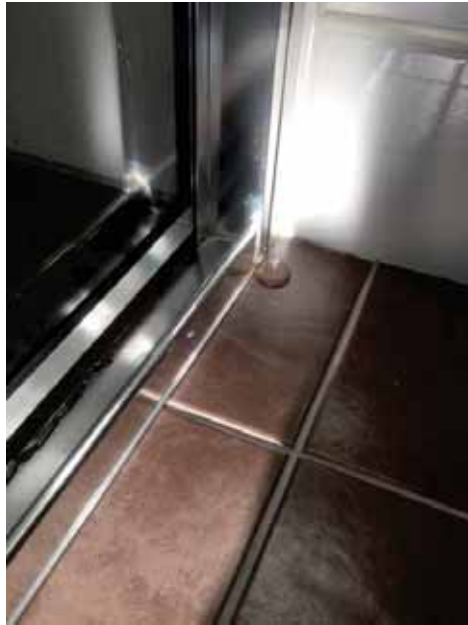
✗ Leaking around shower screen evident

**Defect Significance:** Minor  
**Defect Type:** C (Water Penetration Damp Related)

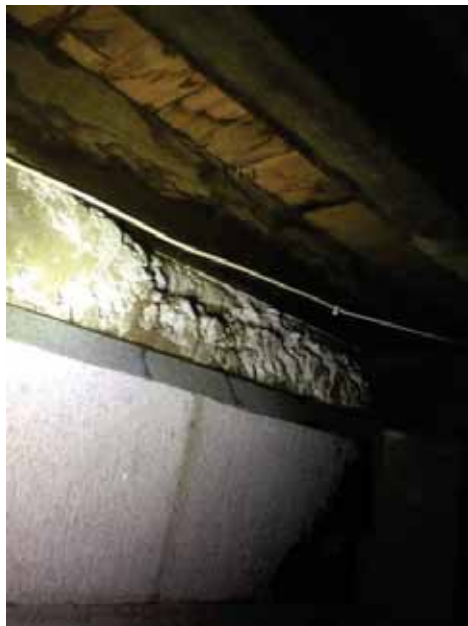
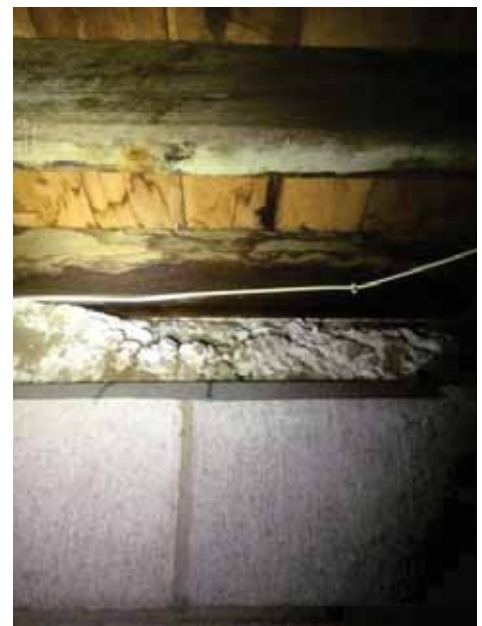
✗ Evident of shower recess leak in subfloor

Defect Significance: Major  
Defect Type: C (Water Penetration Damp Related)

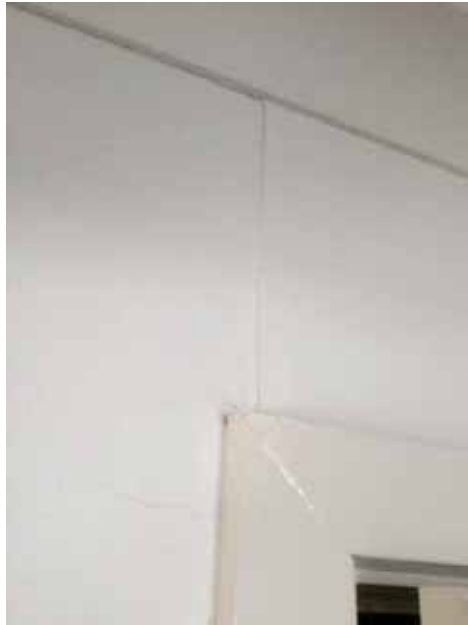
✗ Any other associated marks, indents, holes, scratches, cracks and/or poorly patched areas to some of the wall areas to this room can be rectified prior to the next time of repainting.

Defect Significance: Minor  
Defect Type: A (Damage)

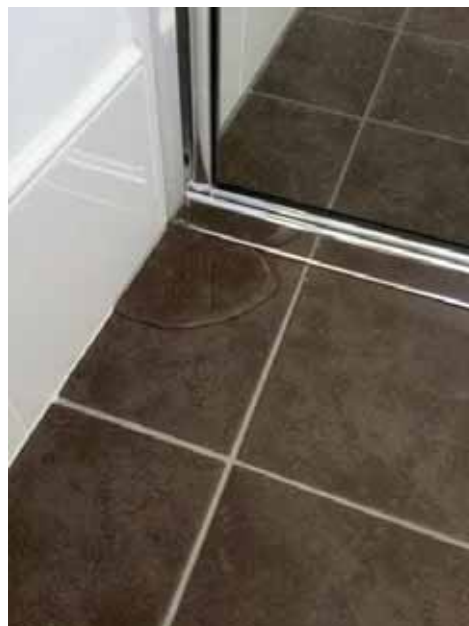
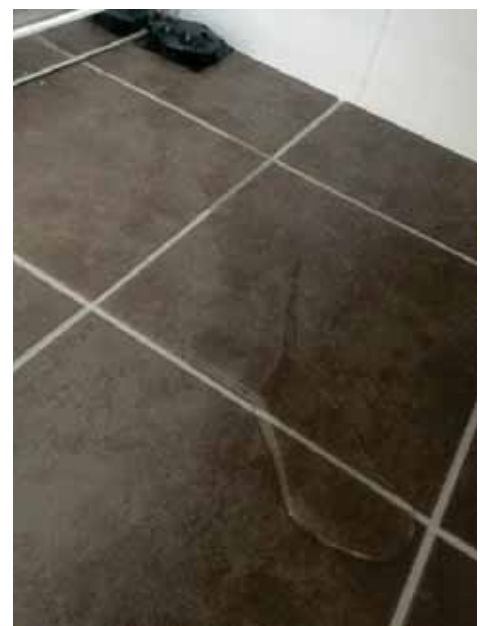
✗ Leaking around shower screen evident

Defect Significance: Minor  
Defect Type: C (Water Penetration Damp Related)

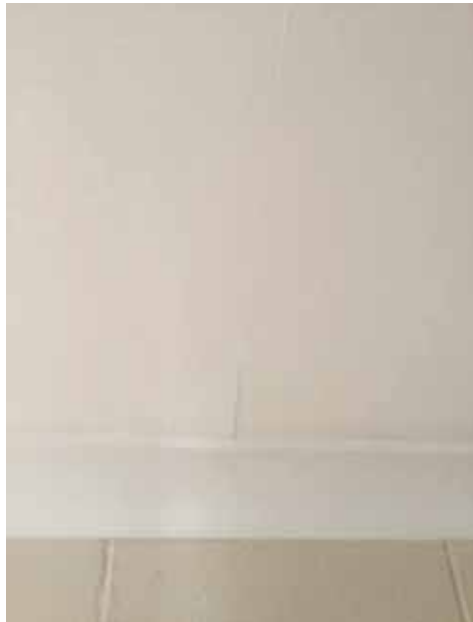
✗ Minor cracks evident in areas

Defect Significance: Minor  
Defect Type: A (Damage)

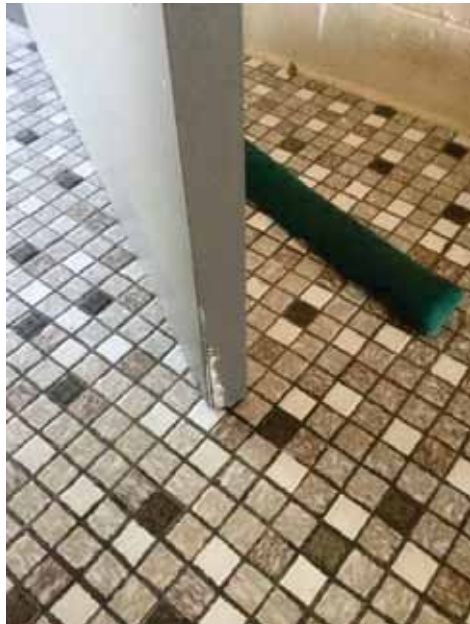
✗ Damage evident in areas

Defect Significance: Minor  
Defect Type: A (Damage)

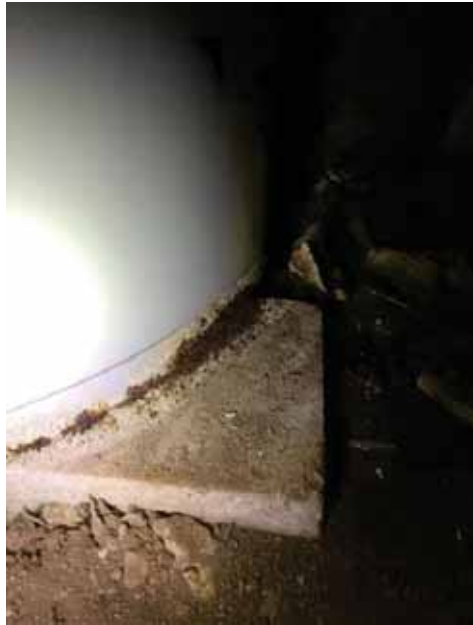
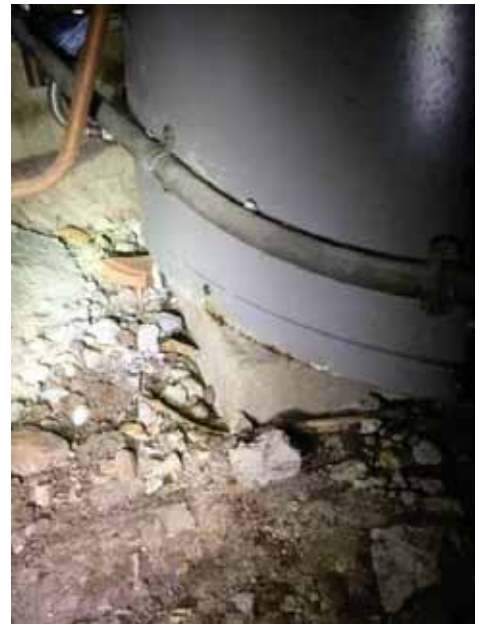
✗ Rust & corrosion is evident in areas

Defect Significance: Minor

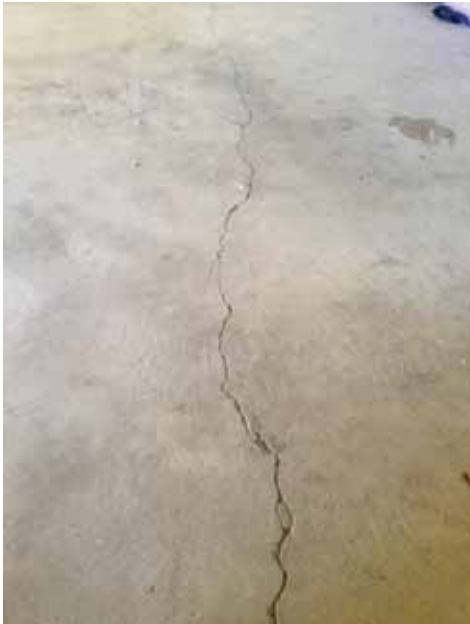
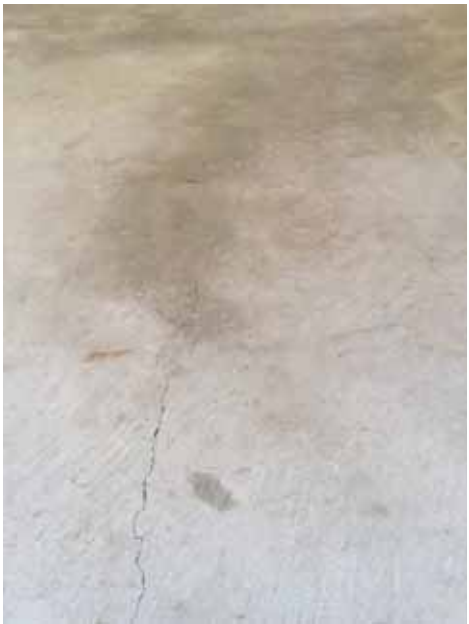
✗ Common cracks were located

Defect Significance: Minor  
Defect Type: A (Damage)

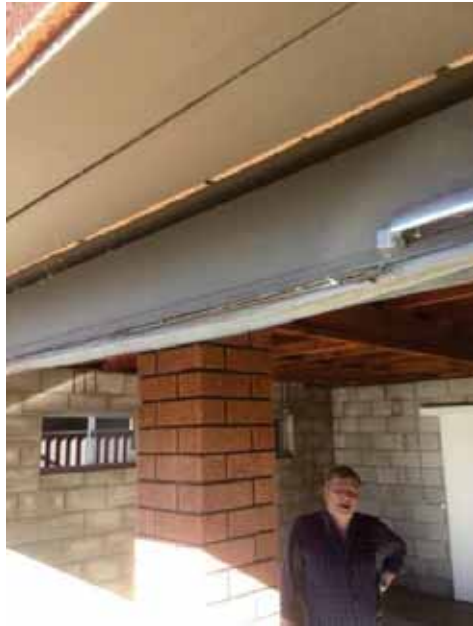
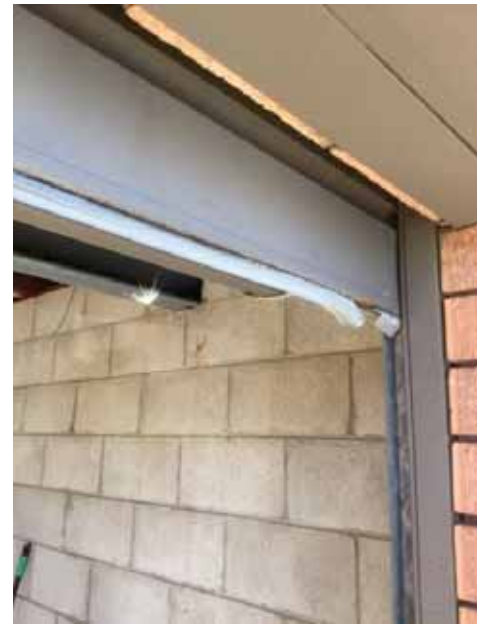
Comments : Suggest replacing rubber seal  
Defect Significance: Minor  
Defect Type: D (Material Deterioration: rusting, rotting, corrosion, decay)

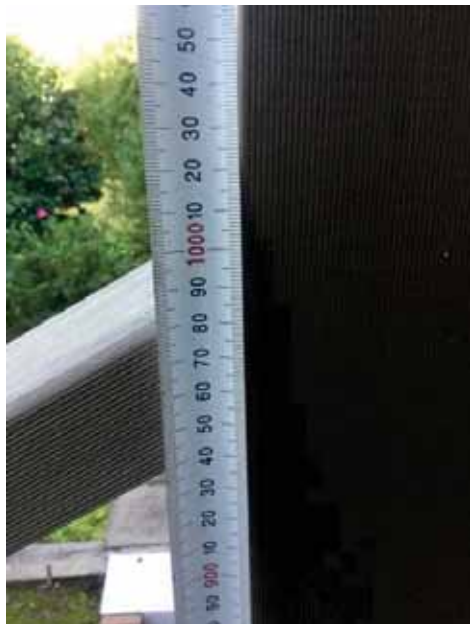
✗ All veranda's, decking, balconies and any internal void area railings must be a minimum height of 1.0metre high for compliance with the most recent Australian Standards. (If under 1.0m this is a safety hazard.)

Defect Significance: Safety Hazard  
Defect Type: E (Operational)

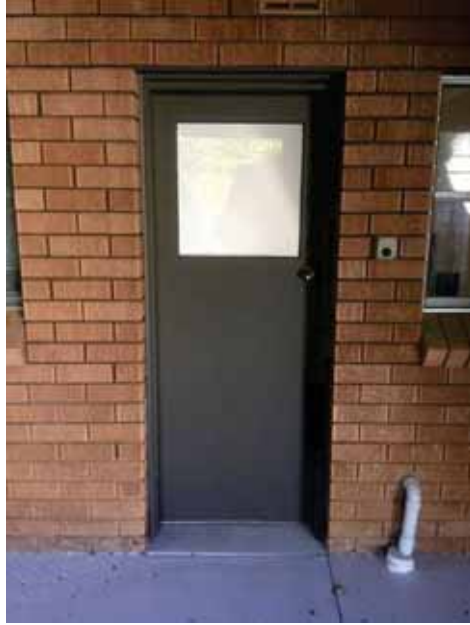
Comments : Binding suggest shaving or cutting  
Defect Significance: Minor  
Defect Type: A (Damage)

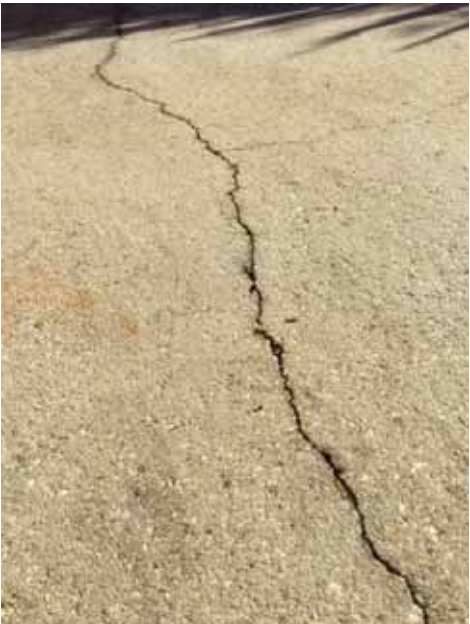
✗ Cracks evident in areas

Defect Significance: Minor  
Defect Type: A (Damage)

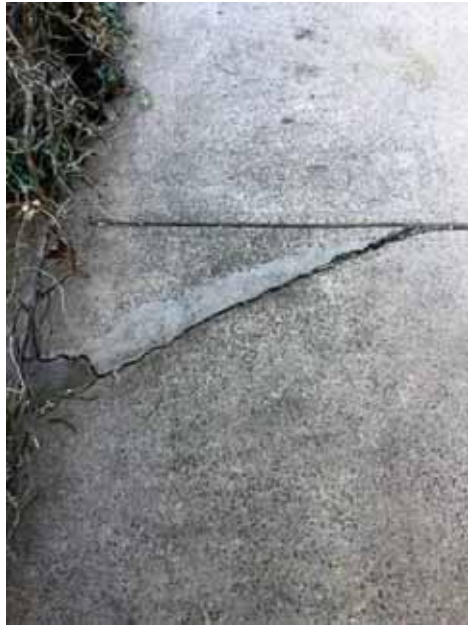
✗ Concrete paths cracked in areas

Defect Significance: Minor  
Defect Type: A (Damage)

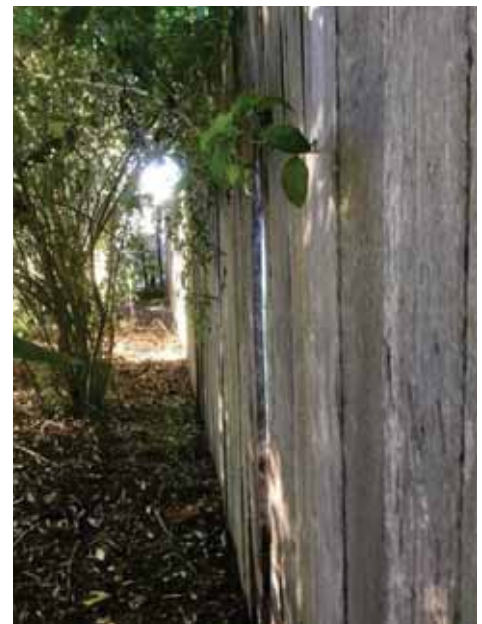
✗ Timber posts show timber decay & posts are leaning

**Defect Significance:** Minor  
**Defect Type:** D (Material Deterioration: rusting, rotting, corrosion, decay)

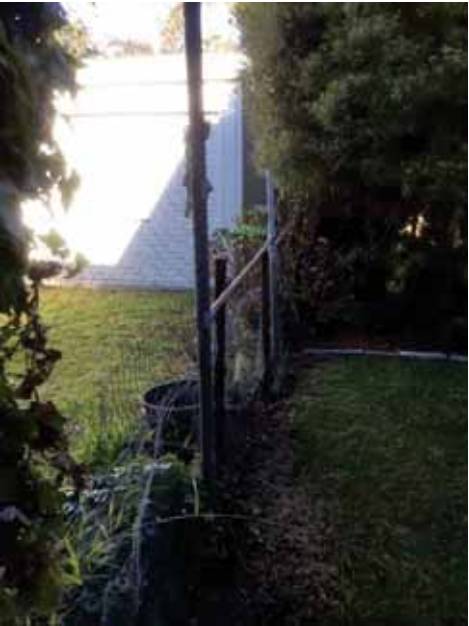
Comments : Maintenance required  
Defect Significance: Minor  
Defect Type: D (Material Deterioration: rusting, rotting, corrosion, decay)

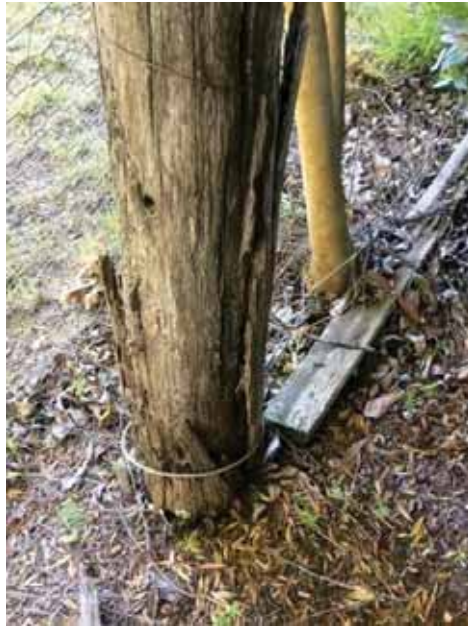
Comments : Decay evident in areas  
Defect Significance: Minor  
Defect Type: D (Material Deterioration: rusting, rotting, corrosion, decay)

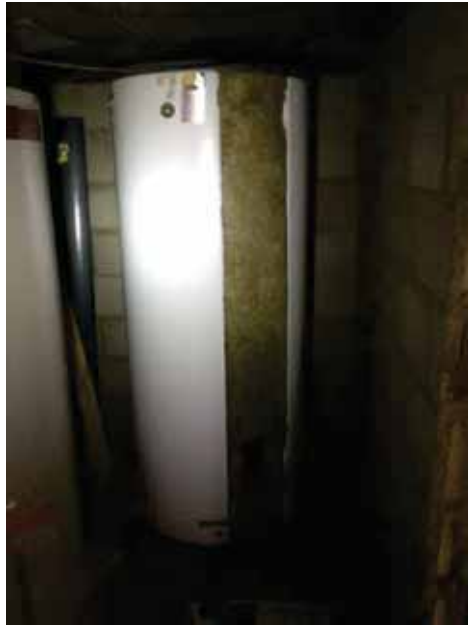
Old water heater stored in subfloor  
Minor  
D (Material Deterioration: rusting, rotting, corrosion, decay)

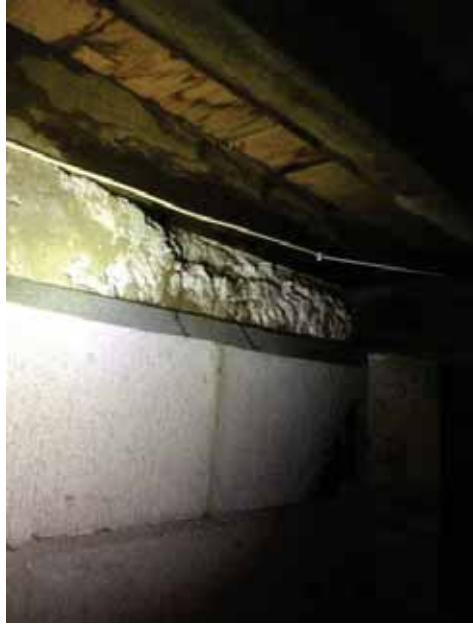
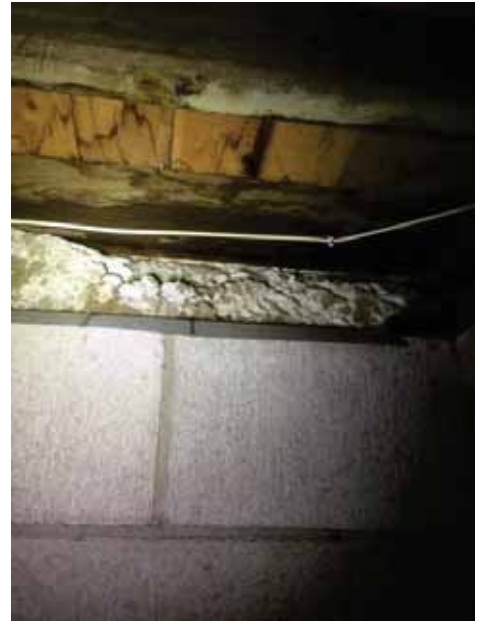
✗ Water damage evident in areas

Defect Significance: Major  
Defect Type: C (Water Penetration Damp Related)

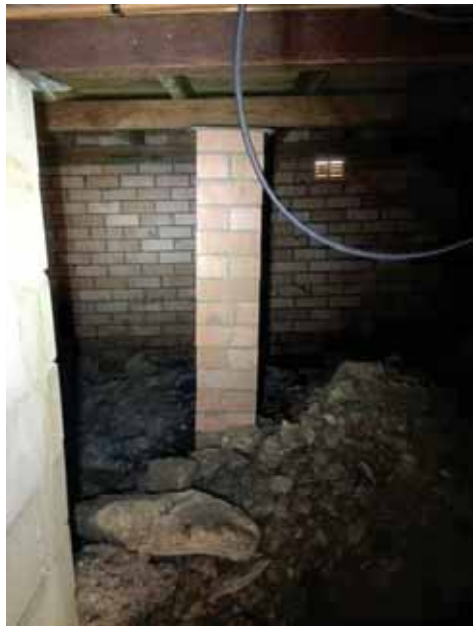
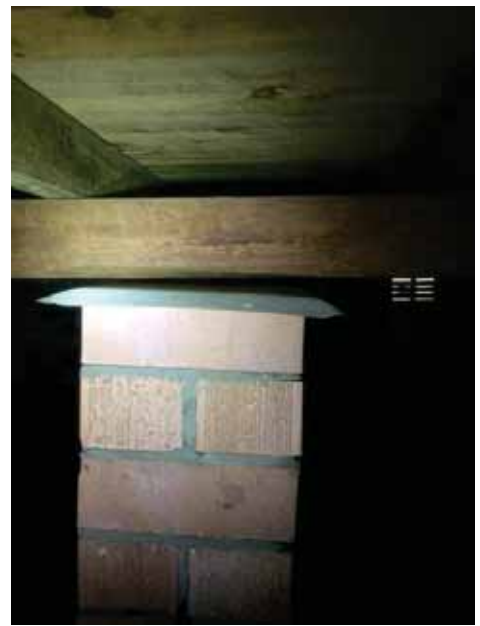
Defect Significance: Major  
Defect Type: B (Distortion, Warping, Twisting)

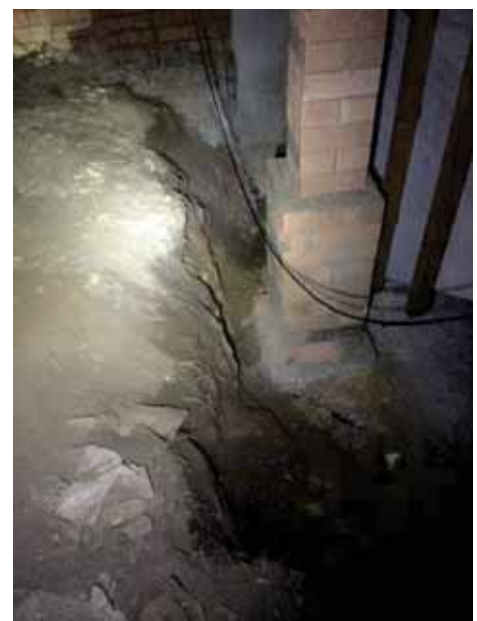
Comments : Suggest a retaining wall to support foundation coverings from movement  
Defect Significance: Minor  
Defect Type: D (Material Deterioration: rusting, rotting, corrosion, decay)

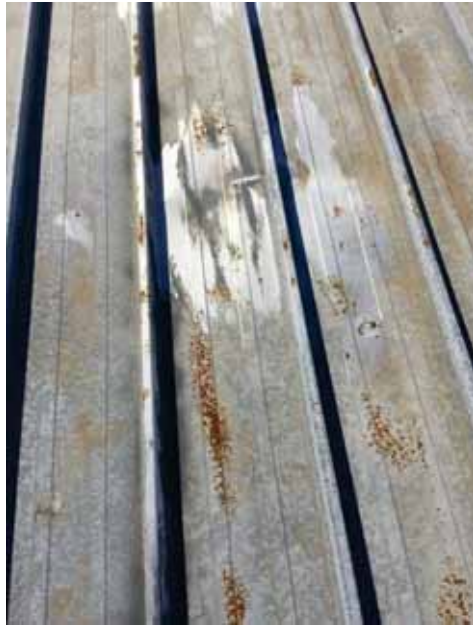
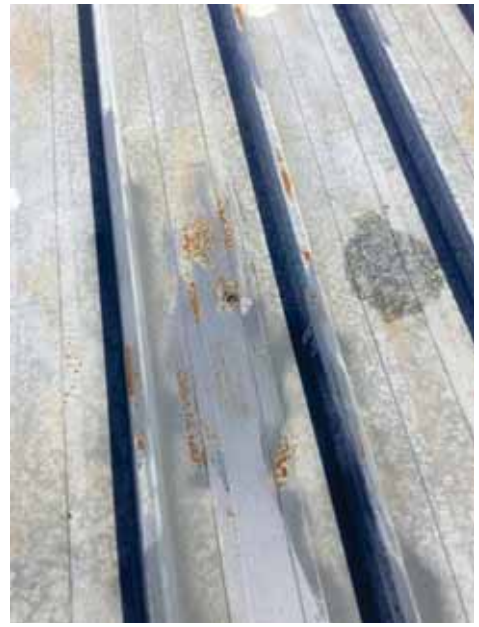
✗ Roof sheets coating shows signs of deterioration suggest sealing for further weather protection

**Defect Significance:** Minor  
**Defect Type:** D (Material Deterioration: rusting, rotting, corrosion, decay)

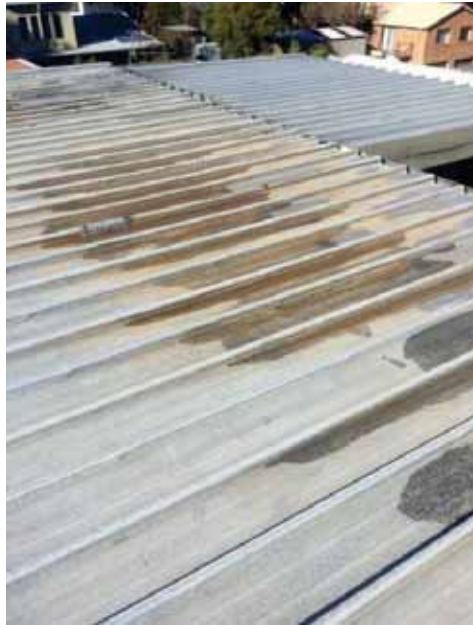
Comments : Water pooling evident in areas  
Defect Significance: Minor  
Defect Type: C (Water Penetration Damp Related)

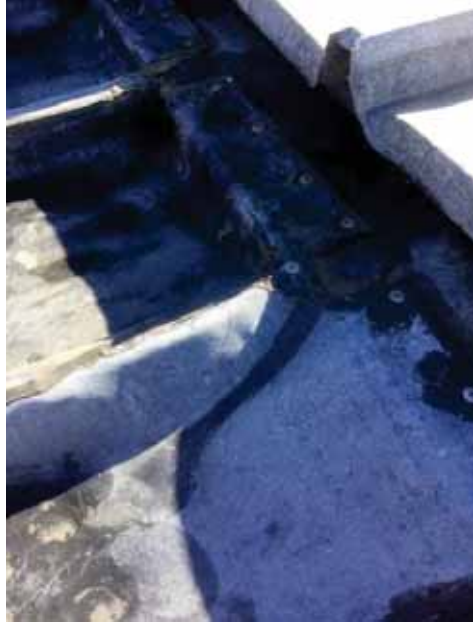
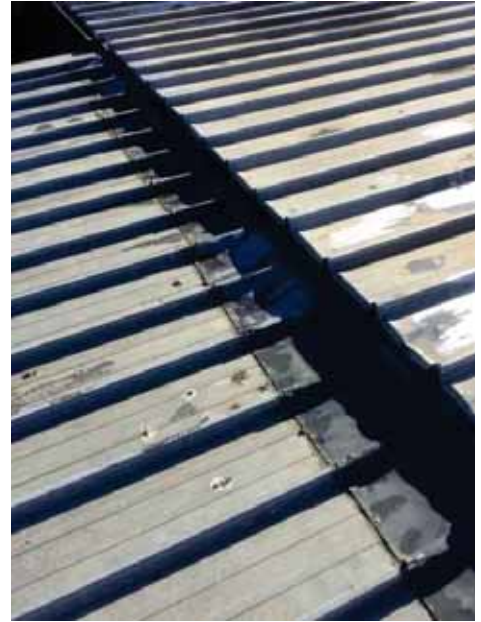
✗ Flashing shows signs of deterioration suggest replacing or re-sealing

**Defect Significance:** Minor  
**Defect Type:** D (Material Deterioration: rusting, rotting, corrosion, decay)

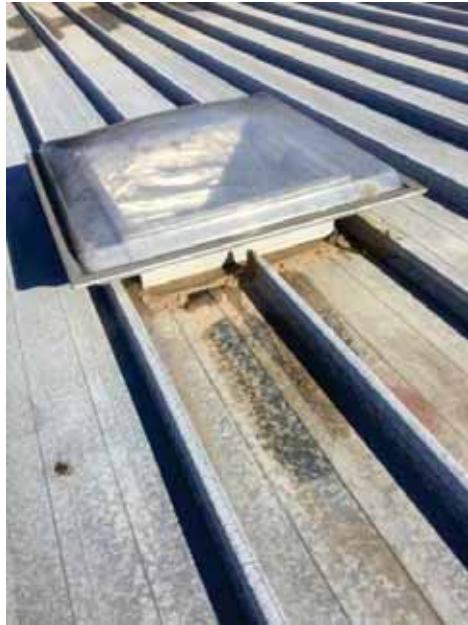
**Comments :** Suggest re-sealing  
**Defect Significance:** Minor  
**Defect Type:** D (Material Deterioration: rusting, rotting, corrosion, decay)

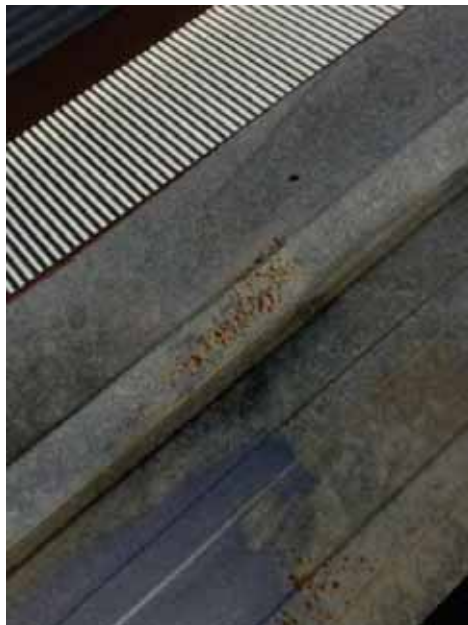
✗ Rust & corrosion is evident in areas

**Defect Significance:** Minor  
**Defect Type:** D (Material Deterioration: rusting, rotting, corrosion, decay)

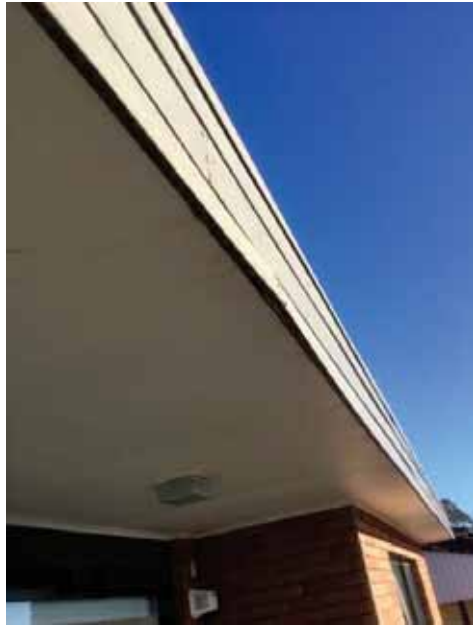
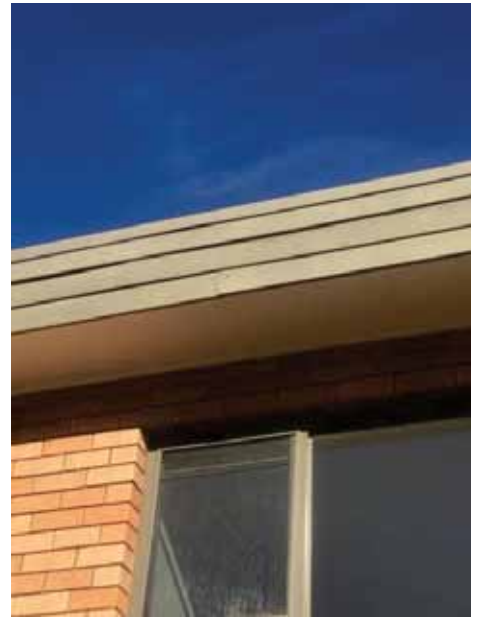
✗ Visible wood decay damage was evident in areas

**Defect Significance:** Minor  
**Defect Type:** D (Material Deterioration: rusting, rotting, corrosion, decay)

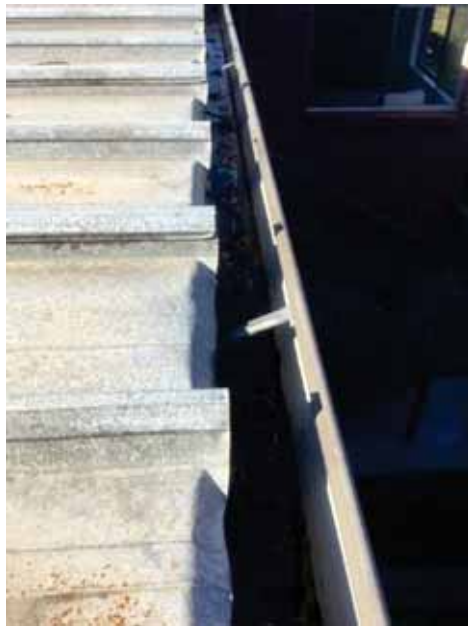
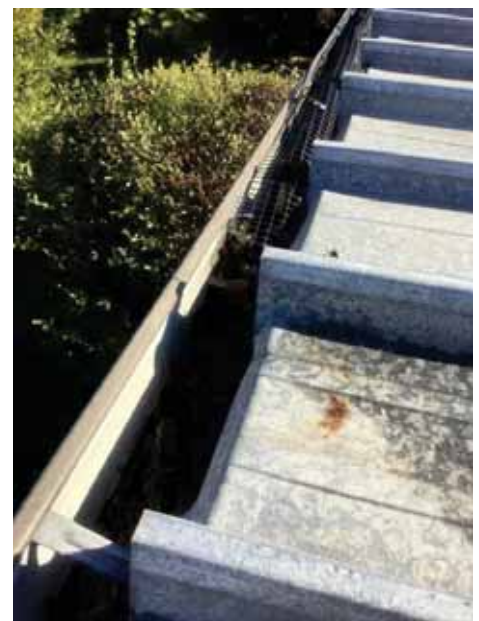
✗ Gutters & downpipes are leaking at their joints in areas & need rectification. (Excessive leaking can cause "Conducive" conditions to possible termite attack.) inadequate drainage

Comments : Water pooling inadequate fall  
Defect Significance: Minor  
Defect Type: C (Water Penetration Damp Related)

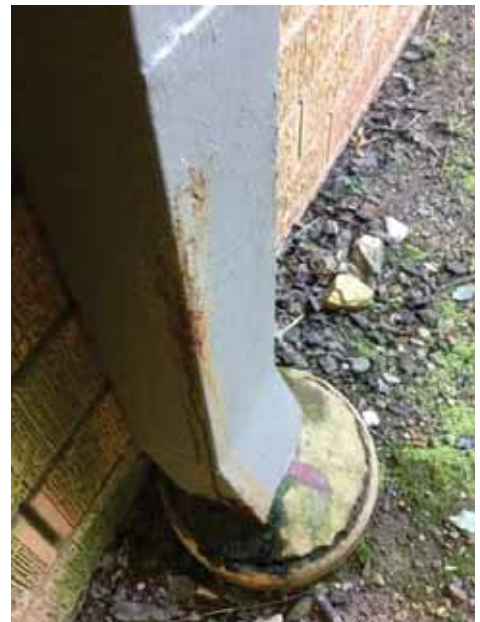
- ✗ Downpipes are leaking at their joints in areas & need rectification. (Excessive leaking can cause "Conducive" conditions to possible termite attack.) inadequate drainage

**Defect Significance:** Minor  
**Defect Type:** D (Material Deterioration: rusting, rotting, corrosion, decay)
