BUILDING INSPECTION

Complies with Australian Standard AS 4349.1-2007 Inspection of Buildings Part 1: Pre-Purchase Inspections of Residential Buildings - Appendix C

19 Bunberra St Cronulla, NSW 2230, Australia

Inspection Date: 04 Sep 2016 Inspected by:

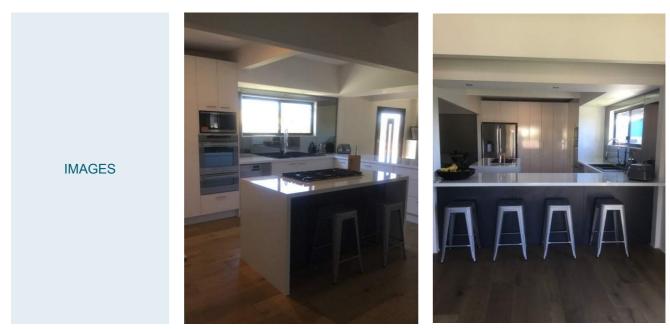
Kitchen

Comments : Defect Significance: Defect Type: Nail popping evident near down light & bulk head Minor B (Distortion, Warping, Twisting)

Comments : Defect Significance: Defect Type: Doors binding above fridge hinges require adjusting Minor E (Operational)

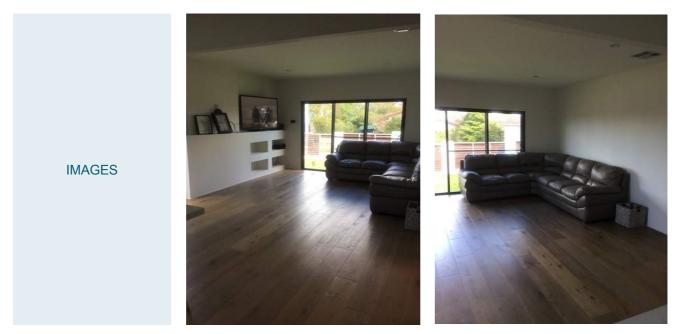
Lounge Room

EXPLANATIONS	Comments :	Cracking under support beam evident (Next to side entrance door)
	Defect Significance: Defect Type:	Minor B (Distortion, Warping, Twisting)

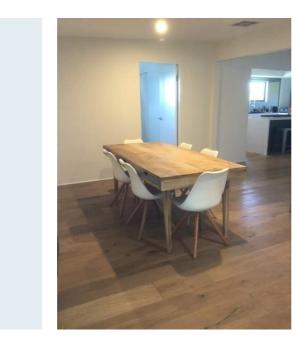
imes Minor cracks to lining joints evident in areas

EXPLANATIONS	Comments :	Cracks evident at wall & ceiling junction rear wall (north wall) of dining
	Defect Significance: Defect Type:	Minor B (Distortion, Warping, Twisting)

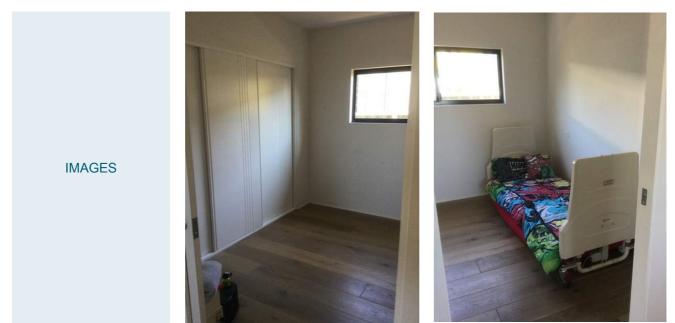
Bedroom 2

Patching evident above power point western wall Minor A (Damage)

Defect Significance: Defect Type: Man hole located in robe bed 2 , man hole cover incomplete. Minor E (Operational)

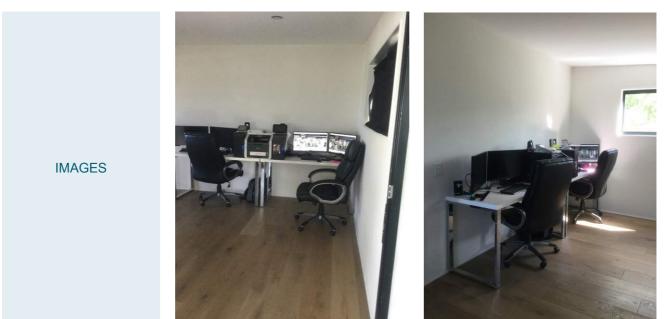
Study

× Minor cracks to lining joints evident

Cracking evident around sliding glass door Minor B (Distortion, Warping, Twisting)

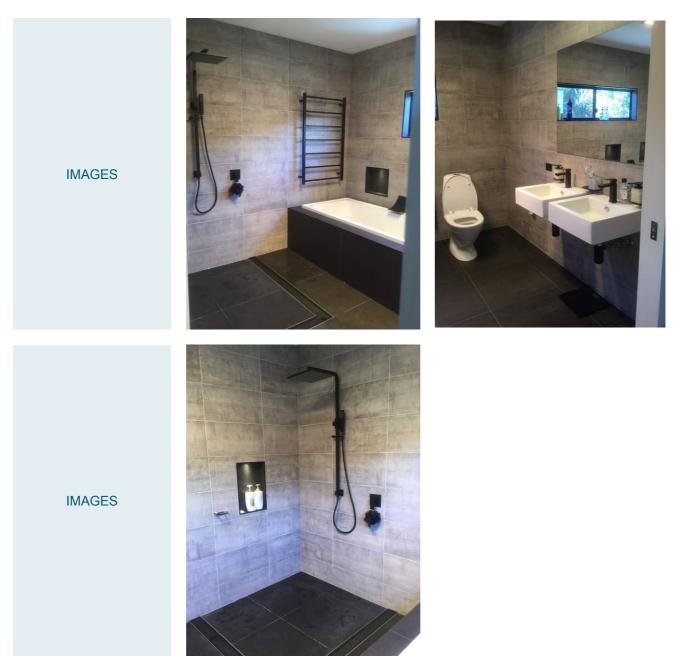
Comments : Defect Significance: Defect Type: Re-sealing required around door jamb Minor C (Water Penetration Damp Related)

EXPLANATIONS	Comments : Defect Significance: Defect Type:	Drummy tile evident in shower (front tile on the right) Minor F (Installation, including omissions)

Comments : Defect Significance: Defect Type: Soap dispenser not located in shower recess Minor E (Operational)

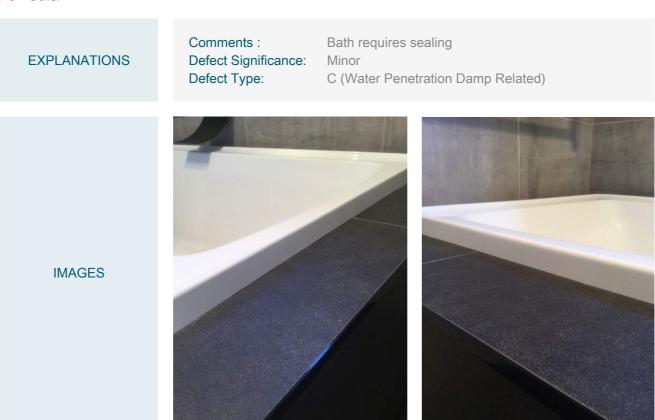
Bath

× Cistern leaking water
