BUILDING INSPECTION

Complies with Australian Standard AS 4349.1-2007 Inspection of Buildings Part 1: Pre-Purchase Inspections of Residential Buildings - Appendix C

80 Coogee Street Kiama, NSW 2533, Australia

Inspection Date: 16 Feb 2017, 7:44 AM to 10:08 AM

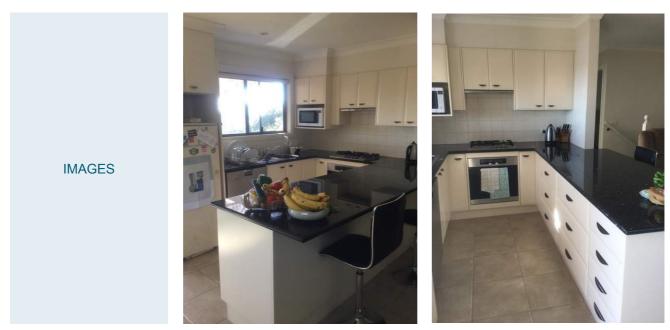
Kitchen

➤ Cracks to lining evident in some areas

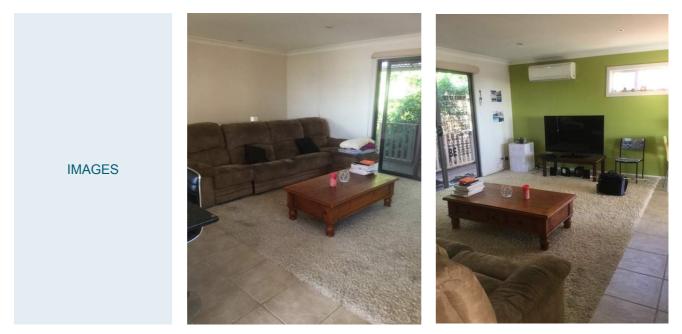
Lounge Room

imes Minor cracks to lining joints evident in areas

Defect Significance: Defect Type: Minor A (Damage)

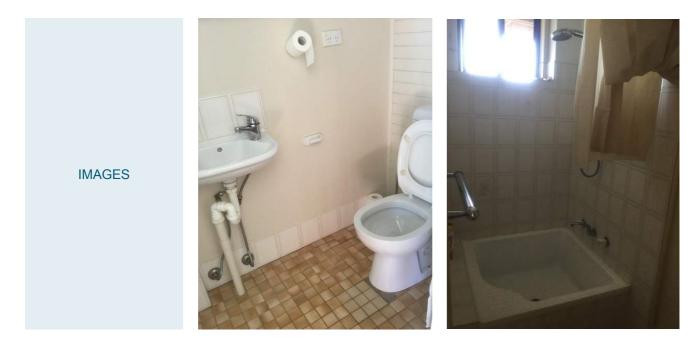
General View

× Inadequate ventilation rectification is required

EXPLANATIONS	Defect Significance: Defect Type:	Minor E (Operational)
Со	rnice		
~	No defects evident		
Wa	alls		
~	No defects evident		
Pa	inting		
\times	Average condition		
Та	ps/Mixers Shower		
~	No defects evident

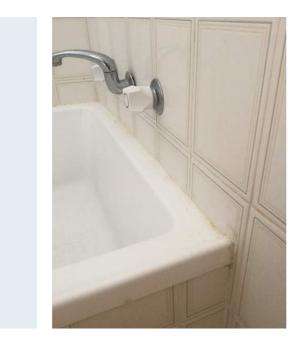
Bath Side Tiles

Comments : Defect Significance: Defect Type: Skirting tiles & floor tiles separating Major D (Material Deterioration: rusting, rotting, corrosion, decay)

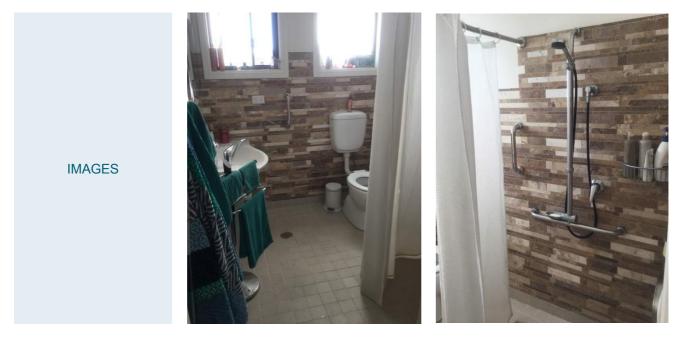
Main Bathroom

× Cracked tiles evident

× Door damaged

× Water damage evident

Defect Significance: Defect Type: Suggest shower screen to stop further water penetration Minor C (Water Penetration Damp Related)

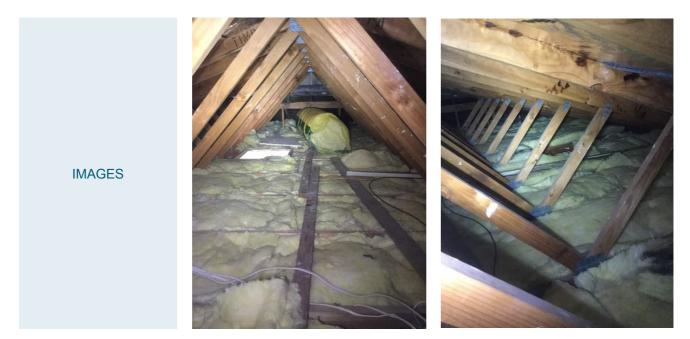
\times Decay evident in roof elements

Decay & water damage evident Minor C (Water Penetration Damp Related)

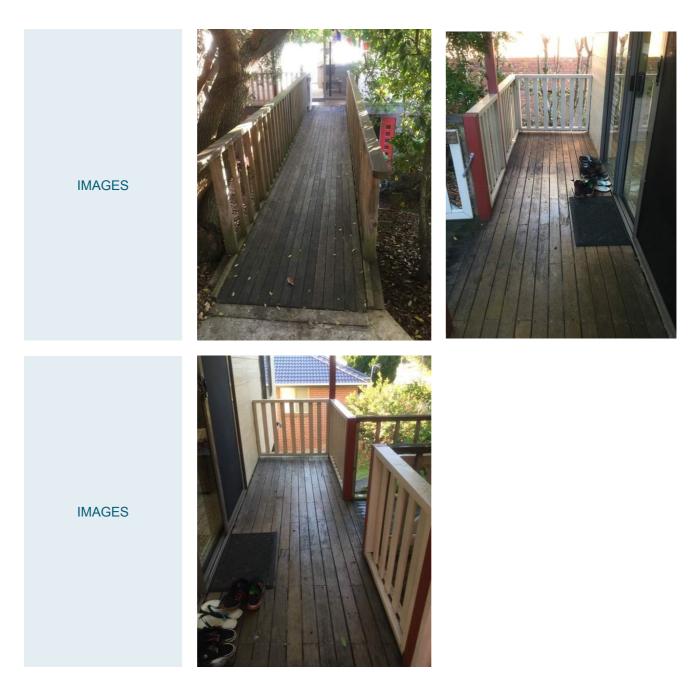
Comments : Defect Significance: Defect Type: Suggest gutter & down pipe to improve drainage Minor C (Water Penetration Damp Related)

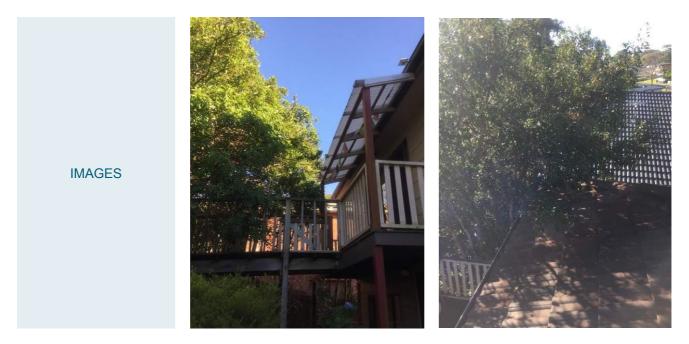
Drainage

X This site has inadequate surface inlet drainage. We recommend that additional site surface run off inlet and or diversion drainage be put into place around this property to protect this dwellings foundation materials.
