BUILDING INSPECTION

Complies with Australian Standard AS 4349.1-2007 Inspection of Buildings Part 1: Pre-Purchase Inspections of Residential Buildings - Appendix C

8 Clarence Street Batemans bay, NSW 2536, Australia

Inspection Date: 14 Feb 2017, 12:52 PM to 3:25 PM Inspected by: Travis Reeves

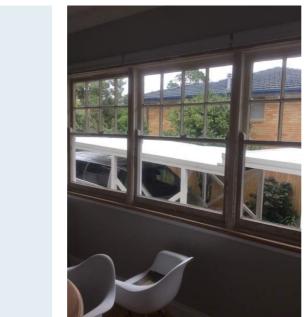
Comments :	Sashes open. S
EXPLANATIONS	Defect Significance: Defect Type:	Minor E (Oper

s missing handles, suggest easing tight to Sash balances may require replacing E (Operational)

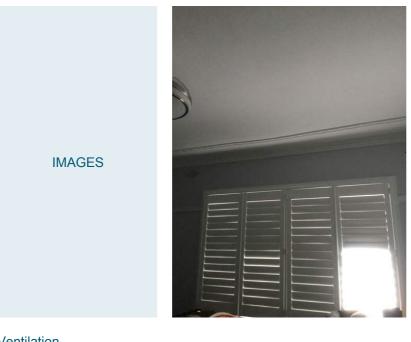
Defect Significance:MinorDefect Type:B (Dis

Minor B (Distortion, Warping, Twisting)

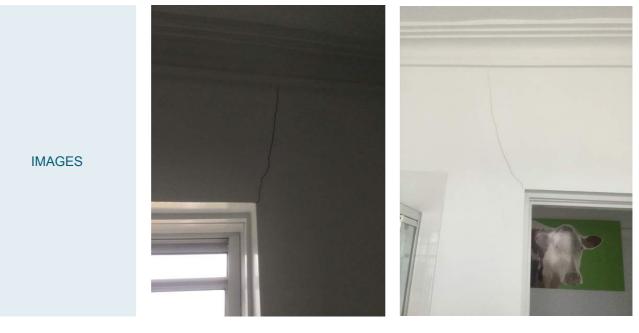
× Moderate cracks were located

Defect Significance: Defect Type:

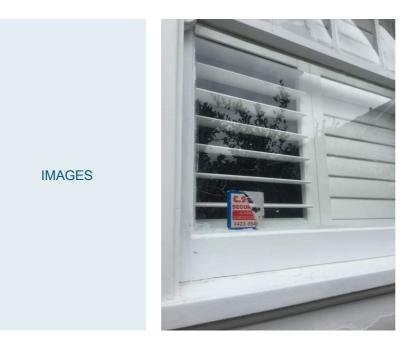
EXPLANATIONS	Comments : Defect Significance: Defect Type:	Windows painted shut suggest easing to open. Sash balances may require replacing Minor E (Operational)
Window/s		
× Cracked glass evident

EXPLANATIONS	Defect Significance:	Minor
EAFLANATIONS	Defect Type:	A (Damage)

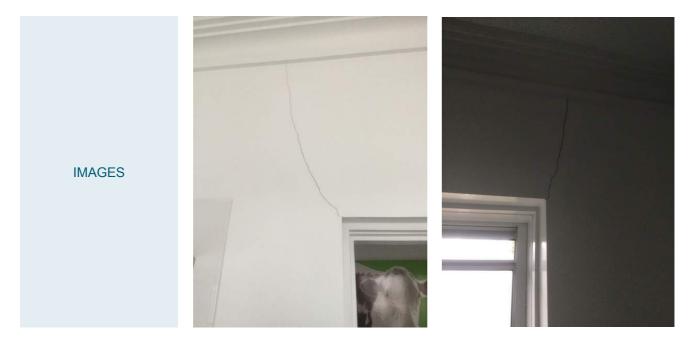
× Moderate cracks were located

Defect Significance: Minor B (Distortion, Warping, Twisting)

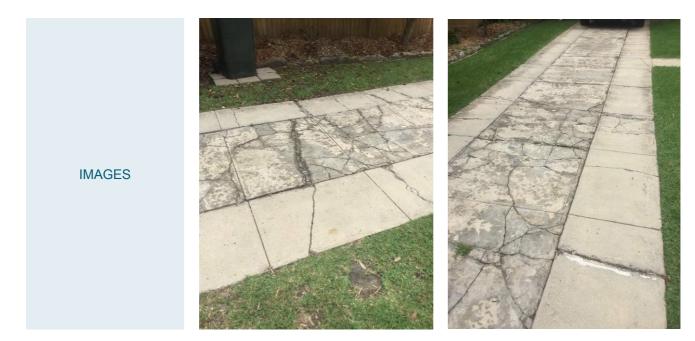
Paths

\times Concrete paths cracked in areas

X Uneven and undulating paving and tiled pavers is a trip hazard

Defect Significance: Safety Hazard Defect Type:

E (Operational)

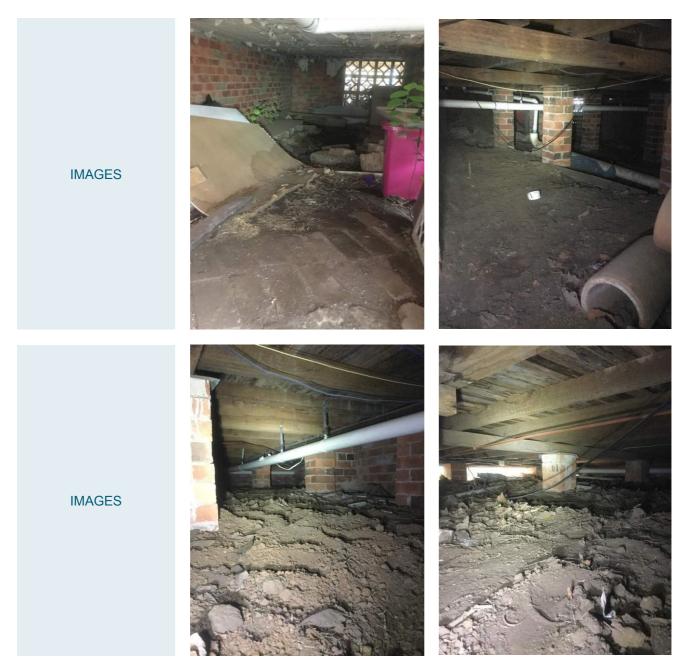
Comments : Defect Significance: Defect Type: Builders waste suggest removal Minor E (Operational)

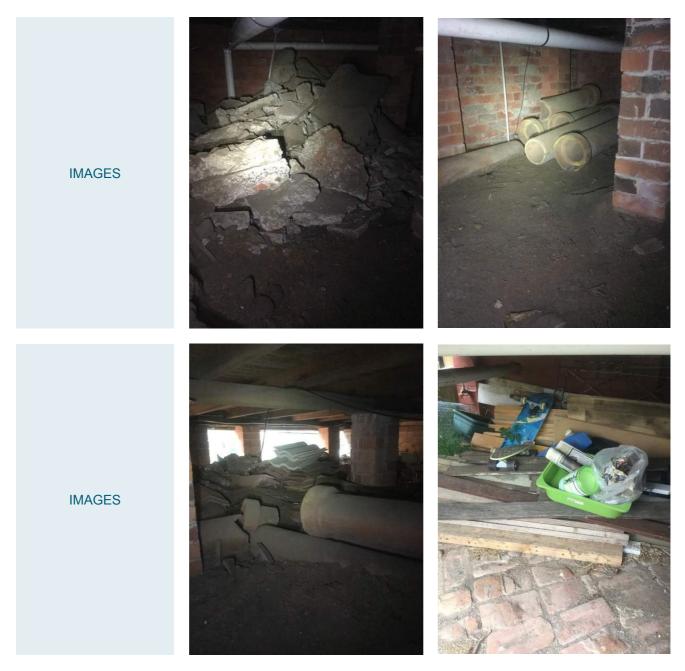
Flooring

imes Water damage evident in areas

Defect Significance: Defect Type:

Previous water damage evident next to main bathroom Minor C (Water Penetration Damp Related)

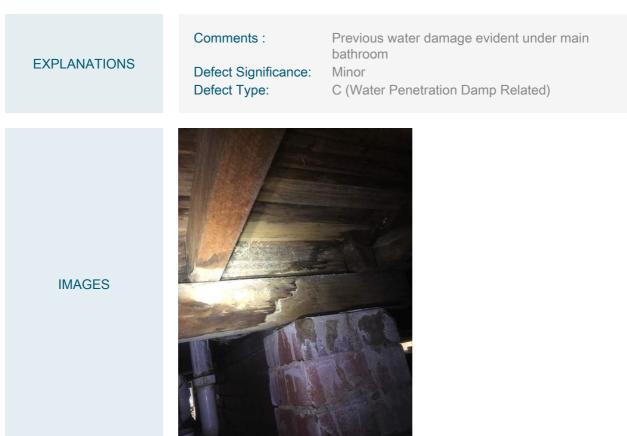
Bearers & Joists

Comments : Defect Significance: Defect Type: Water damage evident under dining area Minor C (Water Penetration Damp Related)

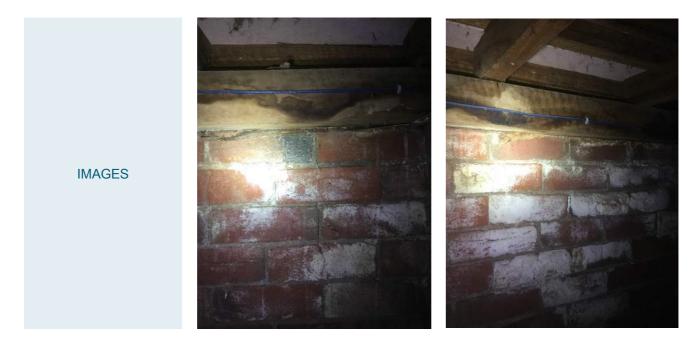
Piers

Comments : Defect Significance: Defect Type:

Cracking evident on front wall under lounge room Minor B (Distortion, Warping, Twisting)

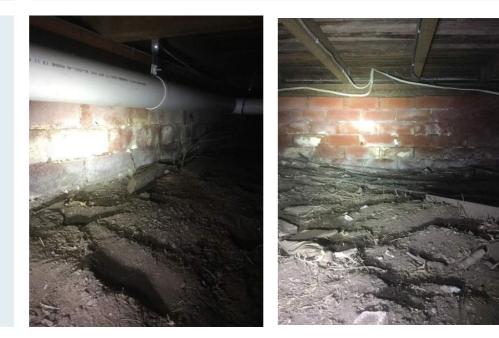
Brick wall

Comments : Defect Significance: Defect Type:

Rising damp evident in areas Minor C (Water Penetration Damp Related)

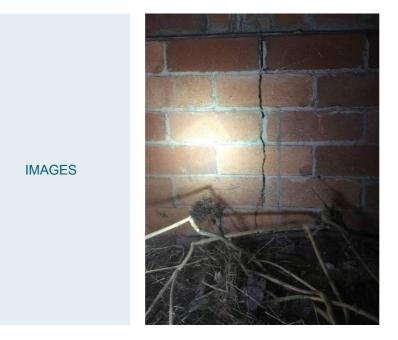
Defect Significance: Defect Type:

Cracking evident to foundation wall supporting bathroom Minor B (Distortion, Warping, Twisting)
