BUILDING INSPECTION

Complies with Australian Standard AS 4349.1-2007 Inspection of Buildings Part 1: Pre-Purchase Inspections of Residential Buildings - Appendix C

9 Glenhaven Avenue North Nowra, NSW 2541, Australia

Inspection Date: 26 Jun 2017, 8:39 AM to 12:05 PM Inspected by: Travis Reeves

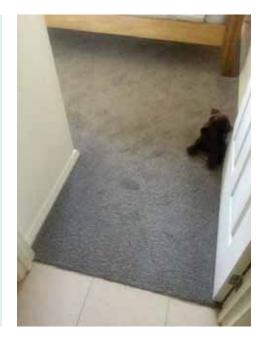
Defect Significance: Minor

Defect Type: B (Distortion, Warping, Twisting)

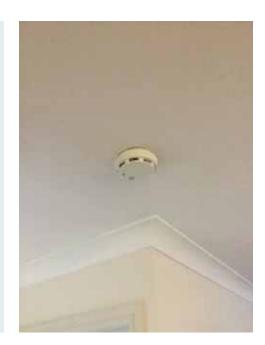
Smoke Detectors

Visually Inspected Not Tested. Smoke detectors are not tested at the time of this inspection. Therefore if unsure call a Licensed Electrician for further advice.
