# BUILDING INSPECTION

Complies with Australian Standard AS 4349.1-2007 Inspection of Buildings Part 1: Pre-Purchase Inspections of Residential Buildings - Appendix C

21 Island Point Road Campbeltown, NSW 2560, Australia

Inspection Date: 23 Jan 2017, (none) to (none)

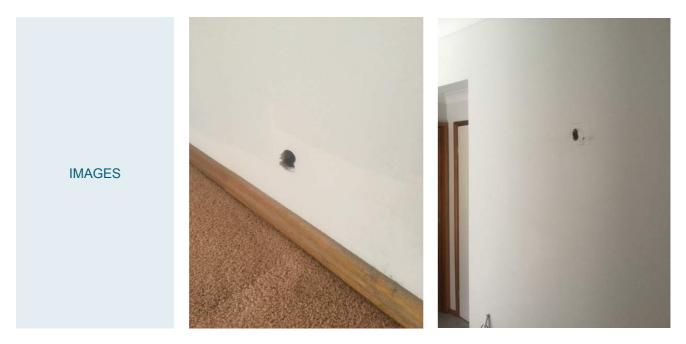
imes Damaged plasterboard evident in areas

Defect Significance: Minor **EXPLANATIONS** Defect Type: A (Damage)

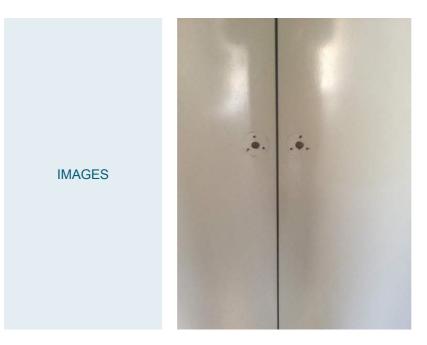
# Linen press

Comments : Defect Significance: Defect Type: Door handles missing suggest replacing Minor A (Damage)

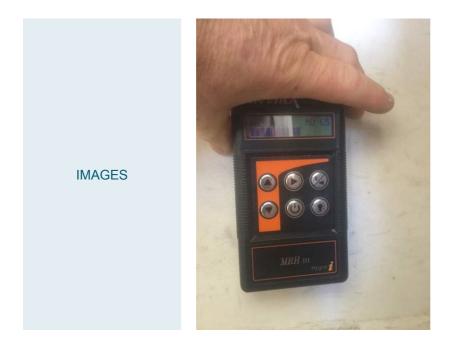
# Moisture

$\times$  Moisture identified

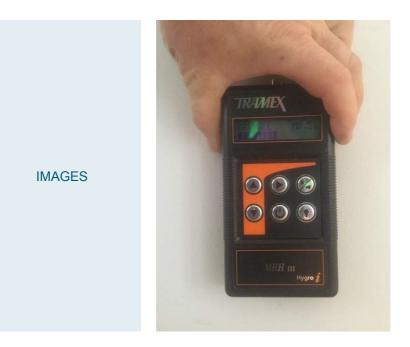
# Moisture

Reading: Comments : Med 31 - 70 Medium moisture reading in bedroom 1 behind shower recess

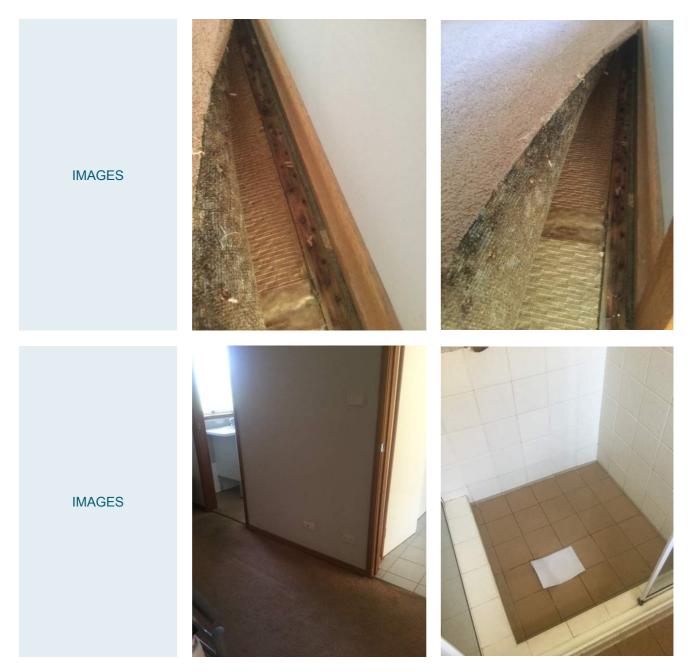
➤ Leaking evident in adjacent room

Defect Significance: Defect Type: Shower leak evident in bedroom 1 wet carpet & underlay Major C (Water Penetration Damp Related)

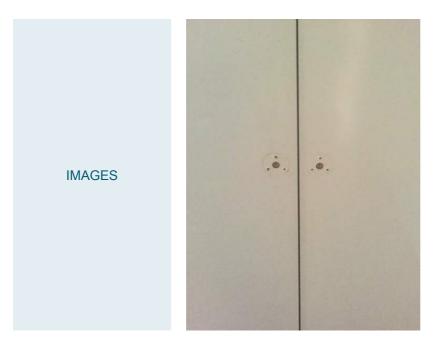
× Door damaged

Door handles missing suggest replacing Minor A (Damage)

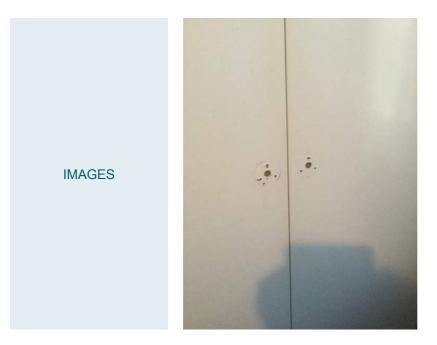
Door handles missing suggest replacing Minor A (Damage)

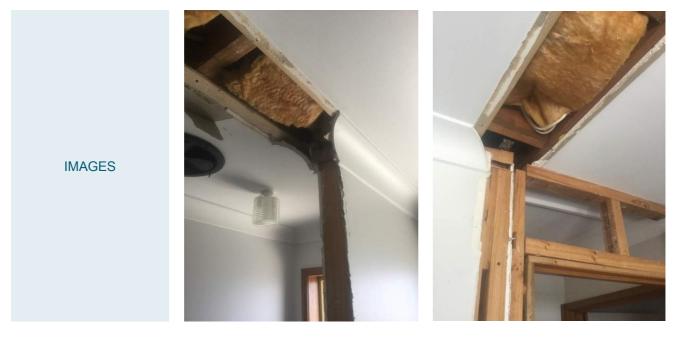
Damage evident Major A (Damage)

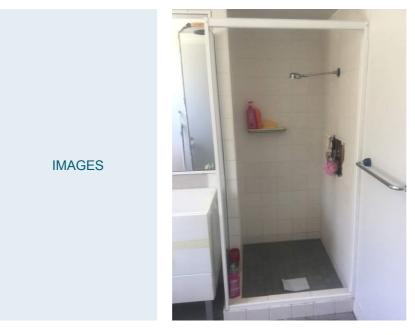
Shower screen panels missing not located Minor E (Operational)

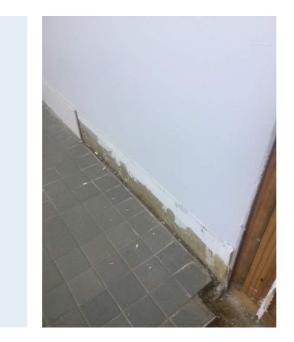
Damage evident Minor A (Damage)

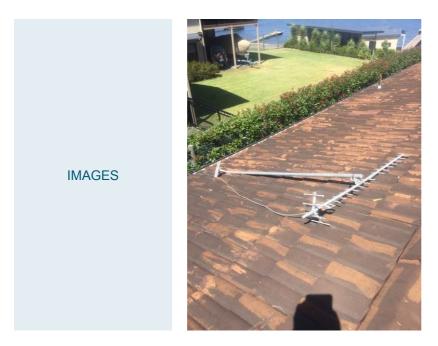
Comments : Defect Significance: Defect Type: Re-fitting is required Minor E (Operational)

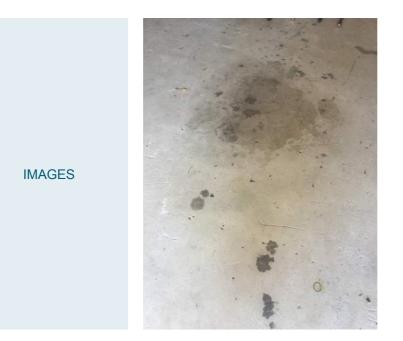
➤ Stained & marked in areas

Minor A (Damage)

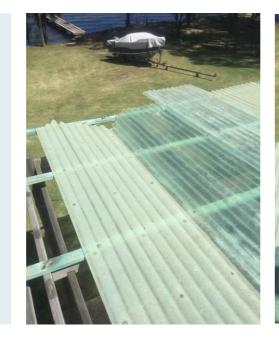
Comments : Defect Significance: Defect Type: Sheeting damaged suggest replacing Minor A (Damage)

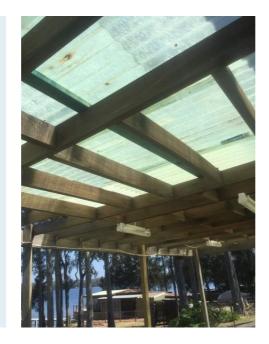
Defect Significance: Defect Type: Spacing between rafters do not meet Australian standards sagging evident suggest removal, seek council for approval of rear pergola Safety Hazard E (Operational)

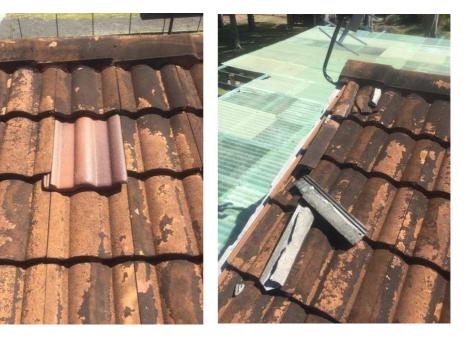
× Roof tiles coating shows signs of deterioration suggest sealing for further weather protection

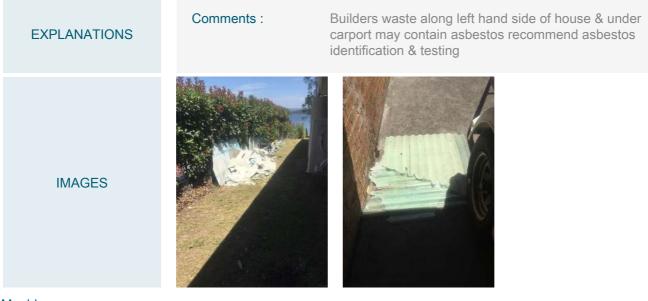
#### Asbestos

Cobserved at site A Full Asbestos ID Report is available for \$350 for visual inspection \$449 for visual inspection + sample Lab test from \$99 per sample
