BUILDING INSPECTION

Complies with Australian Standard AS 4349.1-2007 Inspection of Buildings Part 1: Pre-Purchase Inspections of Residential Buildings - Appendix C

11 Coniston Close Sussex Inlet, NSW 2540, Australia

Inspection Date: 21 Mar 2017, 1:08 PM to 3:48 PM

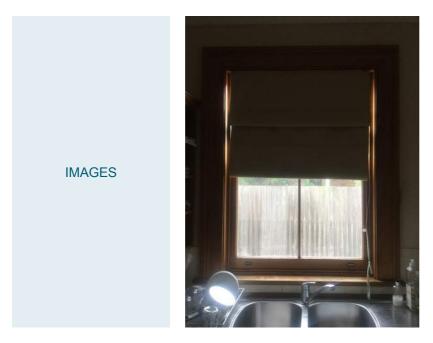
Window/s

X Window sashes painted shut could not be tested, suggest easing for operation. Sash balances/ cords may have to be replaced

Comments : Defect Significance: Defect Type: Top sash only Minor E (Operational)

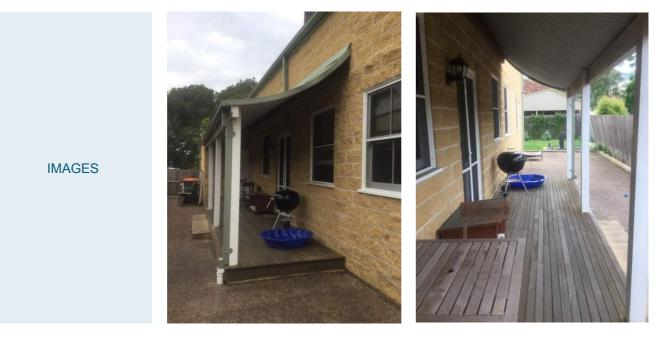
Rear Veranda

| | EXPLANATIONS | Defect Significance: Defect Type: | Minor E (Operational) | | |
|---|---|---|---|--|--|
| \times | ➤ Significant wood decay evident | | | | |
| | EXPLANATIONS | Defect Significance: Defect Type: | Safety Hazard E (Operational) | | |

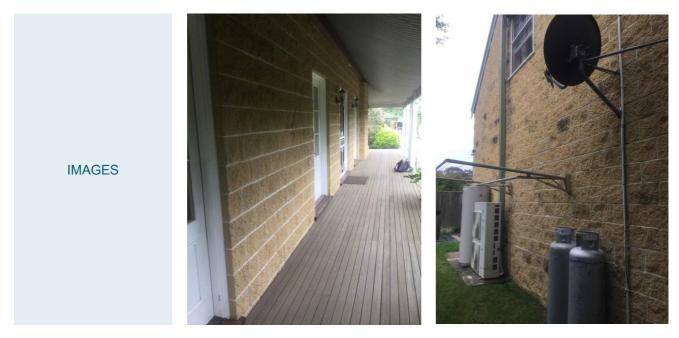
Exterior

Defect Significance: Defect Type: Suggest oiling or staining for further weather protection Minor D (Material Deterioration: rusting, rotting, corrosion, decay)

| EXPLANATIONS | Defect Significance: Defect Type: | Minor D (Material Deterioration: rusting, rotting, corrosion, decay) |

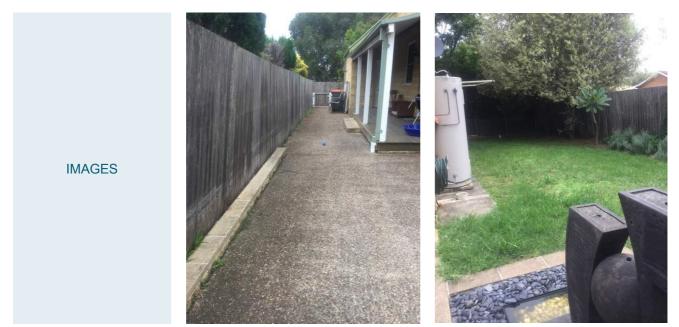
Site

X Timber posts show timber decay & posts are leaning

X This site has inadequate surface inlet drainage. We recommend that additional site surface run off inlet and or diversion drainage be put into place around this property to protect this dwellings foundation materials.

| EXPLANATIONS | Defect Significance: Defect Type: | Minor C (Water Penetration Damp Related) |

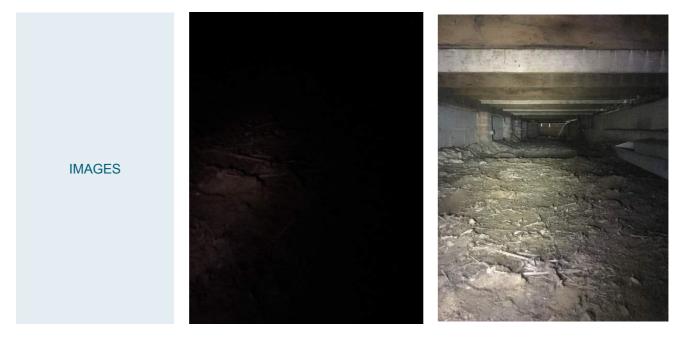
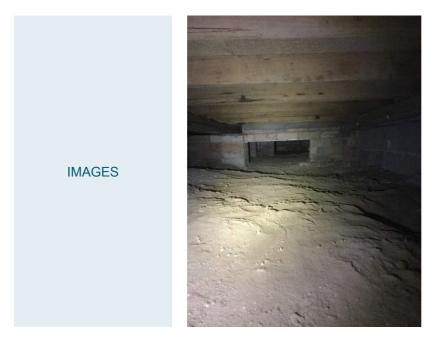
Sub Floor

× Termite damage evident

× Ant capping inadequate

× Ventilation to the subfloor space was observed to be generally inadequate. To help protect against the degradation of timber caused by fungal decay and/or insect attack subfloor ventilation should be upgraded. A further detailed investigation (by a competent person e.g. a licensed building contractor) is recommended to determine the method and extent of any remedial work required, and associated costs. The above recommendation should be implemented as soon as possible.

| | EXPLANATIONS | Defect Significance: Defect Type: | Minor E (Operational) | |
| | EXPLANATIONS | Defect Significance: Defect Type: | Minor C (Water Penetration Damp Related) | |

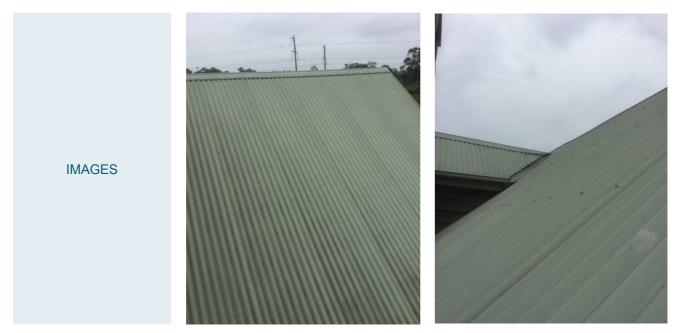
Roof Exterior

× Significant wood decay was evident

X Visible wood decay damage was evident in areas
