BUILDING INSPECTION

Complies with Australian Standard AS 4349.1-2007
Inspection of Buildings Part 1: Pre-Purchase
Inspections of Residential Buildings - Appendix C

88a Emmett Street
Narooma, NSW
2546, Australia

Inspection Date: 04 Apr 2017, 9:05 AM to 11:49 AM

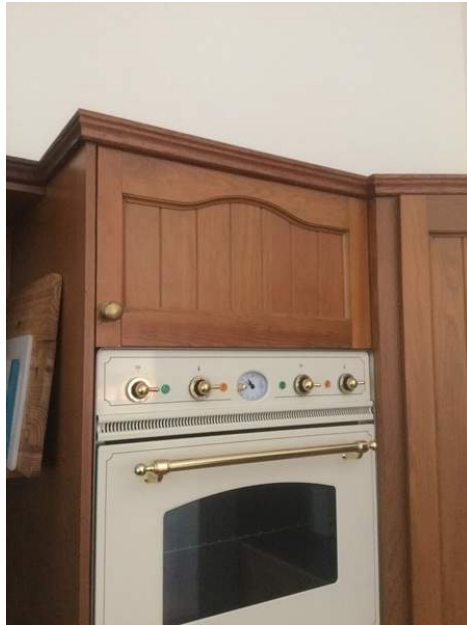
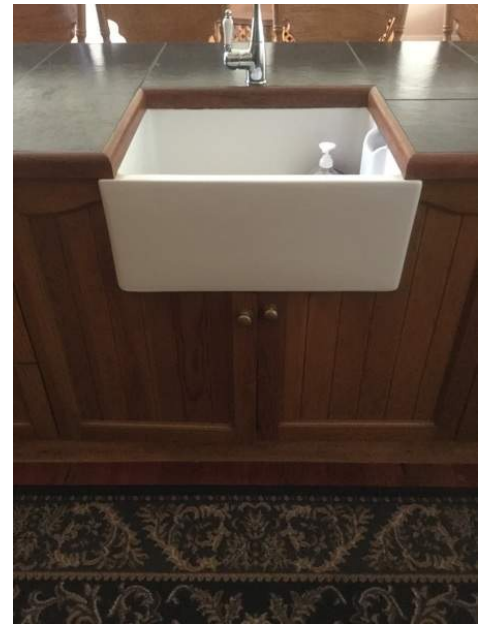
Defect Significance: Minor
Defect Type: E (Operational)

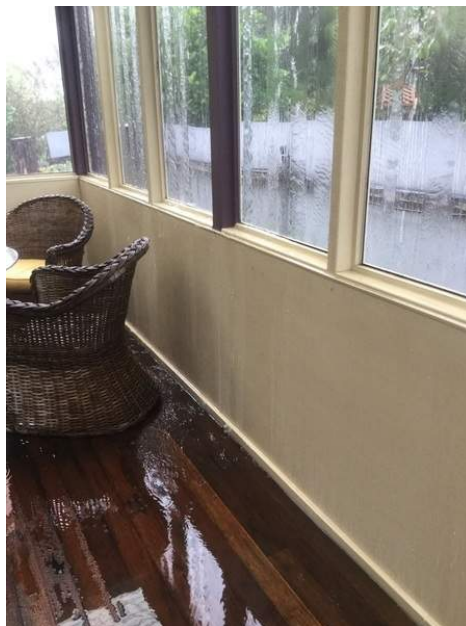
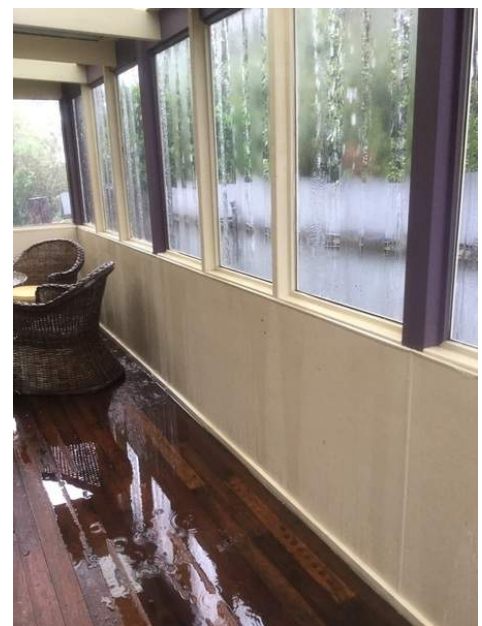
Defect Significance:

Defect Type:

C (Water Penetration Damp Related)

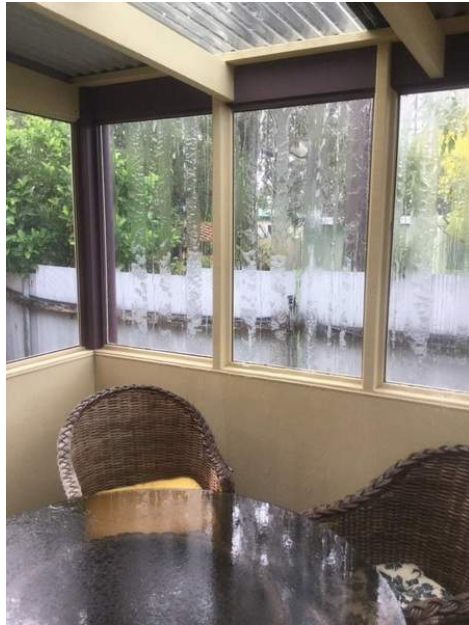
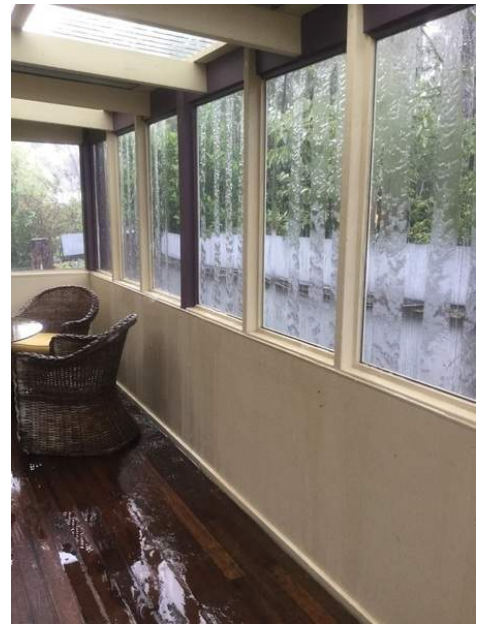
Defect Significance:

Defect Type:

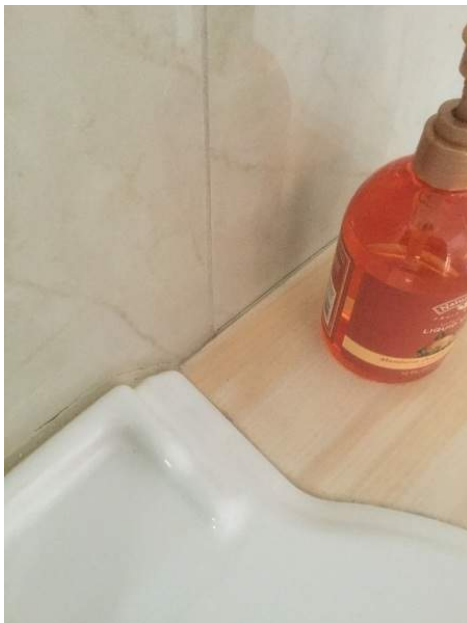
Defect Significance: Minor
Defect Type: D (Material Deterioration: rusting, rotting, corrosion, decay)

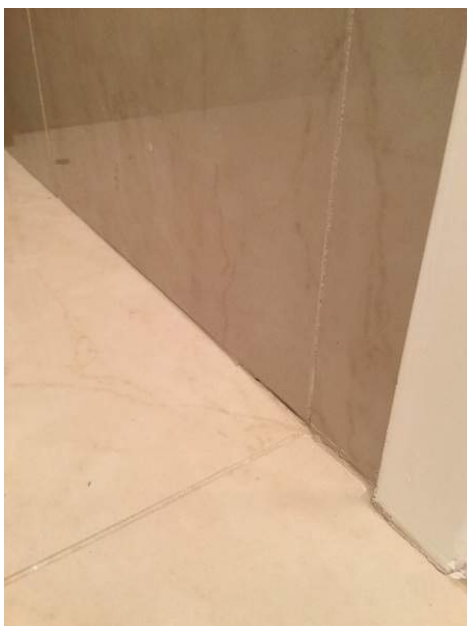
Defect Significance: Minor
Defect Type: D (Material Deterioration: rusting, rotting, corrosion, decay)

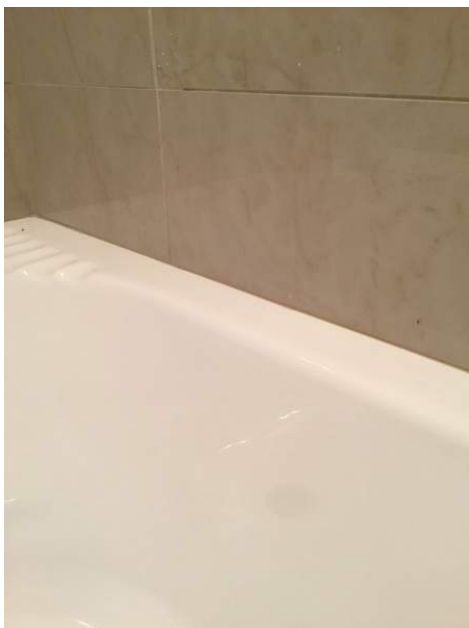
Defect Significance: Minor
Defect Type: D (Material Deterioration: rusting, rotting, corrosion, decay)

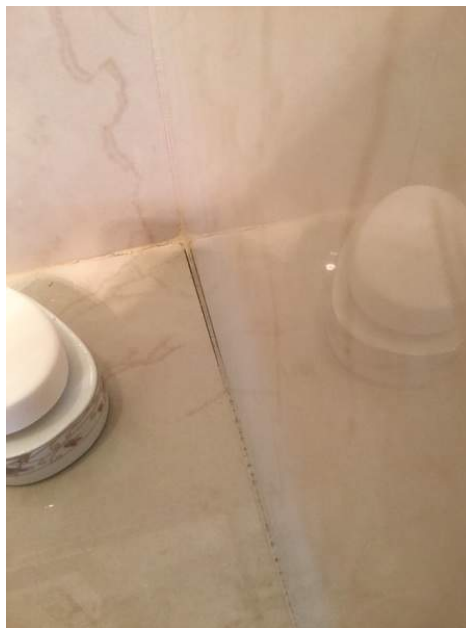
Defect Significance: Minor
Defect Type: D (Material Deterioration: rusting, rotting, corrosion, decay)

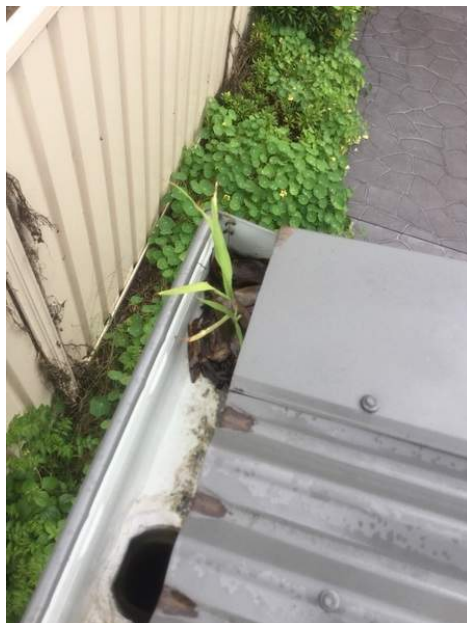
Defect Significance: Minor
Defect Type: E (Operational)

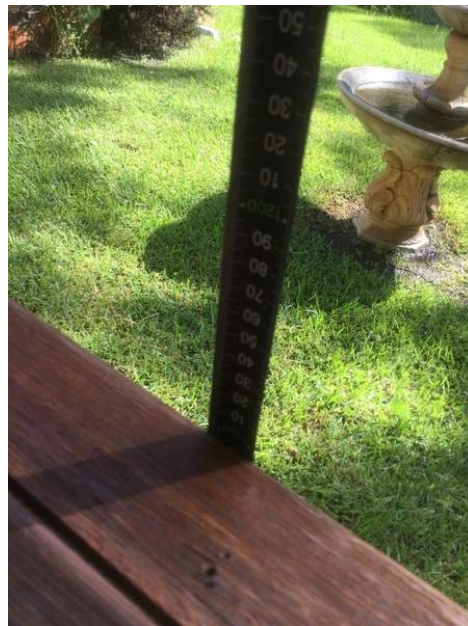
Defect Significance:

Safety Hazard

Defect Type:

E (Operational)

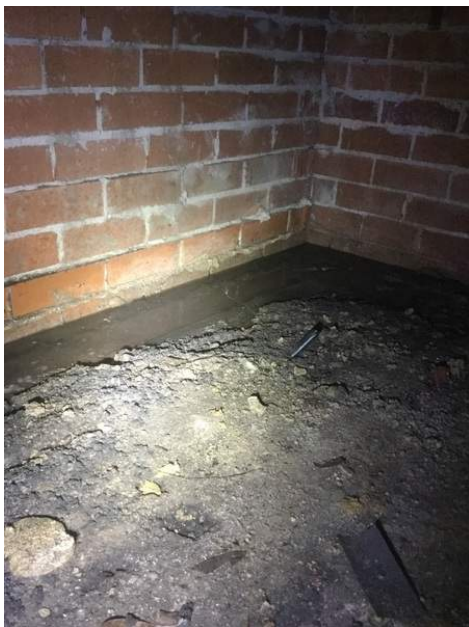
Defect Significance: Major
Defect Type: C (Water Penetration Damp Related)

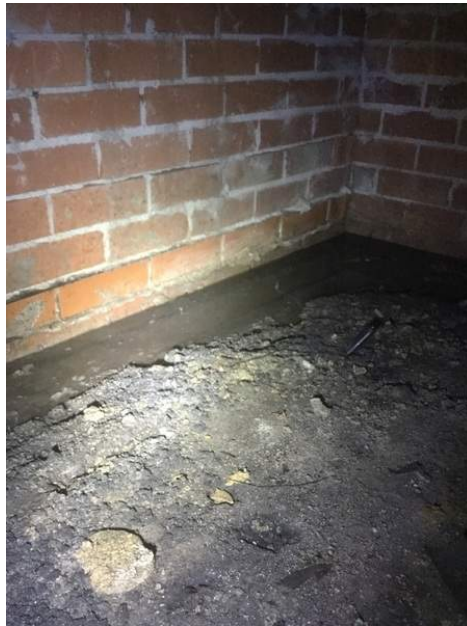
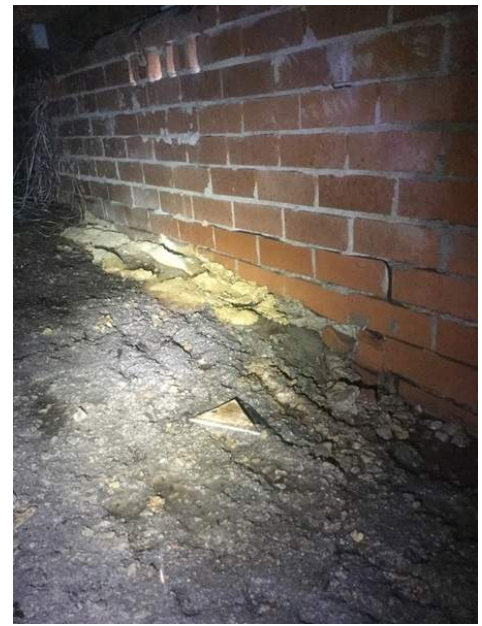
Drainage

✗ Inadequate drainage

Defect Significance: Major
Defect Type: C (Water Penetration Damp Related)

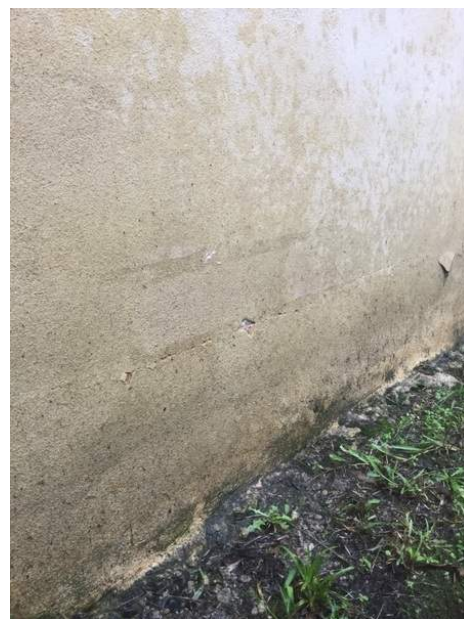
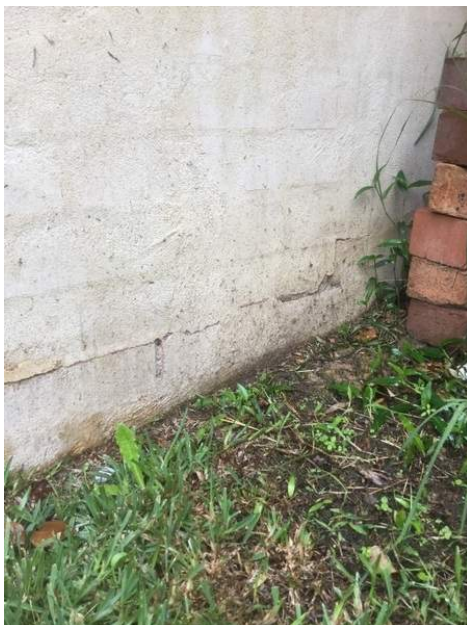
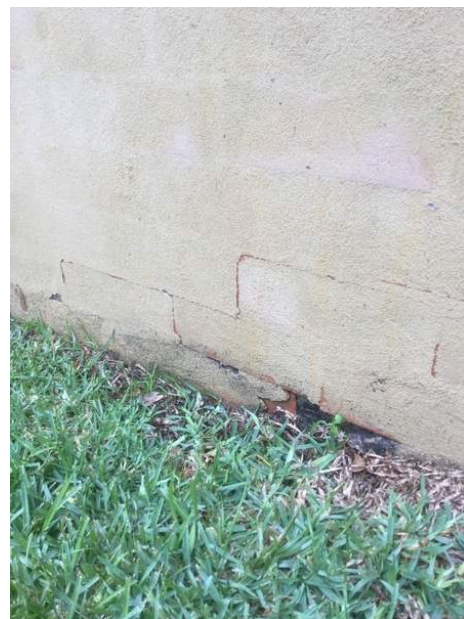
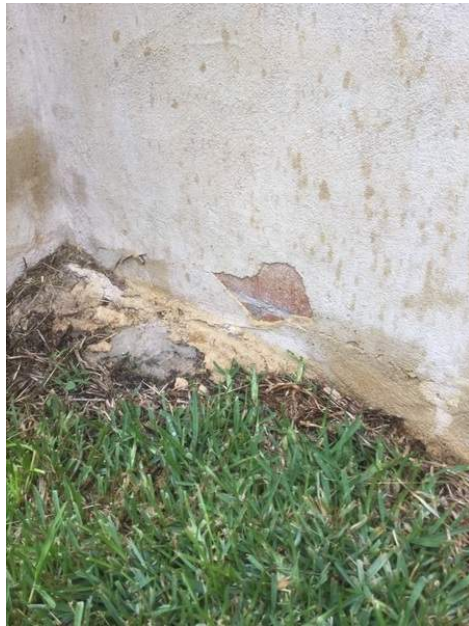
✗ Cracking evident in areas

Defect Significance: Minor
Defect Type: B (Distortion, Warping, Twisting)

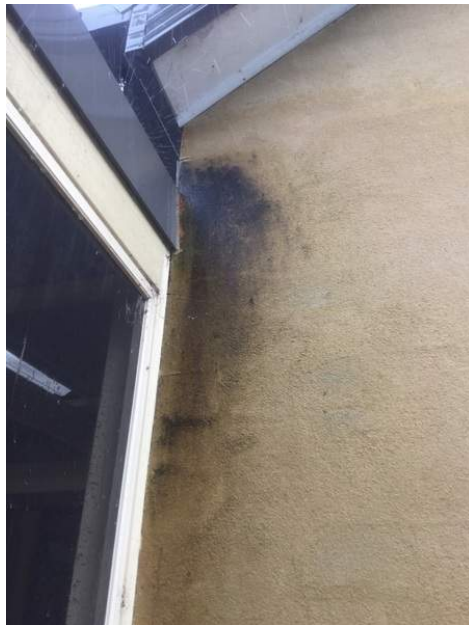
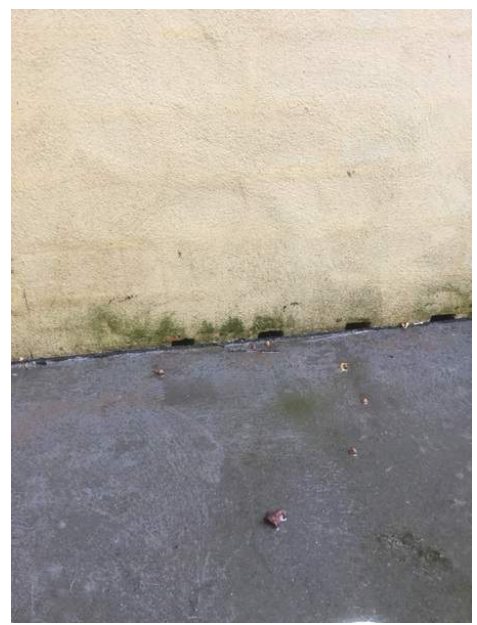
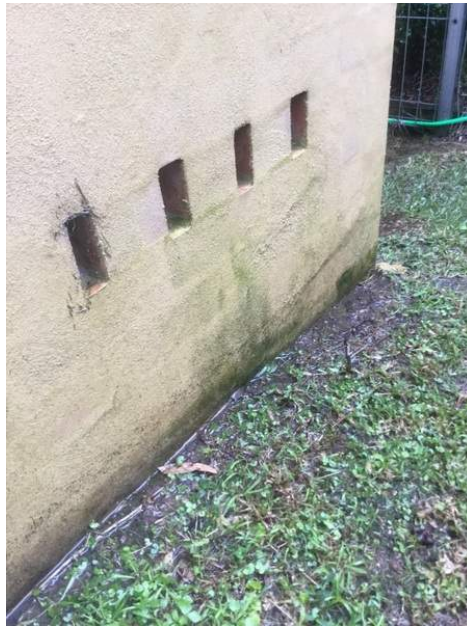
Exterior brick/render finish

✗ The wall is black or green algae affected

Defect Significance: Minor
Defect Type: C (Water Penetration Damp Related)

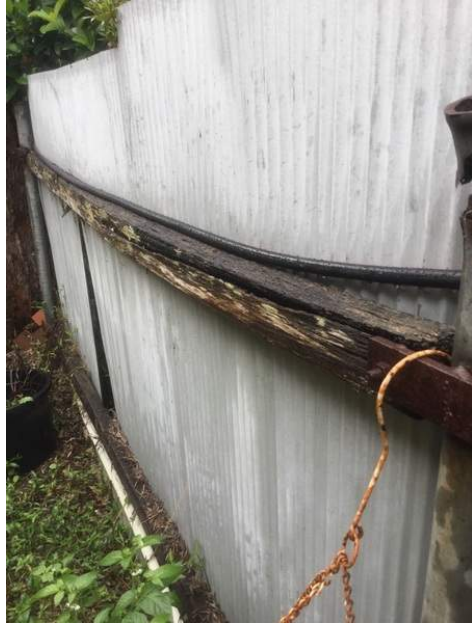
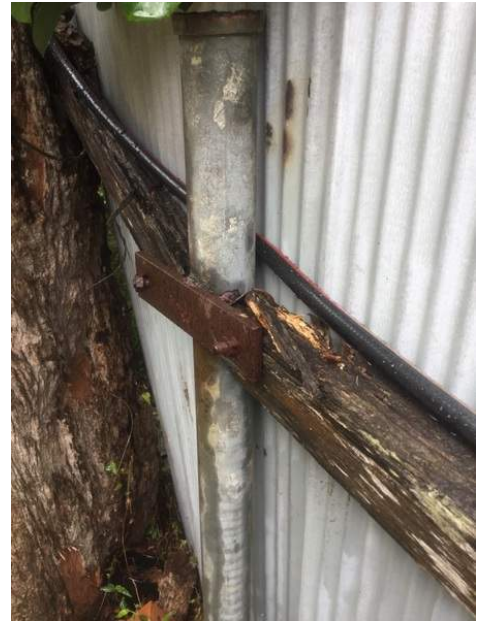
Post & Rail Fencing

Comments :
Defect Significance:
Defect Type:

Significant rust evident on post suggest replacing
Safety Hazard
D (Material Deterioration: rusting, rotting, corrosion, decay)

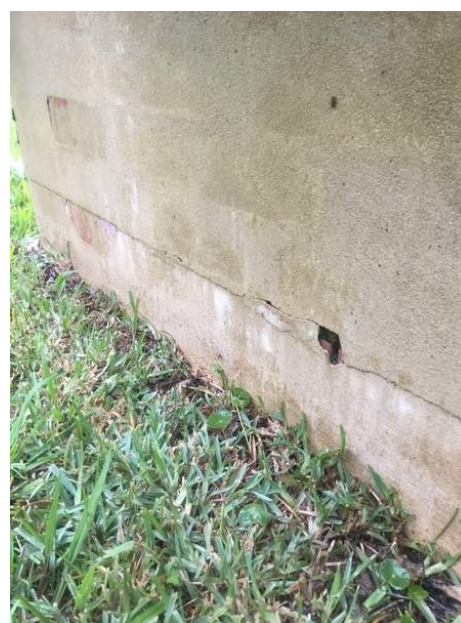
Defect Significance: Minor
Defect Type: D (Material Deterioration: rusting, rotting, corrosion, decay)

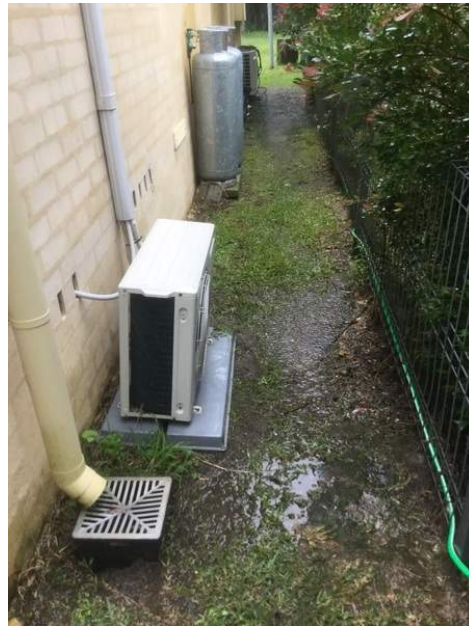
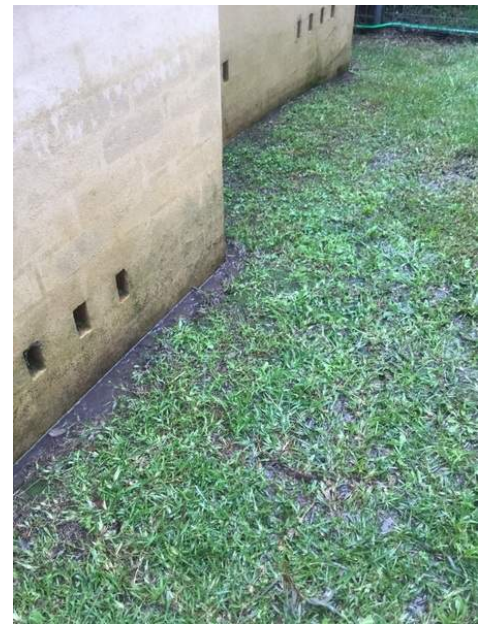
✗ This site has inadequate surface inlet drainage. We recommend that additional site surface run off inlet and or diversion drainage be put into place around this property to protect this dwellings foundation materials.

Defect Significance: Minor
Defect Type: C (Water Penetration Damp Related)

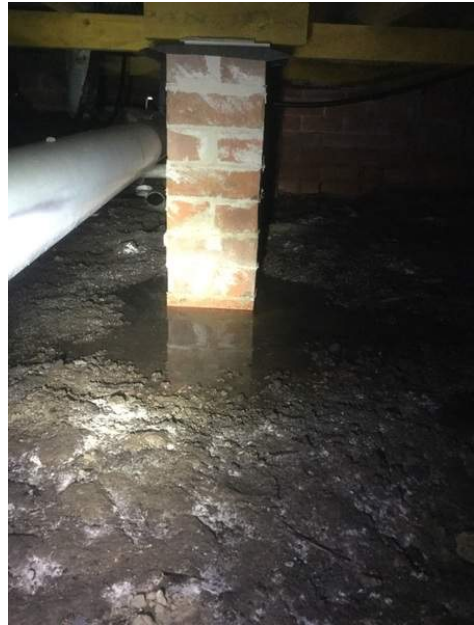
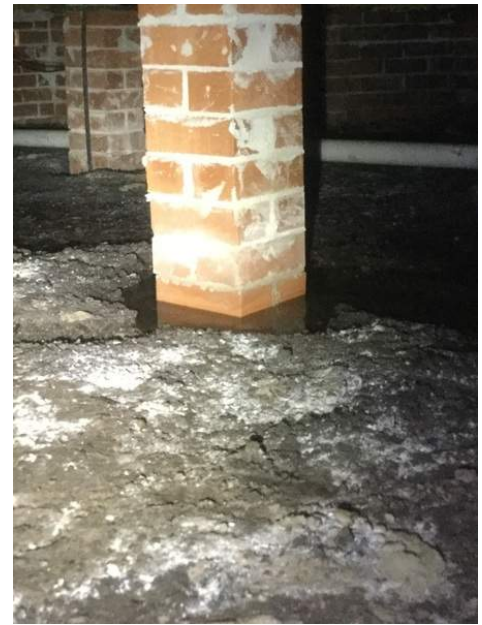
Defect Significance: Major
Defect Type: C (Water Penetration Damp Related)

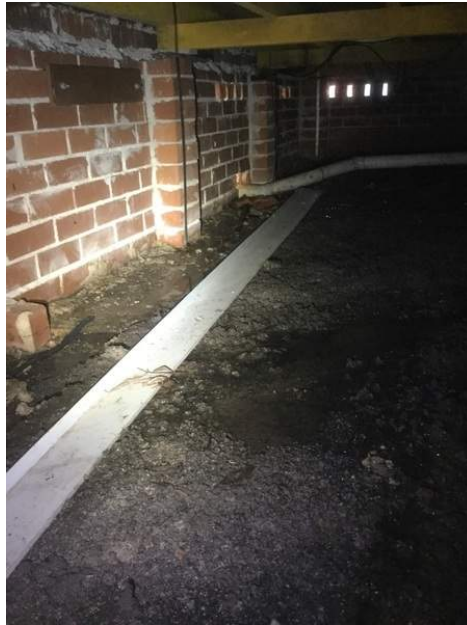
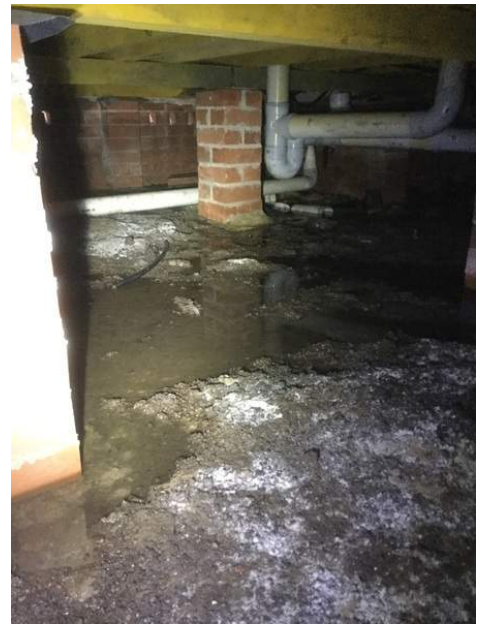
- ✗ Inadequate drainage

Defect Significance: Major
Defect Type: C (Water Penetration Damp Related)

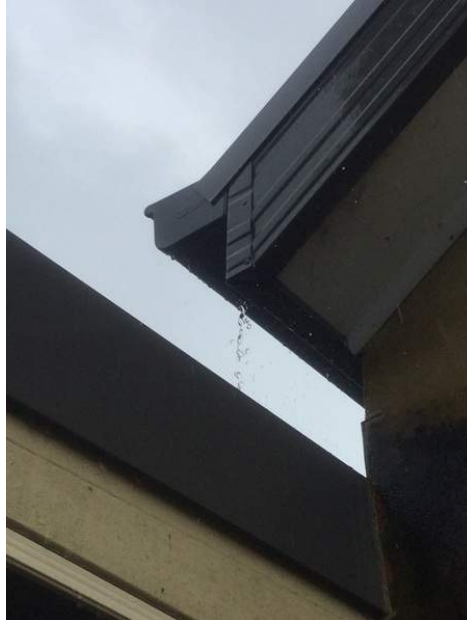
- ✗ Gutters & downpipes are leaking at their joints in areas & need rectification. (Excessive leaking can cause “Conductive” conditions to possible termite attack.) inadequate drainage

Defect Significance: Minor
Defect Type: C (Water Penetration Damp Related)
